Service Bulletin

Subject: Windshield Spalling Or Cracks

Models: 2013 - 2014 Buick Regal

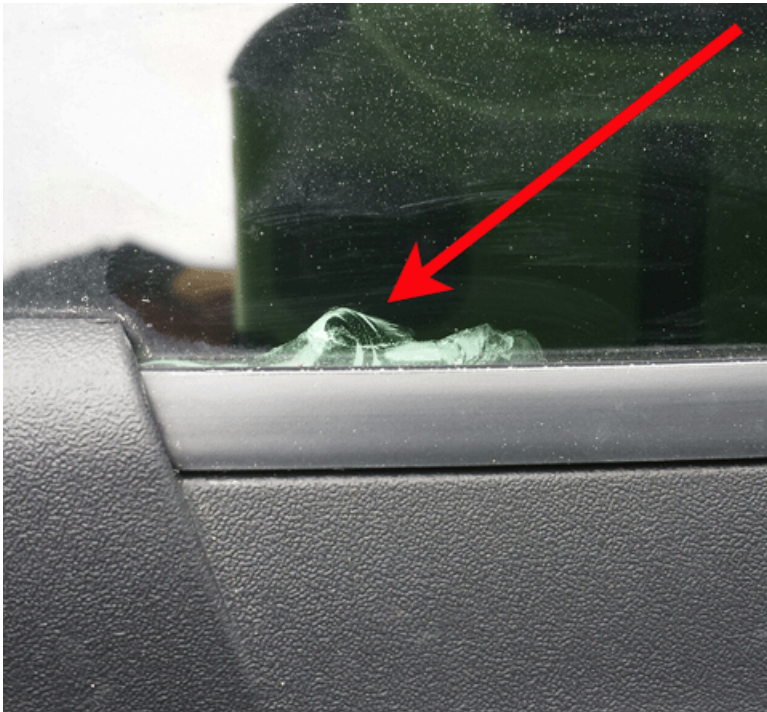
Windshields may have areas of spalling or cracks that cannot be felt from outside the glass. This concern may affect new unsold units as well as customer owned cars. Reference the attached photo which reflects this condition.

These issues were caused by rigid bonding and it generated from a process issue at the supplier
Inspect the windshield. If spalling or cracks are present and no sign of impact is found, replace the windshield.
