# Field Service Campaign

July 2015  
SF513A

## Subject: TBB Mega Fuse Cable Routing

**Models Affected:** Specific Thomas Built Buses Saf-T-Liner C2 with A/C Buses manufactured January 1, 2015, through May 6, 2015.

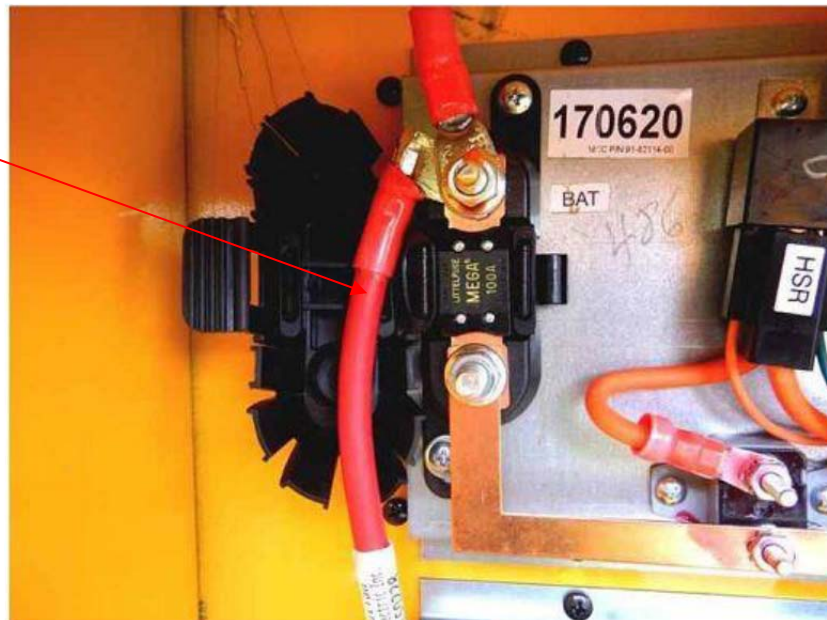
Figure 1, Incorrect Routing

On certain vehicles, the mega fuse cover is not snapping into place to protect the fuse.

NOTE: Refer to **Figure 1**, notice that the battery cable coming from the bottom up to the top and connecting to the input side of the fuse, notice that it is running on the inside of the cover where the cover should fold over.

Cable crossing over where the cover should fold over the fuse

If the cable is routed as shown in **Figure 1**, remove the cable end from the mega fuse and reroute. Go to the next step.

- 3) Remove the cable end from the input on the mega fuse. (Do not allow the input cable from the battery to move off the stud)
- 4) Fold the cover over and run the cable behind the cover. (**Figure 2**)
- 5) Reconnect the cable as shown in **Figure 2**.

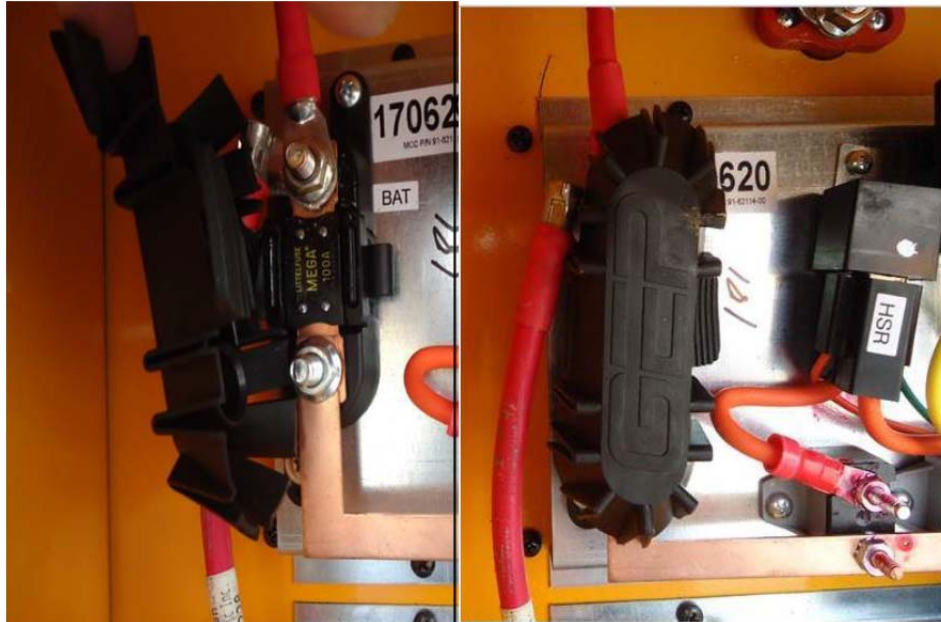
Figure 2, Correct Routing

If the cable is routed as shown in **Figure 2**, no further work is needed. Un-chock the wheels.

- 6) Snap the cover on the mega fuse and verify proper operation of the A/C.
- 7) Un-chock the wheels and reconnect the battery.
