**No.: 15 TS-14**  
July 9, 2015

SUBJECT: **GHG14 DD Engine Cylinder Liner Seal Replacement**

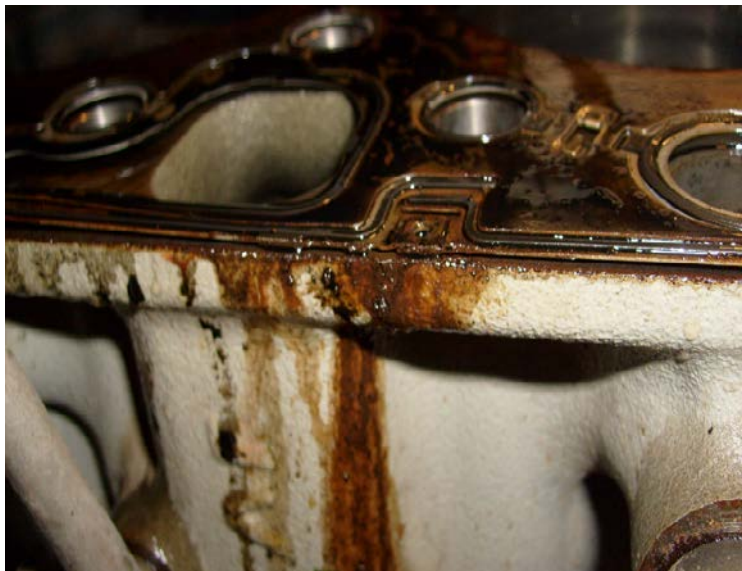
If there is a verified external coolant leak *between* the cylinder head and the cylinder block on a DD engine, the cylinder head must be removed for continued diagnostics. See Figure 1 below.

**Figure 1 External coolant leak between the cylinder head and the cylinder block**

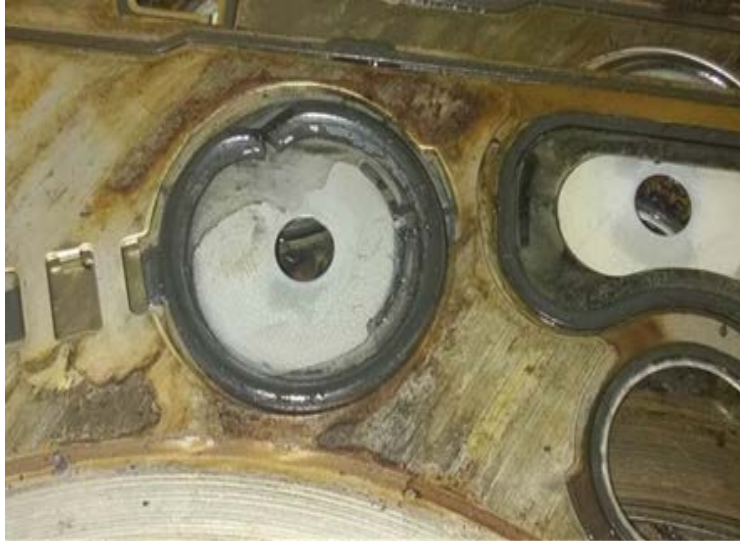
Once the cylinder head has been removed, the cylinder head gasket must be inspected for de-bonded or folded grommets at the cooling passages. See Figure 2 below.

**Figure 2 Example of a failed cooling passage grommet on the cylinder head gasket**

If the head gasket is found to be failed, no further repairs are necessary beyond the head gasket. There is no reason to remove the cylinder liners and replace the liner seals. Removing the cylinder liners adds unnecessary cost and customer downtime.

**Warranty claims for GHG14 cylinder liner seal replacement with failed head gasket coolant grommets may be reduced or partially charged back as over repair.**
