**Title:** Upper Radiator (Inlet) Hose Saddle Clamp Causing Leaks

**Applies To:** DuraStars and CE Buses with Cummins ISB

## DESCRIPTION

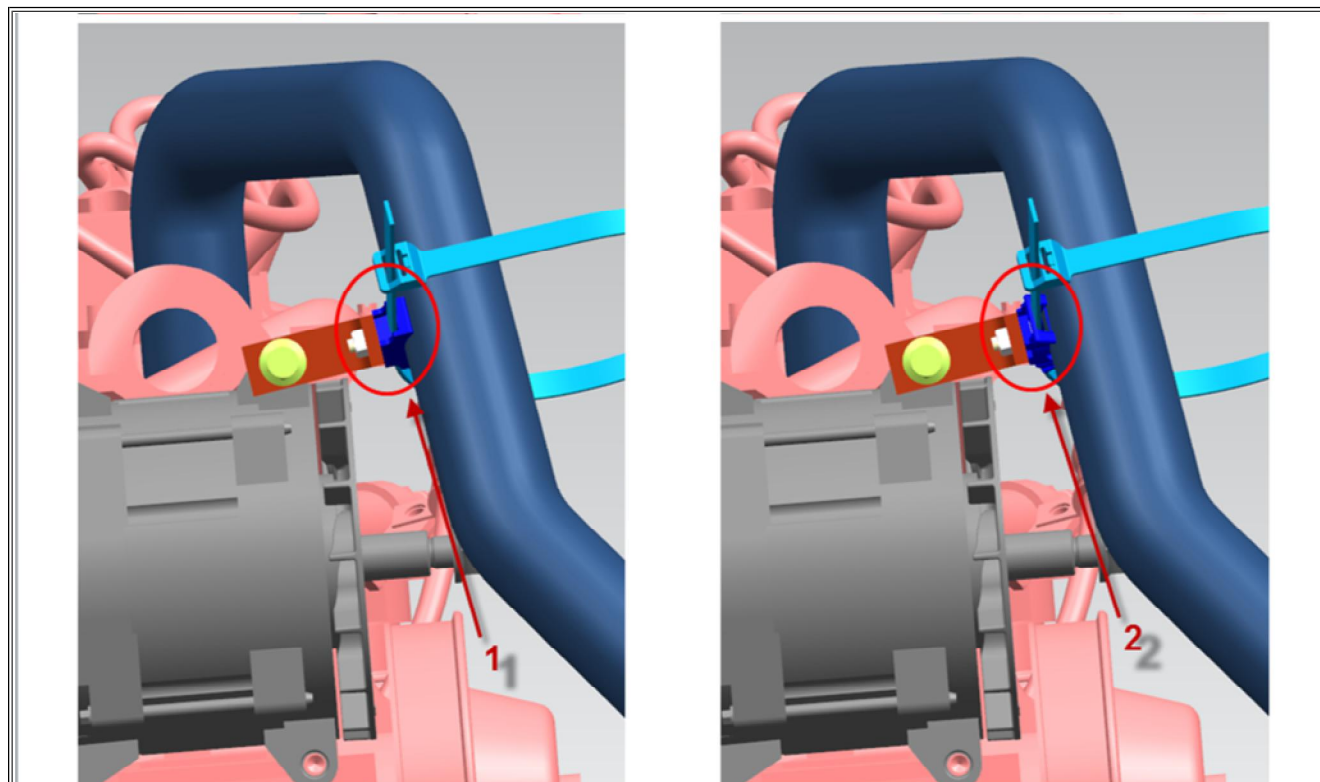
**Figure 1: Old and new design of saddle clamp**

Item 1: Old design - P/N 2041341C1

Item 2: New design - P/N 4039319C1

Visually inspect for rubbing/hose damage. See **Figures 1 and 2** for comparison of old and new saddle clamp design. If the hose is punctured and the saddle clamps are the old design, replace hose and replace saddle clamps with new design.

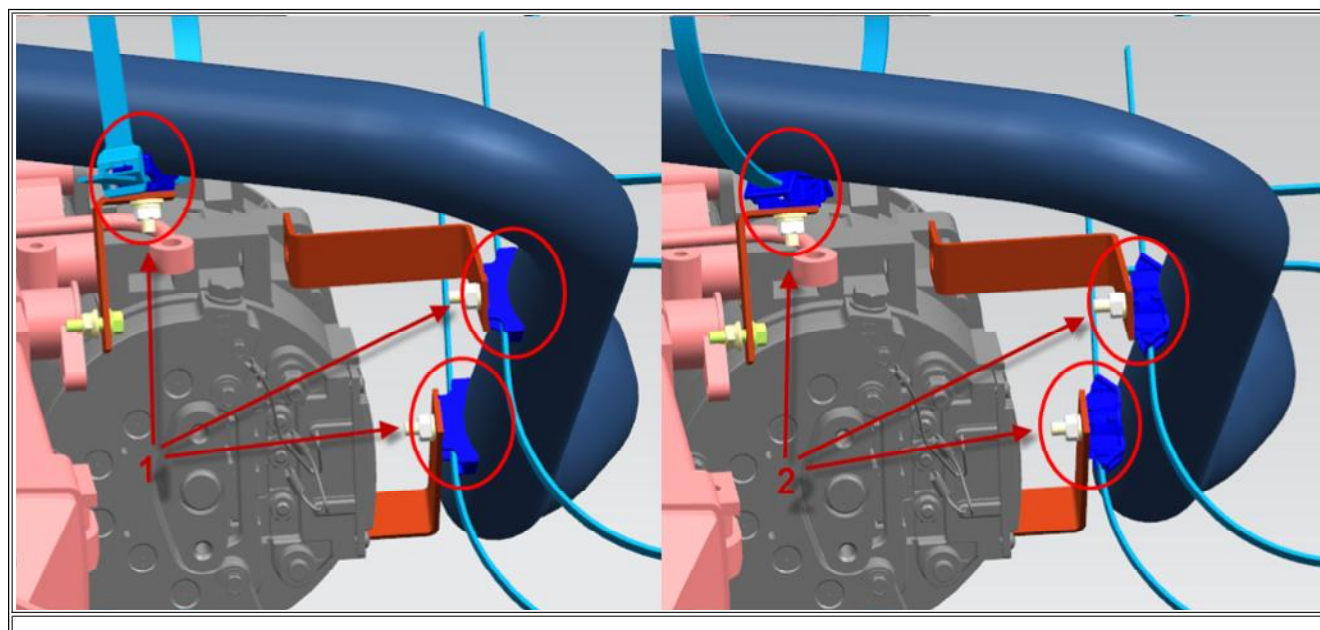
**Figure 2: Old and new design of saddle clamp**

Item 1: Old design - P/N 2041341C1  
Item 2: New design - P/N 4039319C1

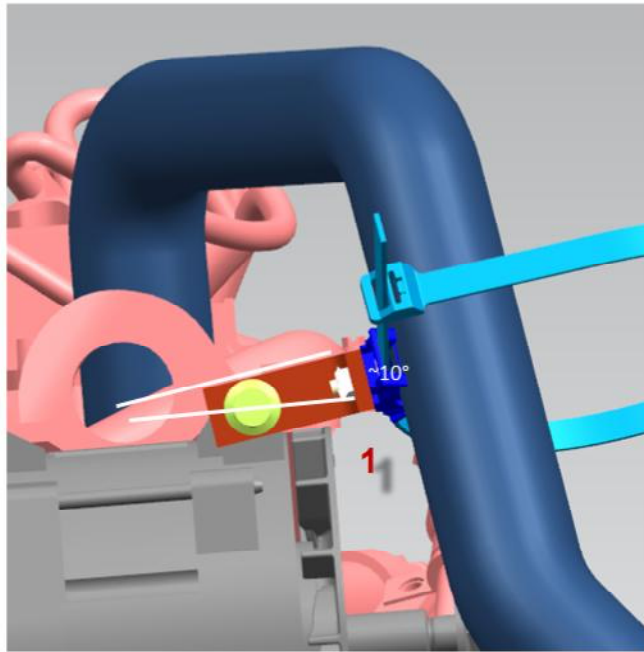
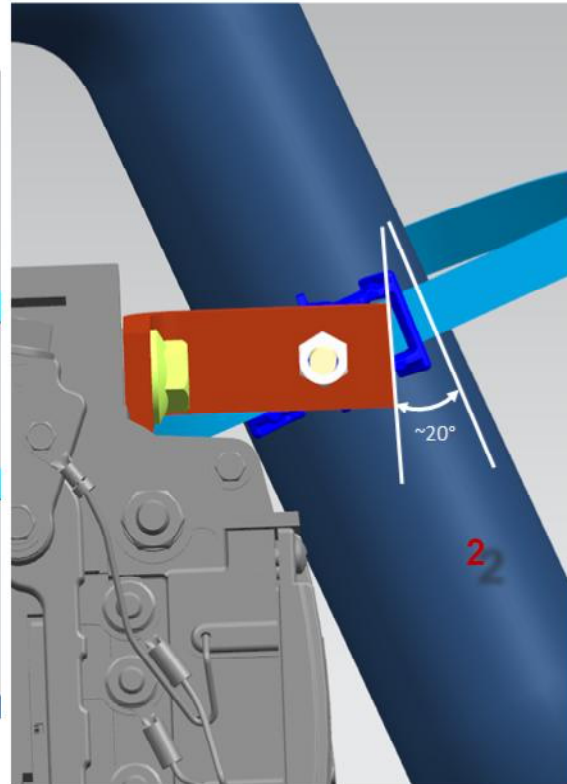
**Figure 3: Engineering specifications for saddle clamp and extension bracket**

Item 1: Extension bracket angled up from parallel  $\sim 10^\circ$ .  
Item 2: Saddle clamp angled  $\sim 20^\circ$  up from parallel. Axis of saddle should align with axis of hose.

1. Remove old zip straps and saddle clamps.
2. Replace upper radiator hose.
3. Install new saddle clamp and zip strap, as shown in **Figure 3**. The angle of both the extension bracket and the saddle clamp in relation to the bracket must be correct, otherwise rubbing can occur.

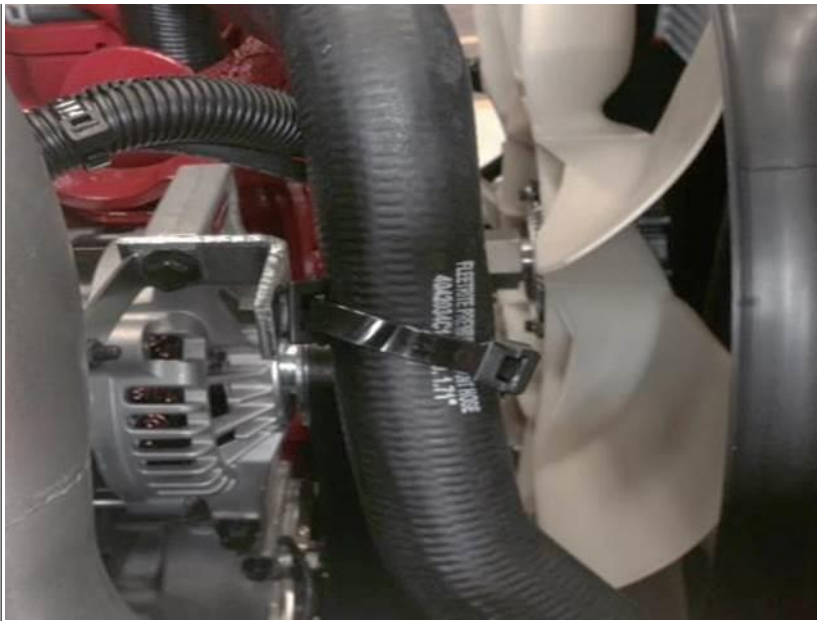
Figure 4: Issues - zip strap loose, extension bracket not at correct angle and saddle clamp is off angle

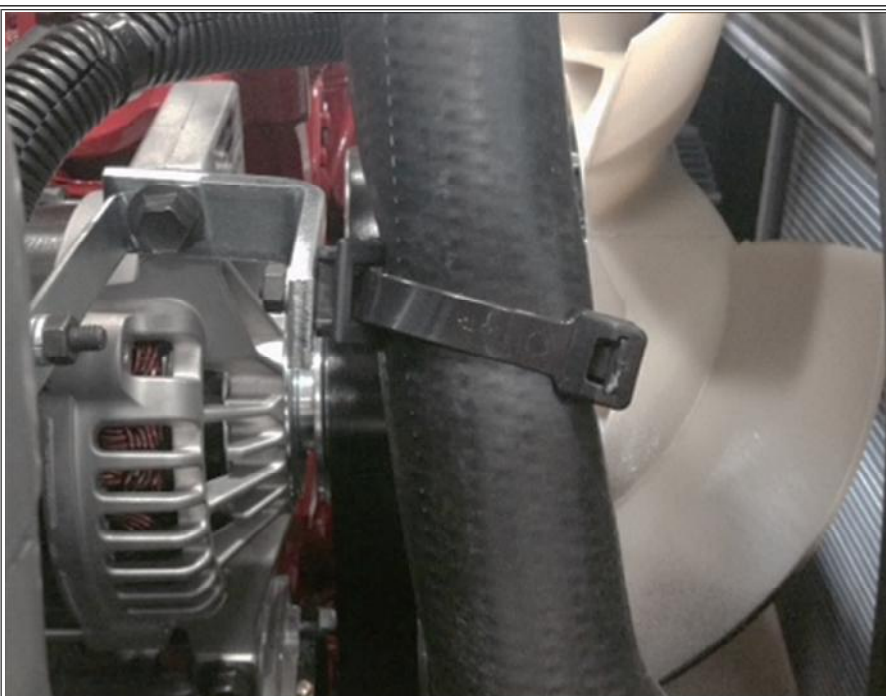
Figure 5: Issues - zip strap over tight, saddle clamp at incorrect angle, and extension bracket at incorrect angle causing saddle and strap to dig into hose

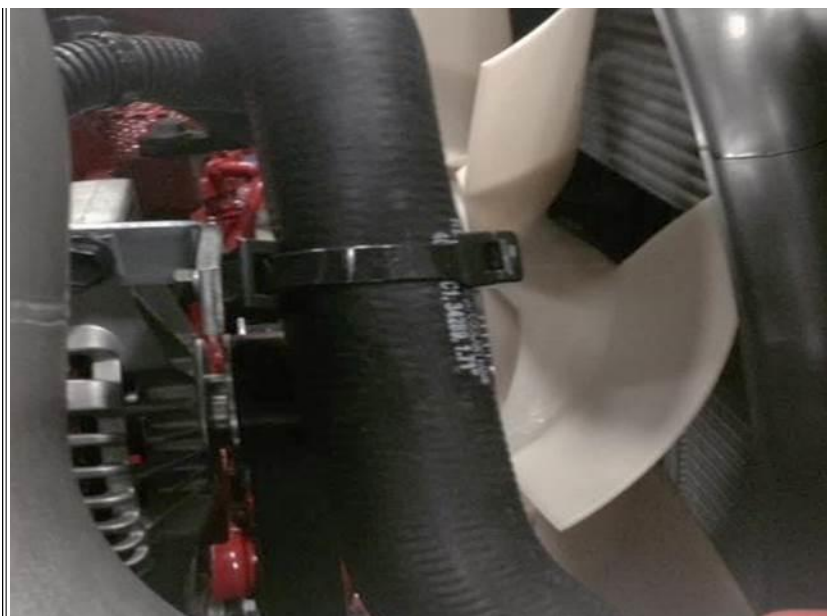
Figure 6: Unit assembled to specifications
