Title: I-6 MAF Sensor Calibration Diagnostics

Applies To: 2010 + MaxxForce DT, 9, 10, N9 & N10 (ESN 3,300,000 and later)

This document provides diagnostic steps for MAF sensor calibration failures.

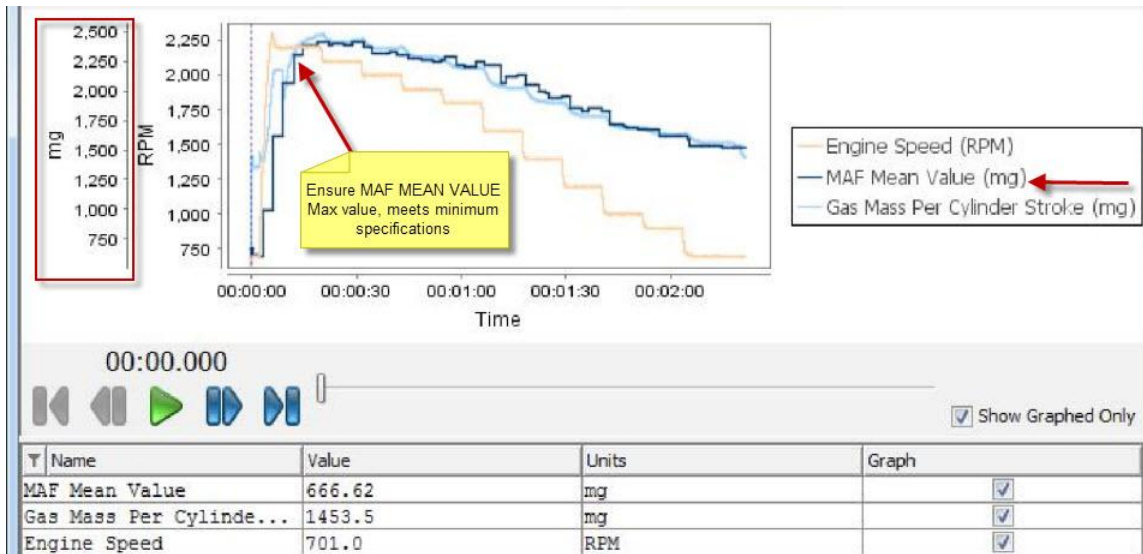
8	Using terminal test kit, inspect connections at the MAF Air Flow (MAF) sensor. With key OFF, disconnect MAF sensor connector. Check MAF sensor and connector for the following: Damaged or pinched wires Corroded terminals Loose, bent, or broken pins Broken connector housing. Are the MAF sensor connector, harness, and terminals clean and undamaged?	Yes: Continue to Step 9
		No: Repair connector, harness, or terminal damage. After repairs are complete, clear the code, and retest for the fault.
9	Check if unit is a Monaco RV and check ServiceMaxx's default page under Vehicle Information for rated power. Is the unit a Monaco RV with rated power of 350 HP?	Yes: If unit has good power and no issues other than passing a MAF calibration. Please open a case file and request MAF A/B coefficient programming.
		No: Continue to Step 10
10	Perform & record MAF Sensor Calibration if one was not already recorded. Plot MAF Mean Value, Gas Mass per Cylinder Stroke and Engine Speed (Excel or in ServiceMaxx). Graph 2 Is MAF Mean Value > (greater than) 1500 MG?	Yes: Continue to Step 12

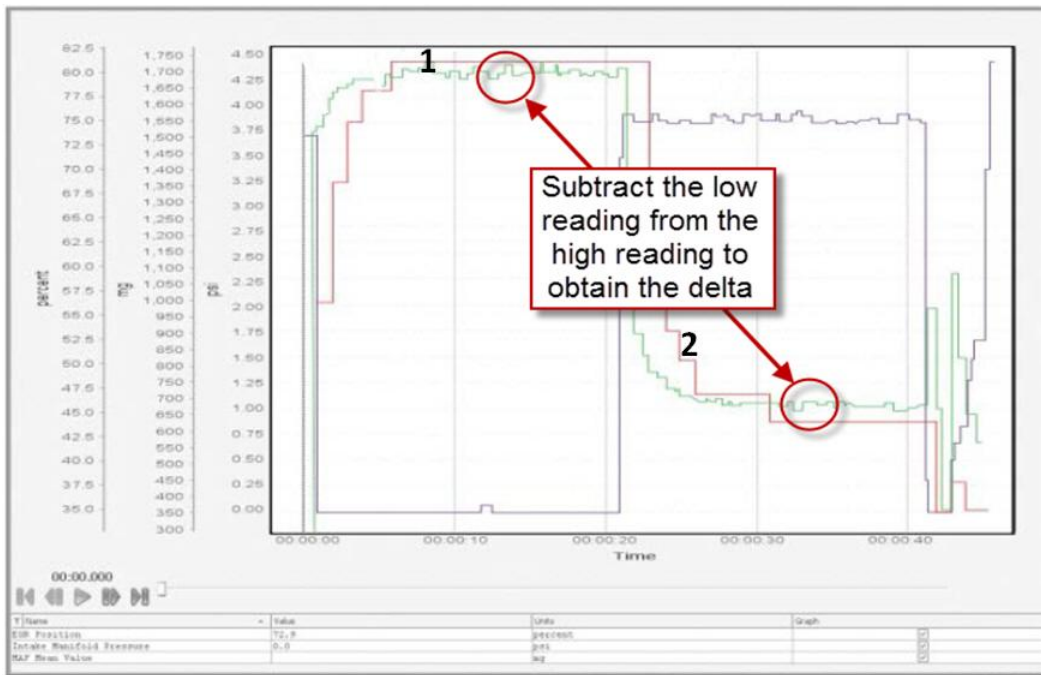
Step	Action	Decision
12	<p>Perform & Record Air Management Test.</p> <p>MAF Mean Value Delta obtain the reading by subtracting the high reading in the beginning of the test to the low reading near the end as shown below in Graph 3:</p> <ol style="list-style-type: none"> 466 ST ≥ 690 mg 466 HT ≥ 740 mg 570 ≥ 850 mg <p>Intake Manifold Pressure (IMP) Graph 4:</p> <ol style="list-style-type: none"> 2 + PSI <p>Does Air Management test meet specifications listed above?</p>	<p>Yes: Continue to Step 16</p> <p>No IMP: Continue to Step 16</p> <p>No MAF Delta: Continue to step 13</p>

Graph 3
 1. MAF Mean Value High Point
 2. MAF Mean Value Low Point

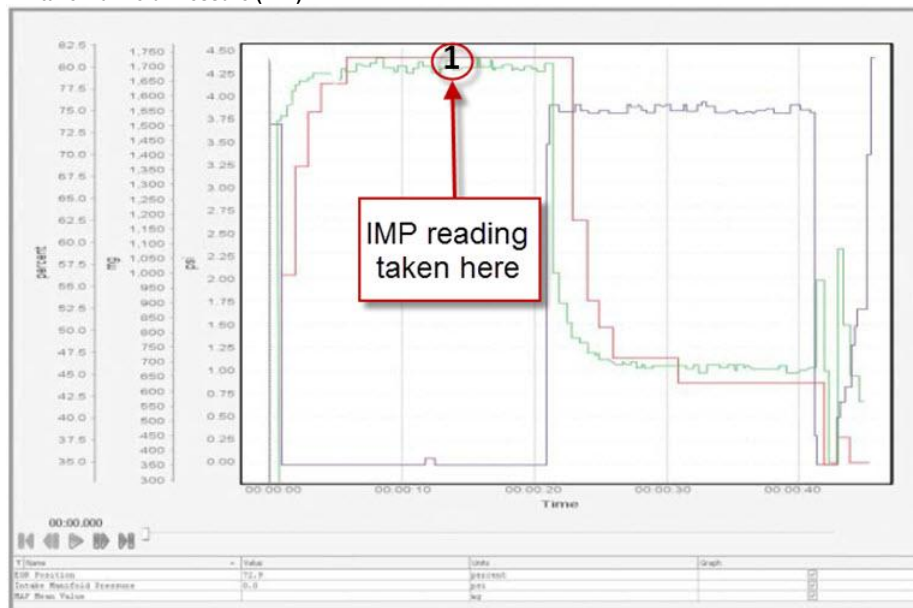
Graph 4
1. Intake Manifold Pressure (IMP)
