**Document ID:** IK1201198  
**Revision:** 2  
**Created:** 8/27/2014  
**Last Modified:** 8/24/2015  
**Author:** Josh Bowman

**Title:** MaxxForce 15L Engine Oil Leaks

**Applies To:** EPA 2011 MaxxForce 15L Engine

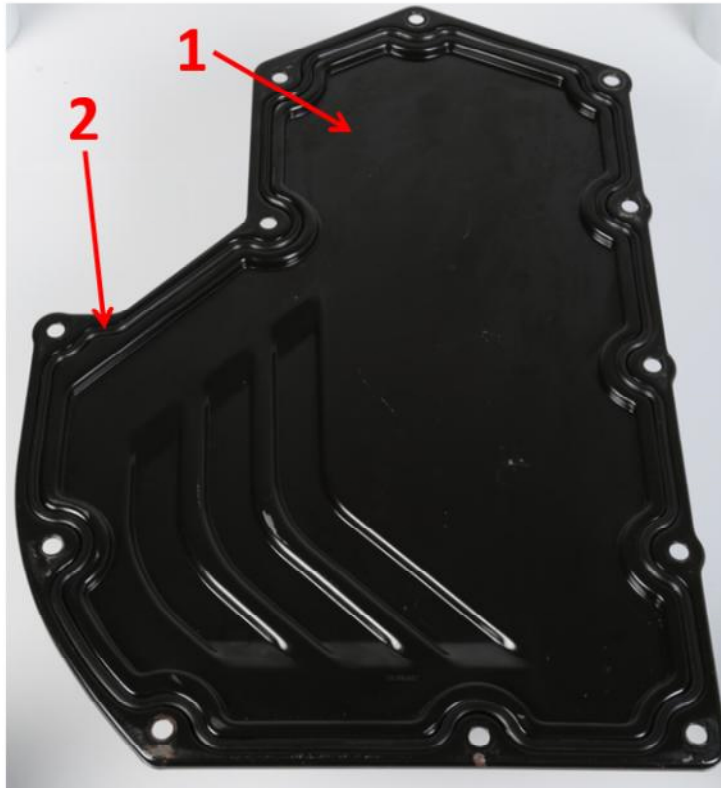
**Figure 2: Gasket Front Cover Plate**

Item 1: Front Cover Plate

Item 2: Gasket

2. Once you have the camshaft gear cover removed, remove and discard the camshaft gear cover gasket
3. Clean gasket mating surfaces
4. Install new camshaft gear cover gasket with **Loctite 515** on both sides

5. Follow the Engine Service Manual (0000001746) for the correct procedures and torque specifications when assembling

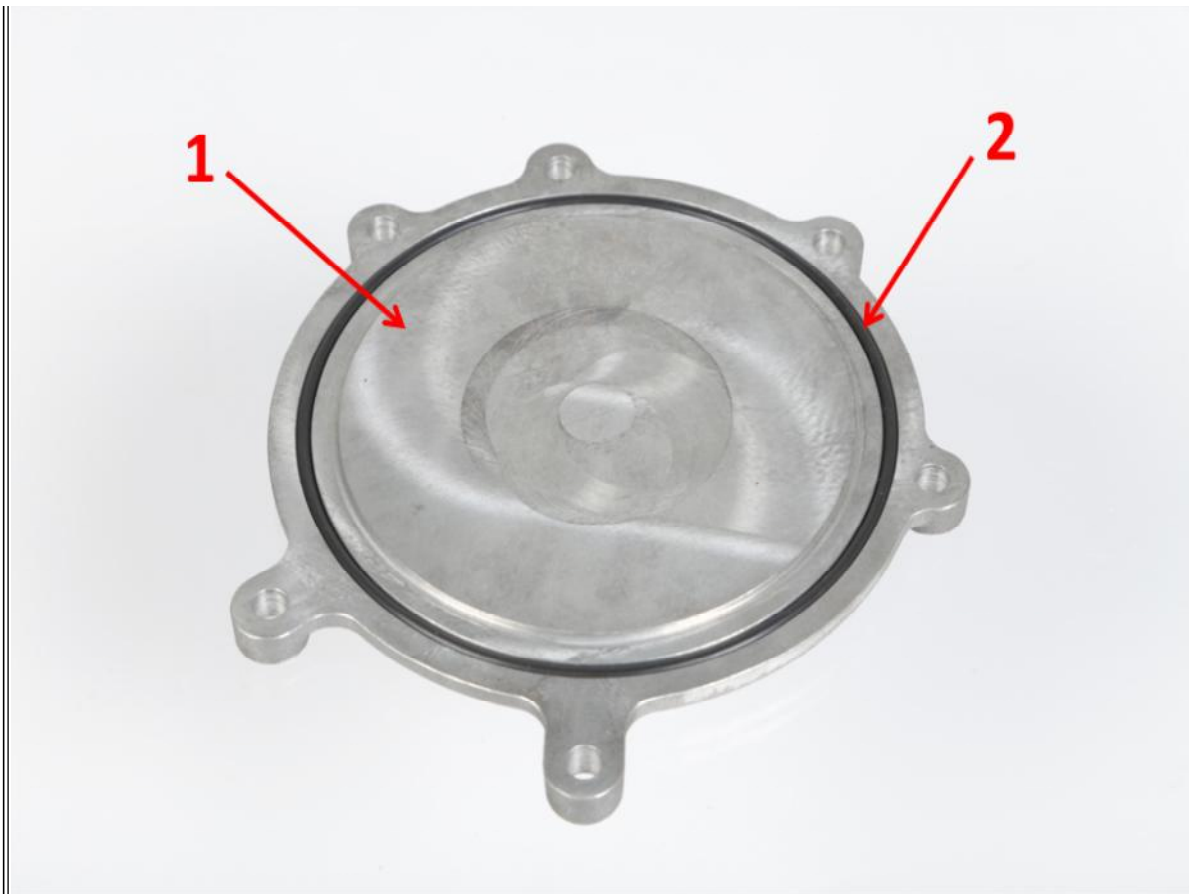
**Figure 4: Cover**

Item 1: Cover

Item 2: O-ring

2. Once you have the high-pressure pump gear cover removed, remove and discard the O-ring from the cover plate
3. Clean O-ring mating surfaces
4. Install new cover plate O-ring with **Loctite 515** on both sides

5. Follow the Engine Service Manual (0000001746) for the correct procedures and torque specifications when assembling

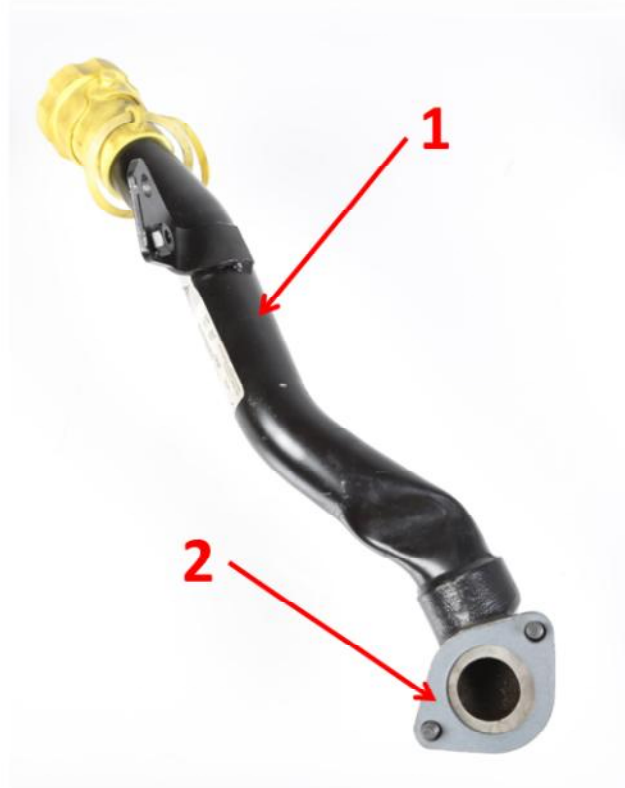
**Figure 6: Oil Fill Pipe Gasket**

Item 1: Oil Fill Pipe

Item 2: Gasket

2. Once you have the oil fill pipe removed, remove and discard the gasket from the fill pipe and/or front cover
3. Clean gasket mating surfaces
4. Install new oil fill pipe gasket with **Loctite 515** on both sides

5. Follow the Engine Service Manual (0000001746) for the correct procedures and torque specifications when assembling

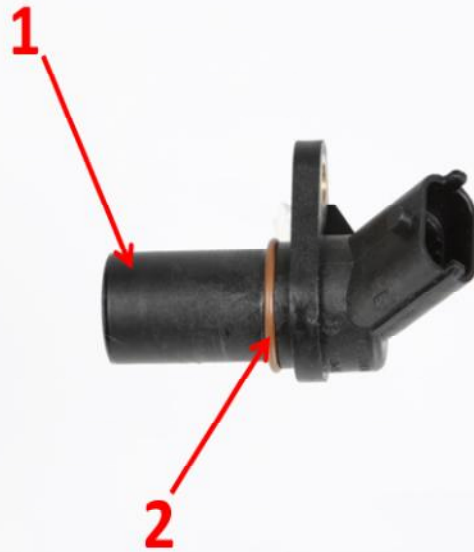
**Figure 12: CKP (crankshaft position)**

Item 1: CKP (crankshaft position) Sensor

Item 2: CKP (crankshaft position) Sensor O-ring

2. Once you have the CKP (crankshaft position) sensor removed, discard the sensor
3. Obtain new CKP (crankshaft position) sensor and apply **Loctite 515** on both sides of O-ring

4. Install new CKP (crankshaft position) sensor

5. Follow the Engine Service Manual (0000001746) for the correct procedures and torque specifications when assembling
