US 60981339-01

Aluminium Case Does Not Fit Correctly

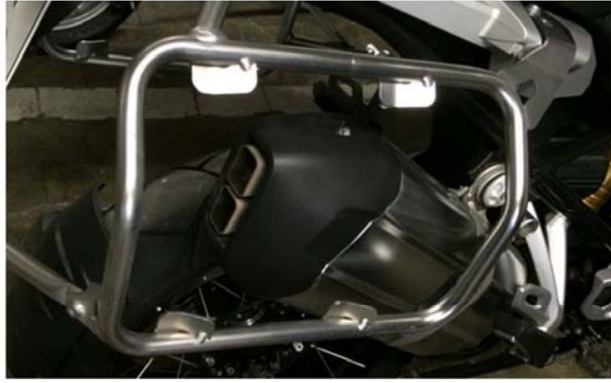
Picture 1 shows the mount with the four tabs that engage the case.

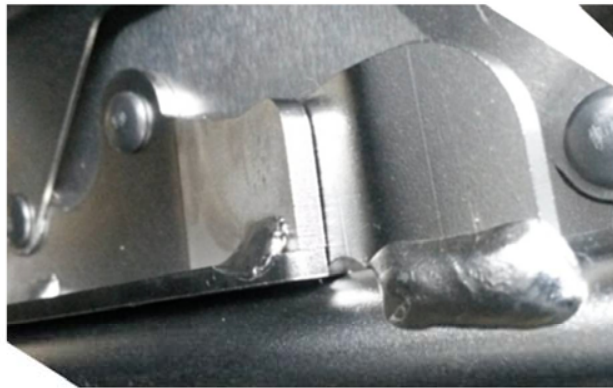
Picture 2 shows a tab that is properly aligned.

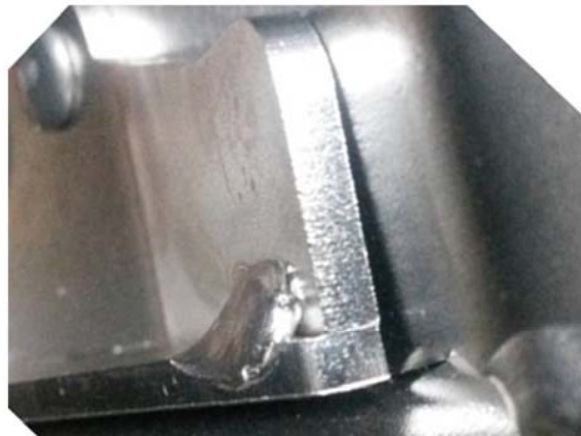
Fault with the welding jig resulting in improperly aligned tabs on the case mount.

Picture 3 shows a tab that is improperly aligned.

If the mount is defective, as shown in picture 3, order a new mount and claim under  
warranty
