US 60576836-01

Top case lock barrel lost

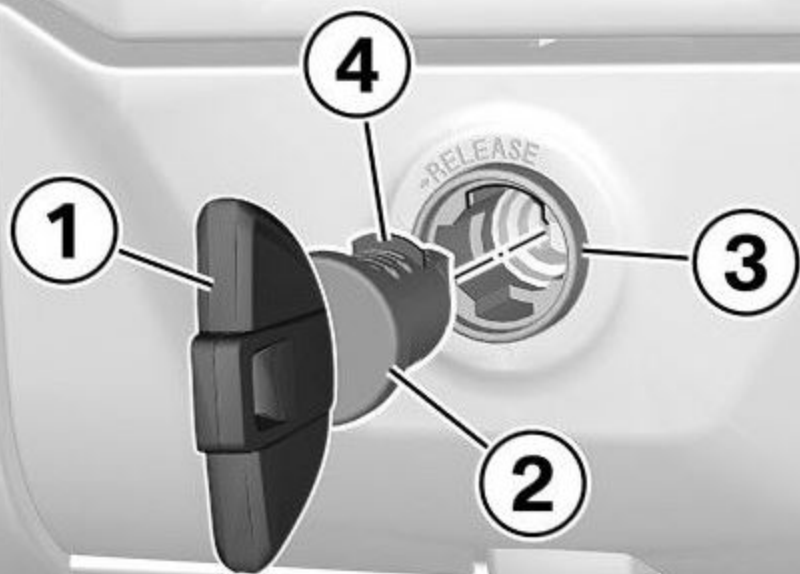
The lock barrel from the top case is lost.

The lock barrel was fitted with the retaining tab 180° from the proper installation position, consequential the lock barrel is lost.

Referencing the attached picture,

Insert the key (1) into the lock barrel (2).

Lubricate the lock barrel (2) with an appropriate lubricant..

Completely insert the lock barrel (2) with key (1) into the lock housing (3) with the retaining plate (4) facing "RELEASE". If required, turn the lock barrel (2) slightly.

The retaining plate (4) snaps into place (audibly).

The lock barrel (2) is securely fitted in the lock housing (3) and can no longer be pulled out.

You must then ensure that a complete functional check on the top case has been carried out and that the lock barrel has locked into place and cannot be pulled out.
