US 62352646-02

New diagnostic connector location

New diagnostic plug (OBD plug)

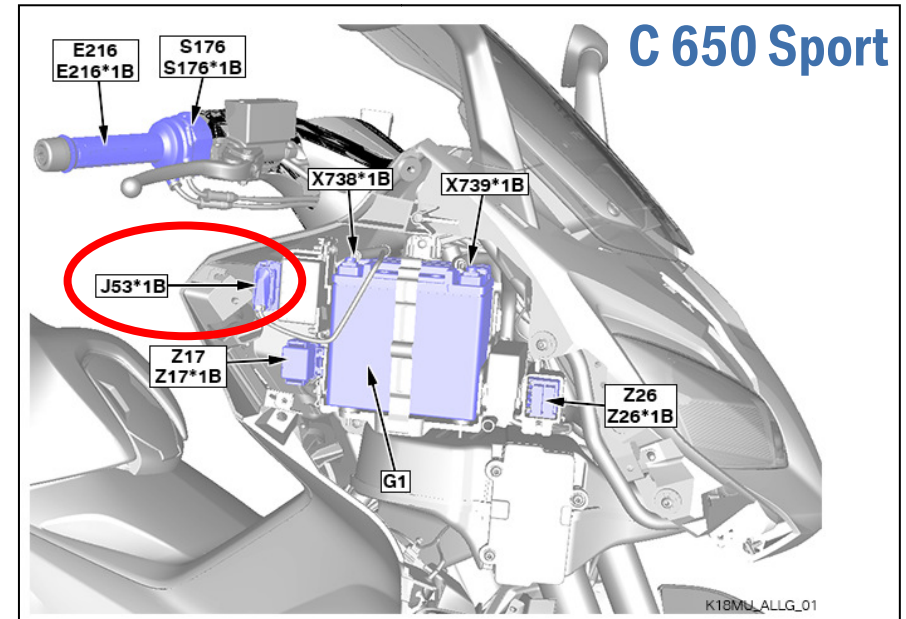
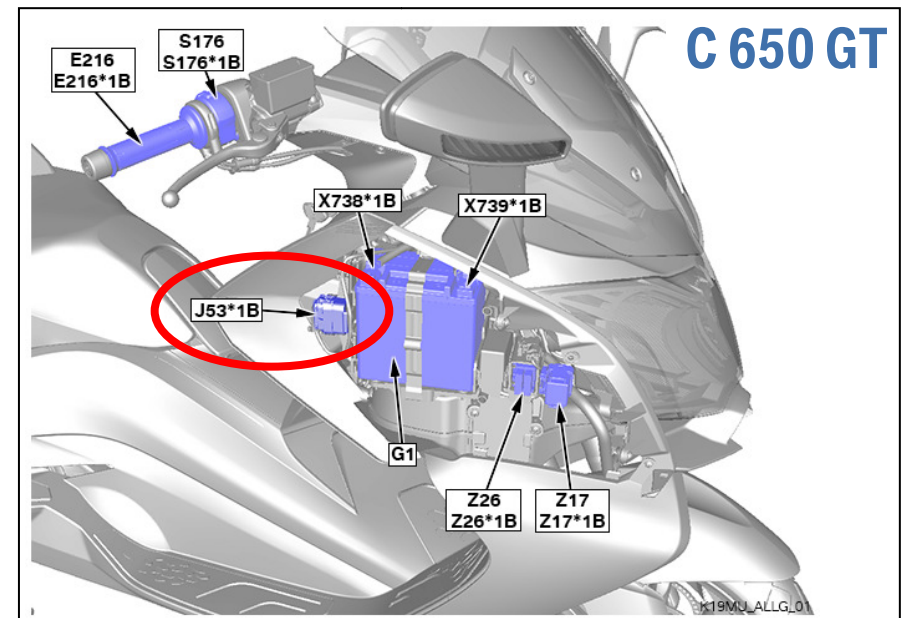
The diagnostic connector (OBD - On Board Diagnosis) is located under the front right side trim panel next to the battery (see attachment).

To access the diagnostic plug on these bikes, remove the side cover on the right-hand side. Refer to the vehicle manual or to the proper repair instructions.

Directly connect the ICOM-A to the new OBD diagnostic connector. The ICOM-D is not needed.
