GROUP: Body

Replace Missing Manual Release Cover For The Electric Fuel Door

This bulletin involves installing a cover for the fuel door manual release cable.

Jeep Renegade (Latin America Vehicles Only)

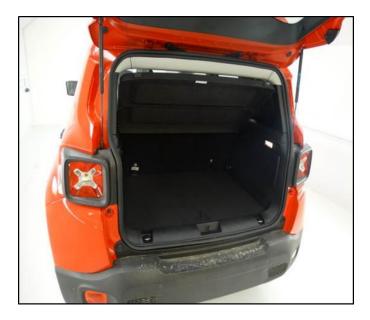
Fig. 1 Rear Hatch

1. Open the rear hatch (Fig. 1).

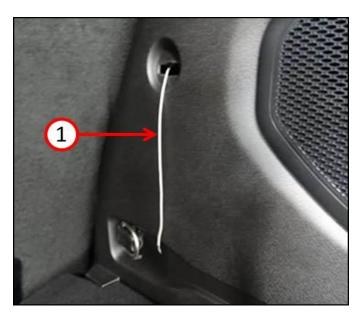
The customer may describe a loose cable hanging in the right rear of the cargo compartment area.

2. If cover is not present and cable (1) is hanging perform the repair (Fig. 2).

1 - Cable

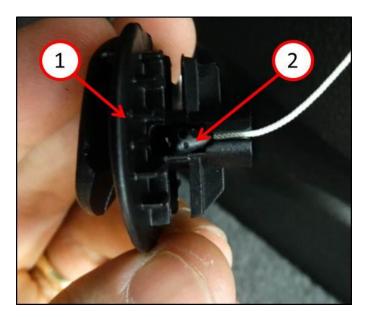
Fig. 3 Cable Insertion

1 - Cover

2 - Cable

3. Install the cable (2) onto the new cover (1) (Fig. 3).

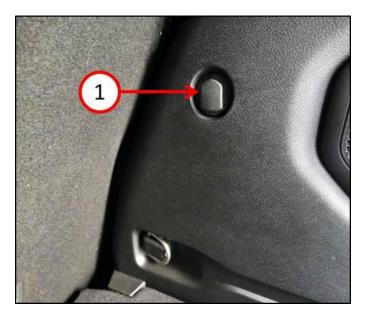
Fig. 6 Cover Installed

1 - Cover

6. Make sure the cover (1) is flush and installed properly (Fig. 6).
