NUMBER: 08-065-15

Front Seat Bottom Cushion Hard Or Lumpy Spot

2015 (UF) Chrysler 200
(NAFTA, Europe, Middle East, South Africa)

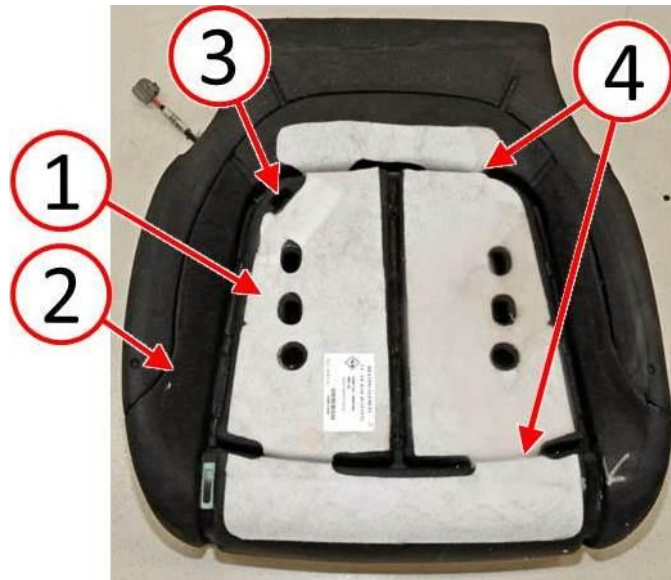
Fig. 2 Install New Heater Pad To Foam Cushion

- 1 - Heated Seat Pad
- 2 - Seat Foam Cushion
- 3 - Heating Pad Wiring Pass-Through
- 4 - Tuck Heater Pad Fully Into Cushion Channel

4. Obtain the appropriate **NEW** seat Foam Cushions, Heated Pads, and if applicable, Ventilated Seat Elements from the Parts Required list.
5. Assemble the **NEW** Heated Pads (1) to the **NEW** Foam Cushions (2) (). Refer to the detailed service procedures available in DealerCONNECT> TechCONNECT under: Service Info> 08 - Electrical> 8G - Heated/Cooled Systems> Heated Seats> PAD, Heater> Installation.

NOTE: Ensure the heated seat pad wire harness lays flat and is guided into the pass-through (3) without kinking ([Fig. 2](#)).

NOTE: Ensure the heated seat pad (1) is tucked fully into the seat foam cushion channels (4) at front and back of the foam cushion and the heater pad lays flat on the foam cushion without wrinkles ([Fig. 2](#)).

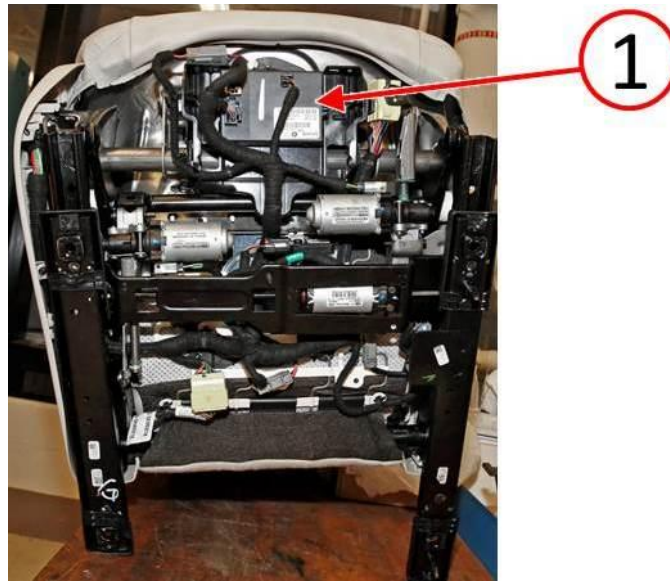
Fig. 4 CSWM Location Under Passenger Side Seat

1 - CSWM

-
8. Assemble the seat cover to the bottom foam cushion using new hog rings, then install the seat bottom cushion with cover to the seat. Refer to the detailed service procedures available in DealerCONNECT> TechCONNECT under: Service Info> 23 - Body> Seats, Front> COVER, Seat Cushion> Installation.
 9. Replace the CSWM (1) located under the passenger side seat (Fig. 4). Obtain the appropriate module from the Parts Required list. Refer to the detailed service procedures available in DealerCONNECT> TechCONNECT under: Service Info> 08 - Electrical> 8E - Electronic Control Modules> MODULE, Comfort Seat and Wheel> Removal/Installation.
