NUMBER: 25-002-15 REV. B

P0455/P0456 Set In The Powertrain Control Module (PCM)

This bulletin involves replacing the evaporative emissions purge valve hose due to a split in the hose that will prevent the system from sealing.

2015	(WK)	Jeep Grand Cherokee
2015	(WD)	Dodge Durango

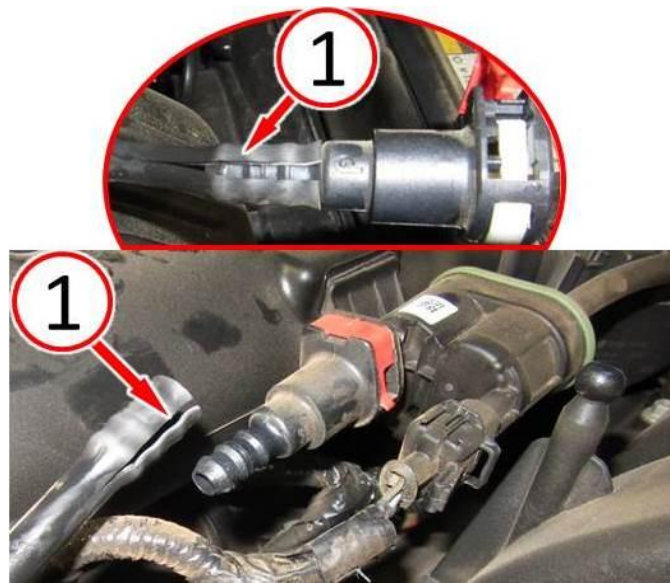
Fig. 1 Split Purge Valve Hose

1. **Is vehicle's VIN on the active RRT VIN list?
 - a. YES>>> Proceed to [Step #4](#).
 - b. NO>>> Continue with [Step #2](#).
2. Inspect the purge valve hose for any splits as shown in ([Fig. 1](#)).
3. Were any splits in the purge valve hose found?
 - a. YES>>> Proceed to [Step #4](#).
 - b. NO>>> This Bulletin does not apply. Normal diagnosis should be performed.**

1 - Split Purge Valve Hose

-
- 4. Replace the purge valve vapor hose with a new hose. Refer to the detailed service procedures available in DealerCONNECT> TechCONNECT under: Service Info> 25 - Emissions Control, Evaporative Emissions> Lines> Removal/Installation.
