**NUMBER:** 08-105-15

Remote Start Is Inoperative, Remote Start Cancelled Hood Open Message Displayed In EVIC

This bulletin involves adjusting the hood latch.

2015 - 2016	(DS)	Ram 1500 Pickup
2015 - 2016	(DX)	Ram Truck (Mexico)

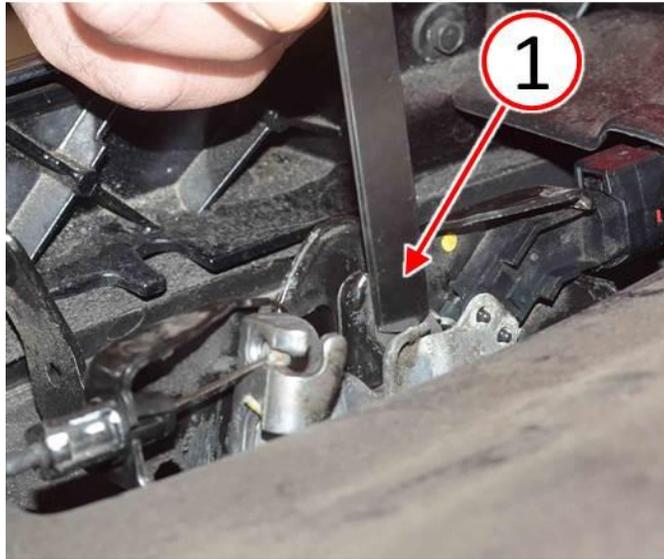
**Fig. 1 Measure Hood Latch Ratchet to Latch Cover Plate Clearance**

1 - Feeler Gauge

1. Using a feeler gauge (1) set to 2 mm (0.08 in.) (Fig. 1), measure the clearance between the latch ratchet (2) and the latch cover plate (3) (Fig. 2).

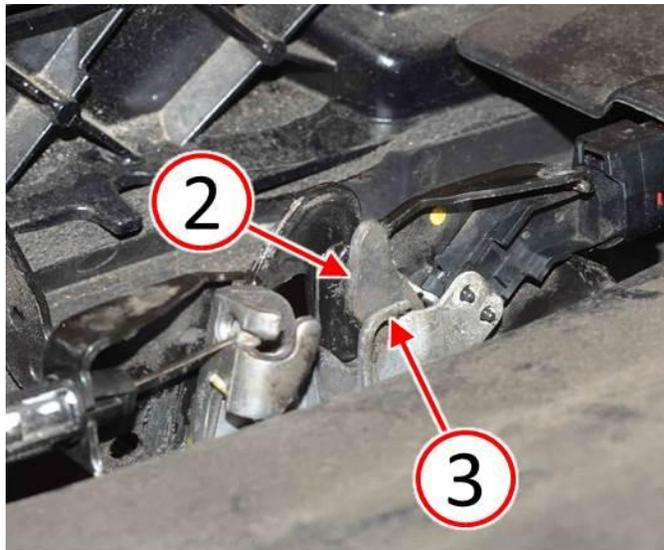
**Fig. 2 Hood Latch Ratchet and Latch Cover Plate**

2 - Latch Ratchet

3 - Latch Cover Plate

2. Is the clearance 2 mm (0.08 in.) or greater?
  - a. YES>>> This bulletin has been completed. Use LOP (23-41-45-92) to close the active RRT. If the remote start is inoperative, normal diagnosis should be performed.
  - b. NO>>> Continue with the Repair Procedure [Step #3](#).
3. Using an appropriate tool (1), increase the clearance between the latch ratchet (3) and the latch cover plate (4) until 2 mm to 3 mm (0.08 in. to 0.12 in.) of clearance is achieved ([Fig. 3](#)).

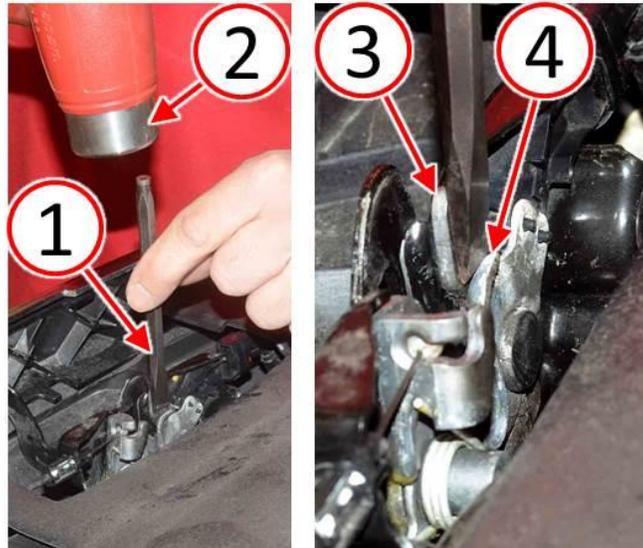
**Fig. 3 Adjust Hood Latch Ratchet to Latch Cover Plate Clearance**

- 1 - Small Chisel
- 2 - Hammer
- 3 - Latch Ratchet
- 4 - Latch Cover Plate

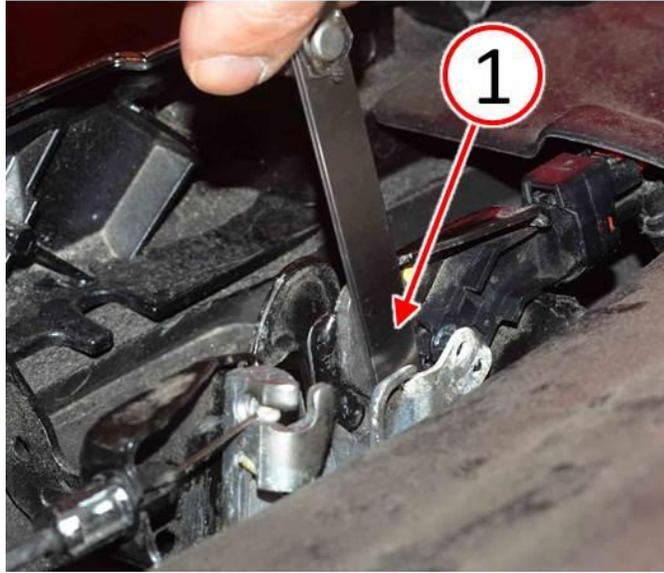
**Fig. 4 Measure Hood Latch Ratchet to Latch Cover Plate Clearance**

1 - Feeler Gauge

- 
4. Using a feeler gauge (1) ([Fig. 4](#)), verify the clearance between the latch ratchet (2) and the latch cover plate (3) is between 2 mm to 3 mm (0.08 in. to 0.12 in.) ([Fig. 5](#)).

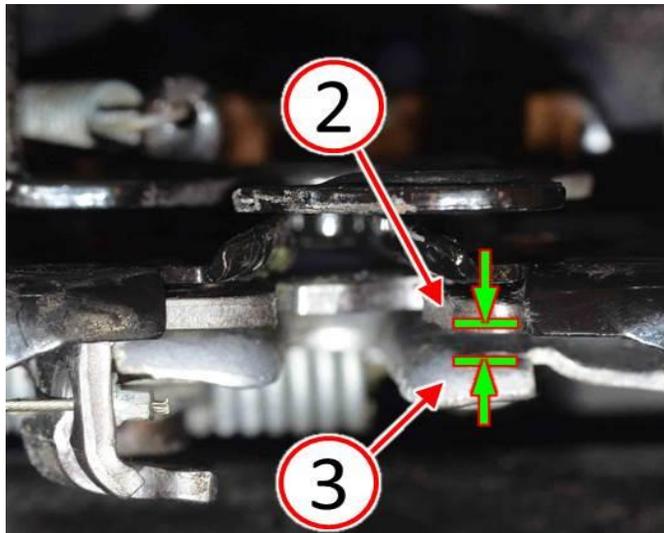
**Fig. 5 Hood Latch Ratchet and Latch Cover Plate Clearance**

2 - Latch Ratchet

3 - Latch Cover Plate
