Field campaign

Topic	Premium audio – amplifier – bass function check and replace (SC15/03)
Market area	Bentley: worldwide (2WBE)
Brand	Bentley
Transaction No.	2039525/1
Campaign number	EA24
Note	
Type	Workshop campaign
US code

Flying Spur

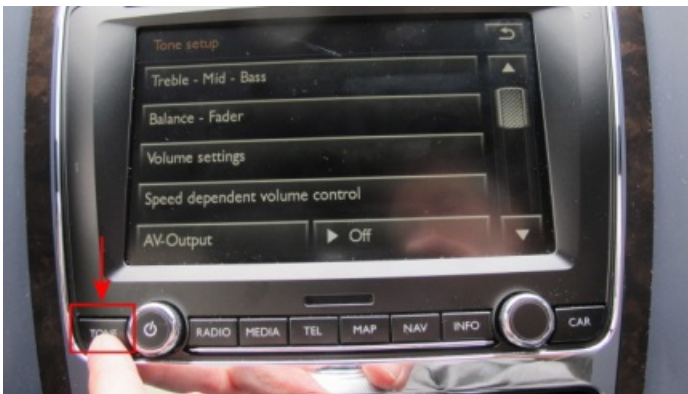
Figure 1

2. Select Tone (see Figure 1)

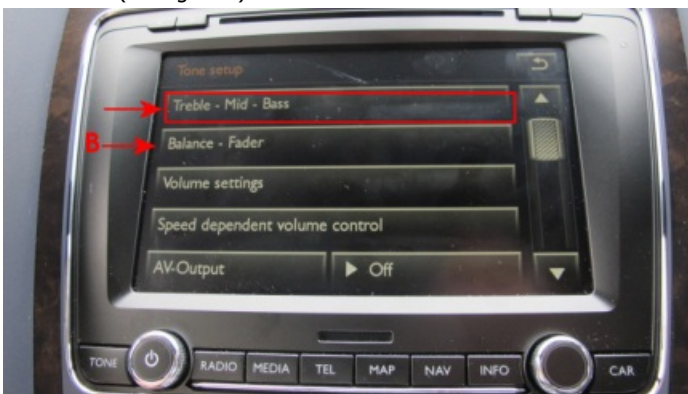
Figure 2

3. Select Treble-Mid-Bass (see Figure 2)

4. Set the three levels to middle position (see Figure 3)
5. Select return –A- (see Figure 3)
6. Select Balance - Fader –B- (see Figure 2)

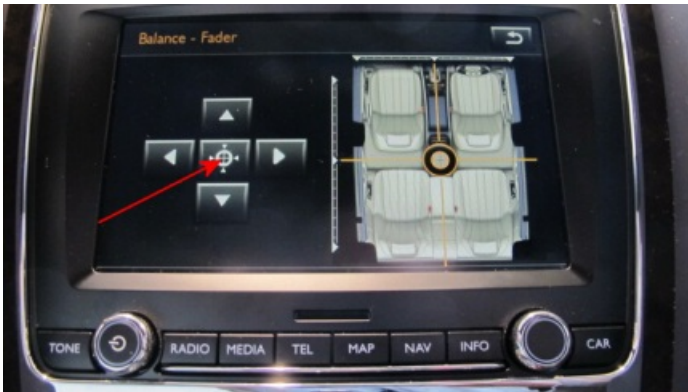
Figure 4

7. Set balance to centre of cabin using middle button (see Figure 4)

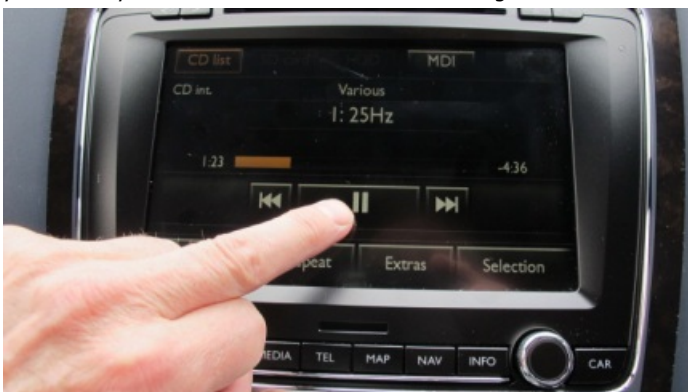
Figure 7

11. Perform the amplifier bass test. Ensure the Tone settings are as specified above. Select track 1, 25 Hz test signal, whilst playing this frequency pause the track (see Figure 7). At the point of pause the sound decay should be quick and reasonably clean as per sample track 2. If this is the case apply blue campaign identification mark (see figure 10), no further action is required. If at the point of pause the sound decay is extended and grainy as per sample track 3 then the amplifier must be removed and replaced. Refer to **Amplifier to replace** in this document

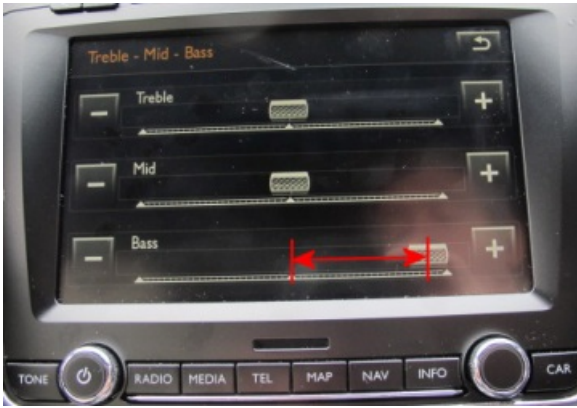
Figure 8

12. If confirmation is required, as a secondary check, the bass adjustment should be tested whilst playing a music track rich in bass. During playback adjusting the bass virtual slider from the middle to the high position should result in a significant change to the bass response if this is not the case then the amplifier is suspect (see Figure 8)

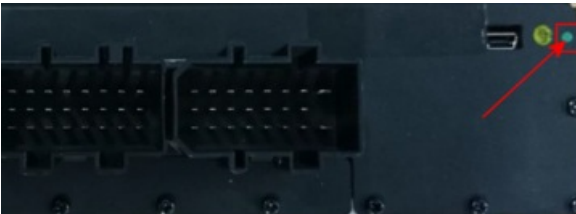
Figure 9

Note: For information any amplifiers already fitted to the vehicle during manufacture known to have the correct link fitted and therefore function correctly will have had a green identification mark applied at the factory (see Figure 9)

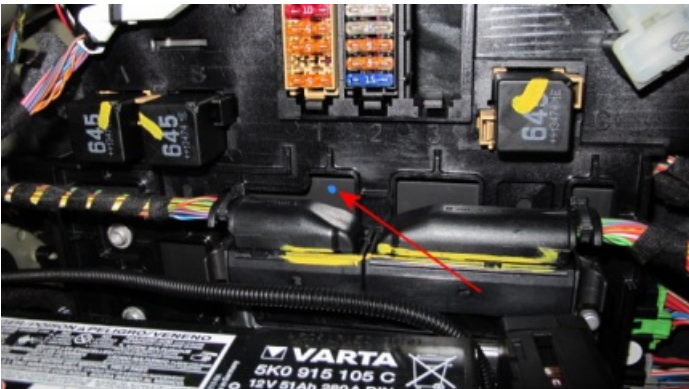
Figure 10

Cars previously tested as a result campaign SC14/06, launched prior to amplifier availability, will have resulted in, a blue campaign completion mark to the front face of the audio amplifier where the amplifier was found to be functioning correctly or If a vehicle was found to have a defective amplifier a red identification mark was applied to the front face of the audio amplifier. The marks can be viewed on the amplifier adjacent to the starter battery (see Figure 10).

If the vehicle is not already listed as required in the "Repair History" (ElsaPro), check for the presence of a blue or red paint identification mark on the amplifier (see Figure 10), should a red or no paint mark be evident then carry out the required work in accordance with these instructions

On completion apply blue campaign completion mark to the front face of the audio amplifier adjacent to the starter battery (see Figure 10)

1. Remove and replace audio amplifier Rep Gr.91 Audio amplifier – To remove and fit
2. On completion apply blue campaign completion mark to the front face of the audio amplifier adjacent to the starter battery (see Figure 10)
