Technical product information

Topic	Engine coolant thermostat - Engine start difficult
Market area	Bentley: worldwide (2WBE)
Brand	Bentley
Transaction No.	2038974/2
Level	EH
Status	Approval
Release date

Mulsanne 11MY to 15MY

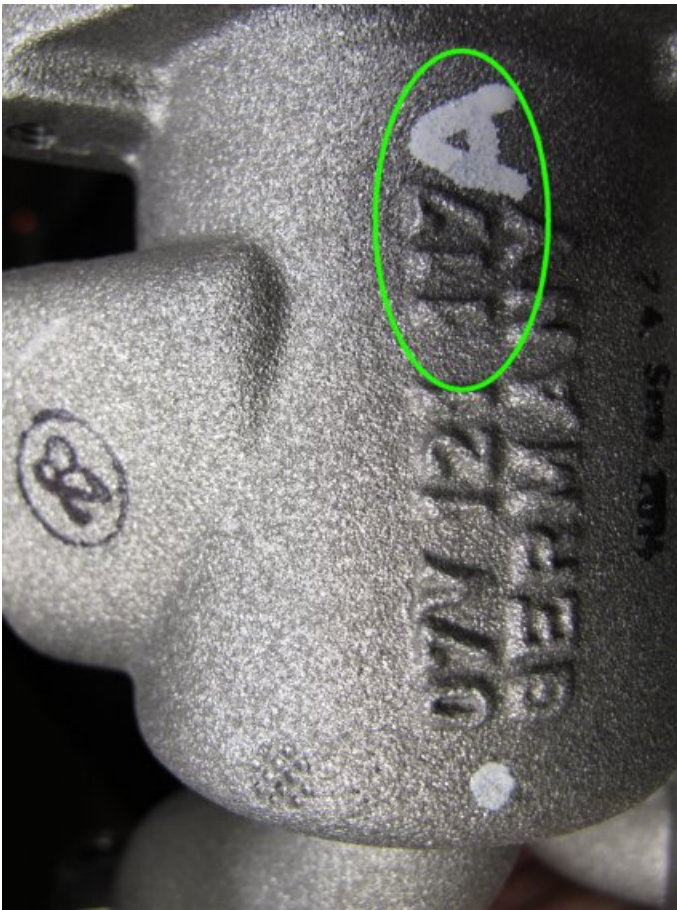
Cars fitted with Figure 2 thermostat housing, part number has an A suffix, will in-service require the later thermostat part number 069121113

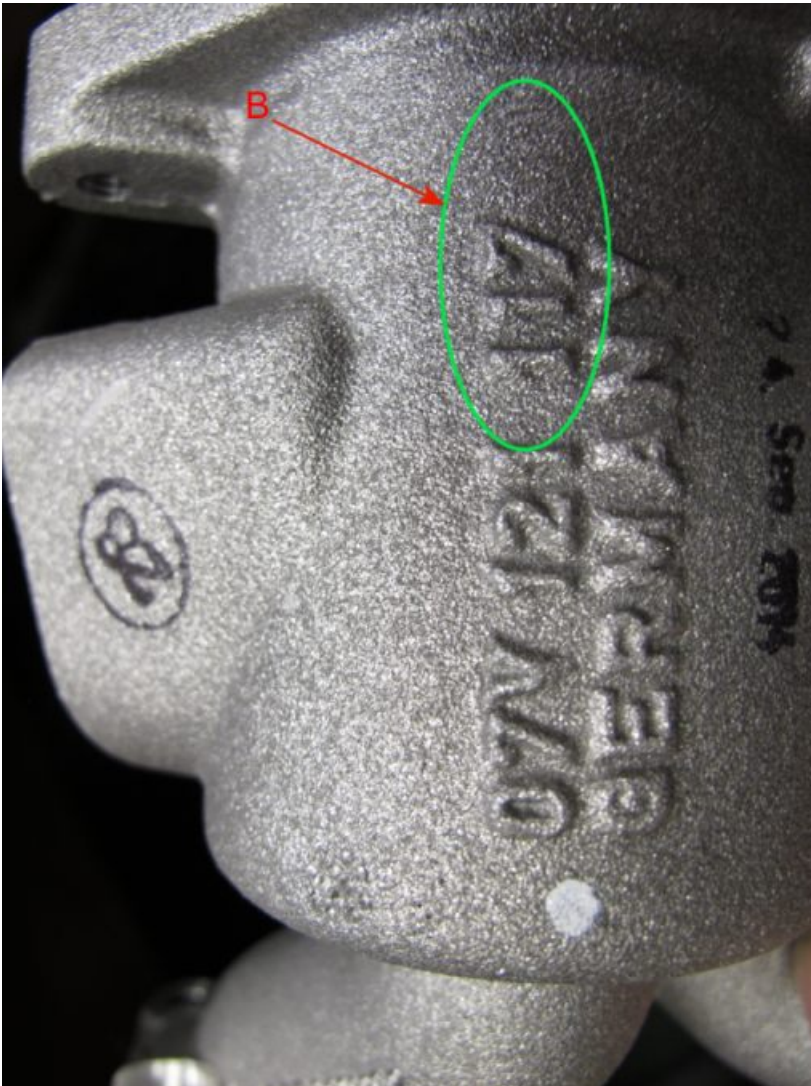
Figure 3

Cars prior to VIN SCBBA6ZH9FC001420 fitted with this thermostat housing with no A suffix visible will require a further check inside the housing to identify which thermostat is required

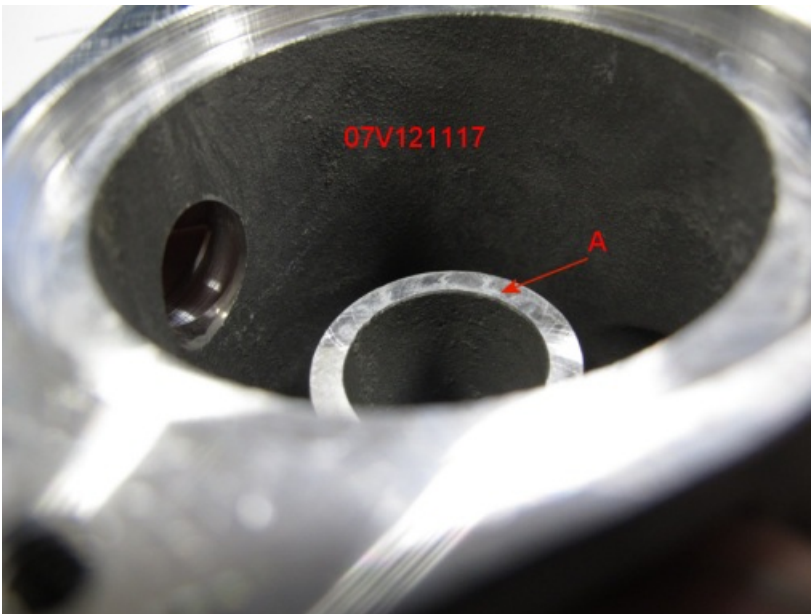
Figure 5

Thermostat housing with no chamfer on surface A is designated part number 07V121117 and must use thermostat 07V121113A (see Figure 5)

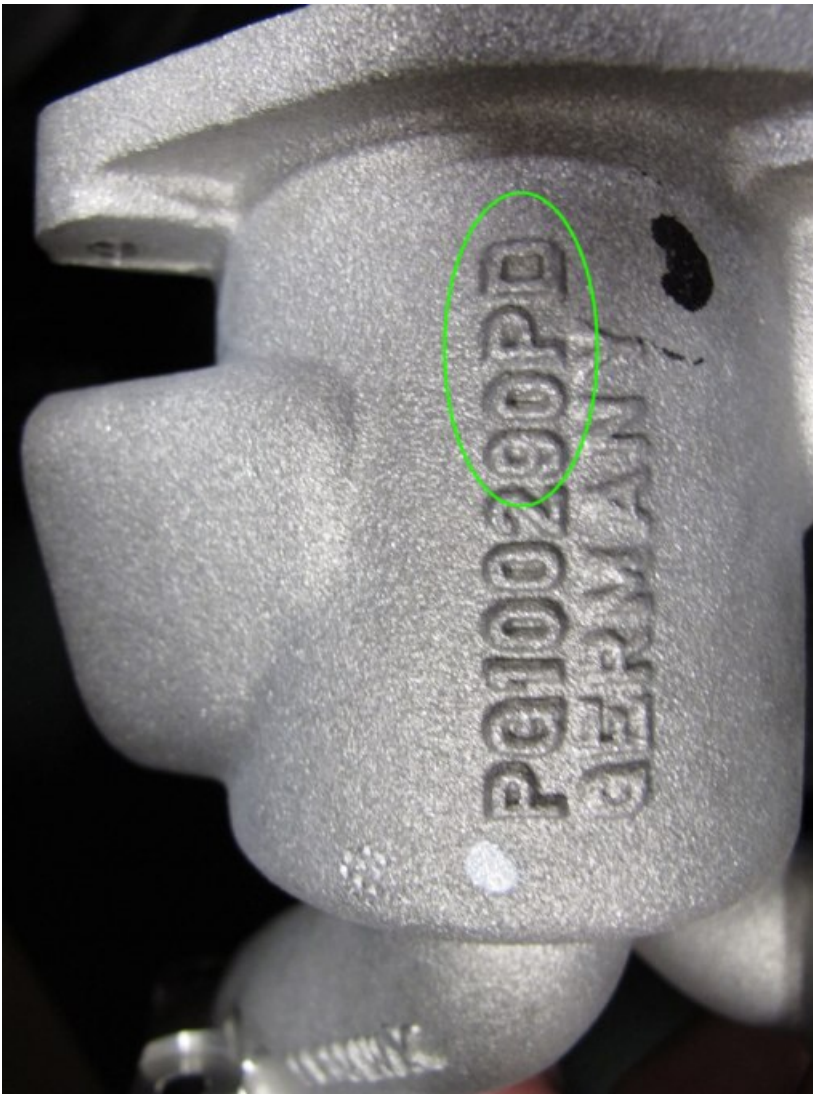
The housing shown in figure 6 may also be seen. Cars fitted with Figure 6 thermostat housing (alternative service part) use the vehicles VIN in ETKA for thermostat parts
