# Team Tips

ARTICLE: **I-15-05-01**DATE: **05/06/2015***Published for Indian Motorcycle Dealerships, Distributors, and Service Technicians*

## **2015 Indian Scout – Tail Lamp Wire Harness Routing**

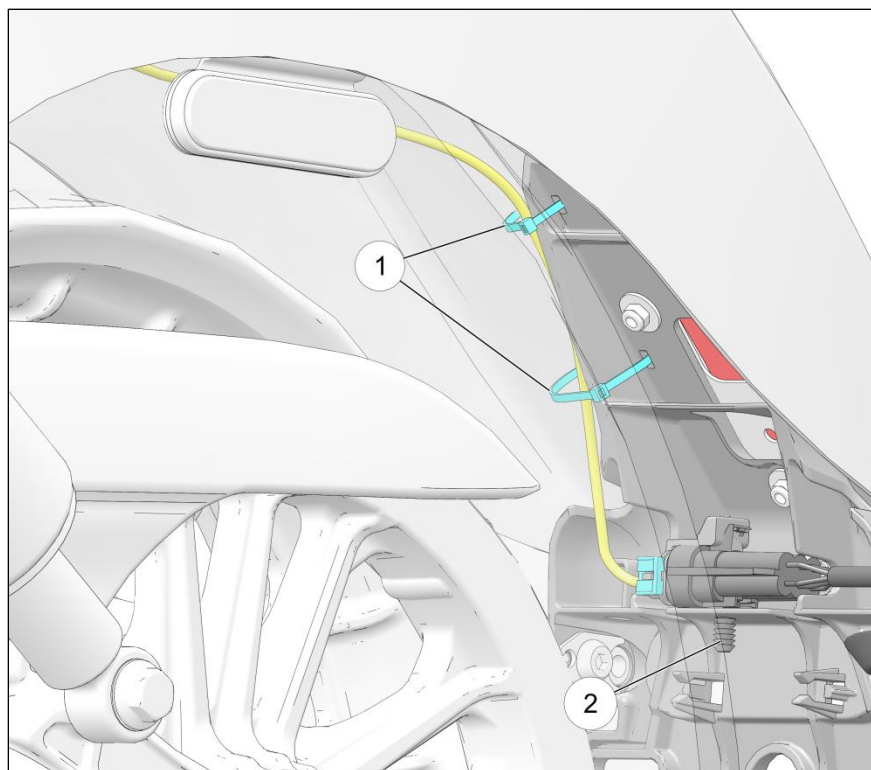
Indian Motorcycles has determined there is a potential for the rear tire to contact the tail lamp wire harness if the harness is not routed and retained correctly during reassembly. As part of tail lamp, rear turn signals, license plate bracket or fender service, verify the tail lamp wire harness is retained with two panduit straps (1) as illustrated below. Also, the tail lamp connector (2) should be secured with a push in dart and oriented as illustrated below.

This Team Tip has been released to communicate the importance of correct tail lamp wire harness routing and connector retention when servicing the fender or license plate bracket.
