TECHNICAL SERVICE BULLETIN

Bulletin Number: I-15-03 A/B
Model Year(s): 2016

SUBJECT: 2016 Indian Scout Motorcycles – VECI Decal Replacement

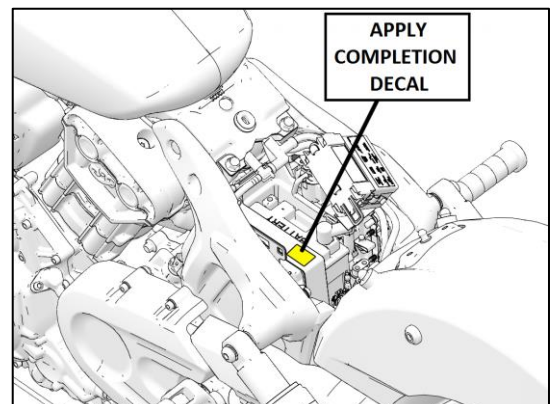
A Service Bulletin Completion Decal must be completed for this bulletin repair. Place the decal on the unit as shown (on battery bracket). Completion decals are available through normal parts ordering channels.
