## Service Campaign 66-01

**AFFECTED:** Winnebago Forza and Itasca Solei Model L36G

**SUBJECT:** Correct Furnace Installation

### Correct Furnace Installation

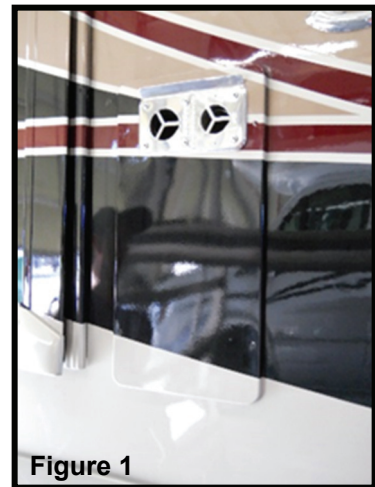
**Overview:** The furnace on certain 2015 & 2016 L36G units may have been installed upside down which could cause moisture to build up inside the furnace.

Figure 1 shows the furnace in the incorrect position and the service campaign will need to be completed.
