TECH TIP

Group:	0-GENERAL
Engine Bulletin No:	TT-15-030
Issue Date:	10-13-2015

75K or 150K MILES BURNER MAINTENANCE

SUBJECT VEHICLES: 11MY-14MY Conventional with burner system

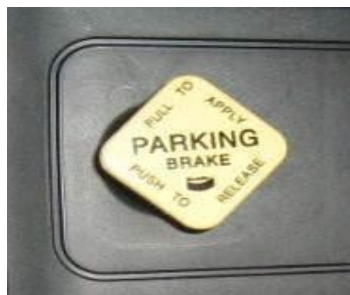
3. Apply the parking brake.

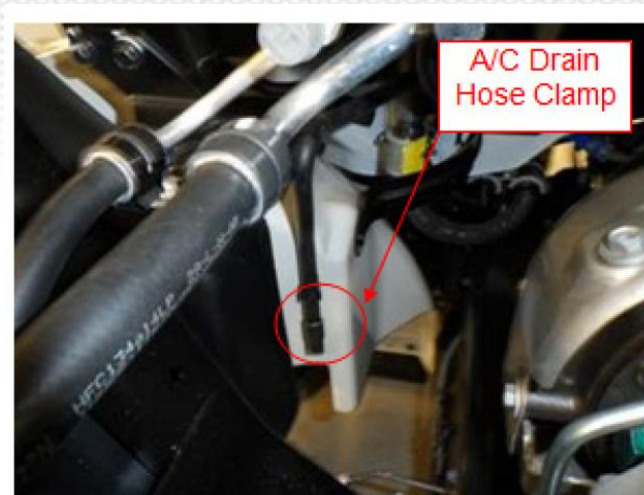
1. Remove the right inner fender. Make certain the A/C drain hose is removed, located on the engine side of the right fender.

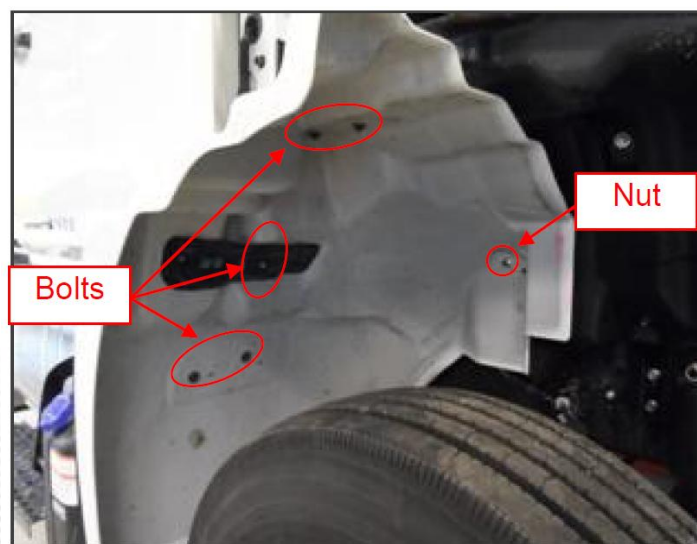
Remove one (1) nut and six (6) bolts (shown in the illustration to the right) that secure the right front fender. Remove the right front fender from the vehicle.

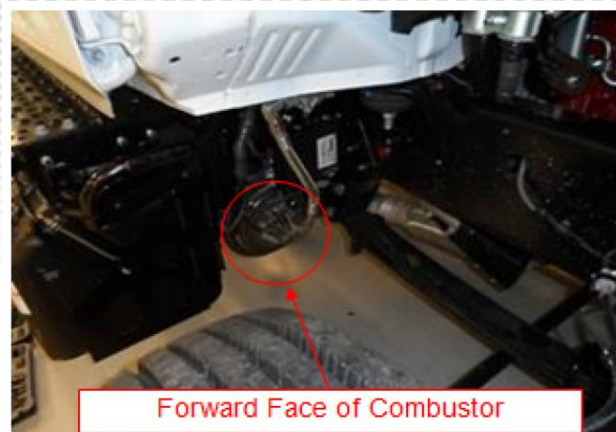
2. Locate the forward face of the combustor and disconnect the ignition wires from both ceramic igniter plugs.

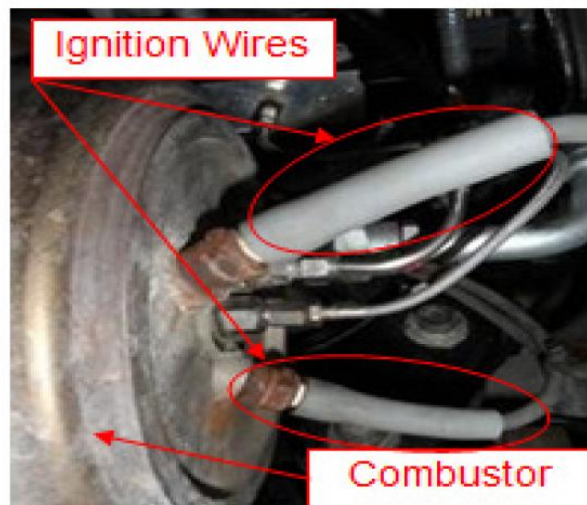
Notice: When disconnecting the ignition wires, securely grasp the center of the ignition wire boot to prevent shifting of the electrical terminal and wire position within the boot.

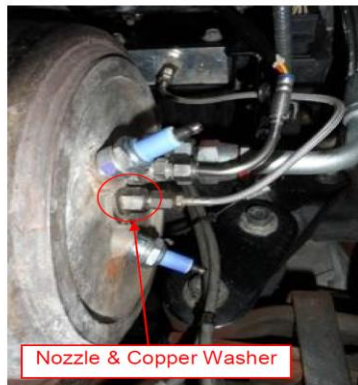
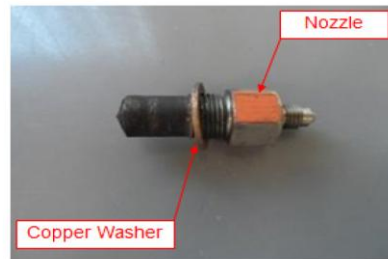
3. Remove the steel braided fuel/air supply line, nozzle and copper washer.

Note: Over 150K miles, replace the nozzle.

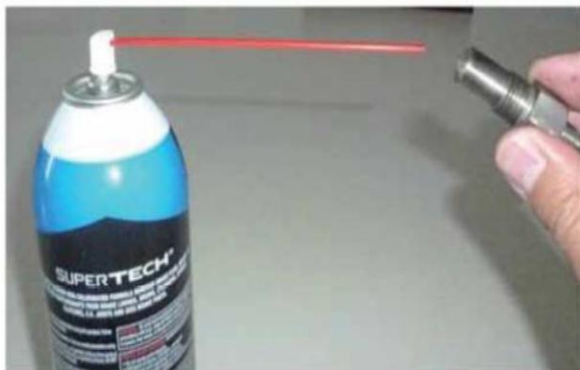
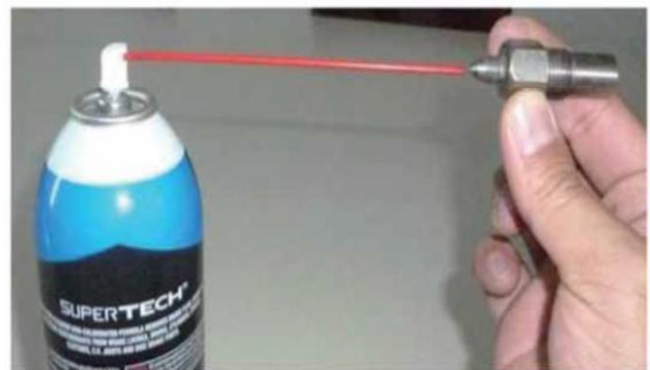
4. Clean the outside and inside of the nozzle with brake cleaner.

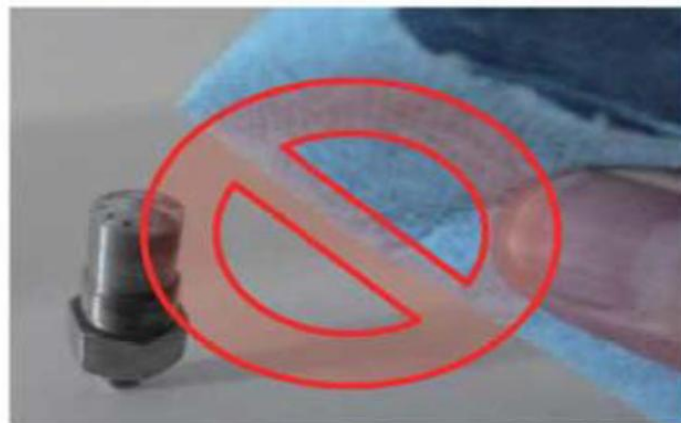
CAUTION: Do not wipe the outside of the nozzle; otherwise, the nozzle may become clogged. If the nozzle is clogged or cannot produce a consistent spray pattern, it is recommended to replace.

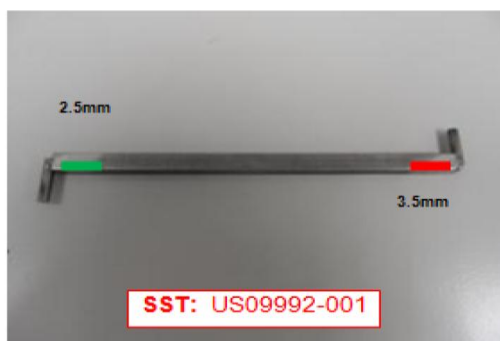
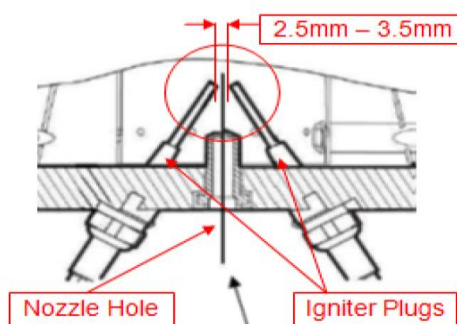
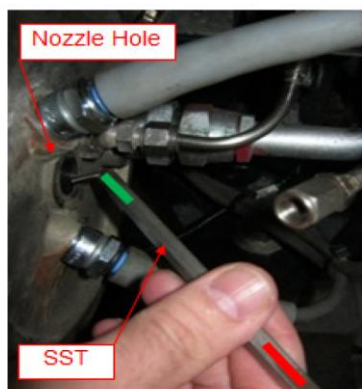
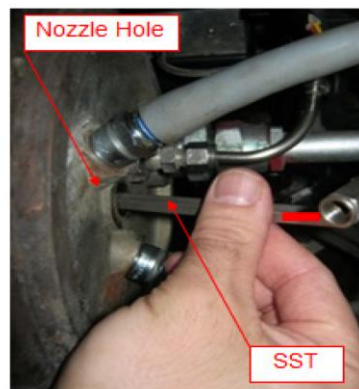
Using the SST, check the igniter plug gap:

The SST is a “Go - No-Go” gauge to check the igniter at the tips. The tool has a 2.5mm gauge on one end and a 3.5mm gauge on the other end. The 2.5mm end should be able to pass between the igniter tips while the 3.5mm end should not.

Specification: 2.5mm – 3.5mm

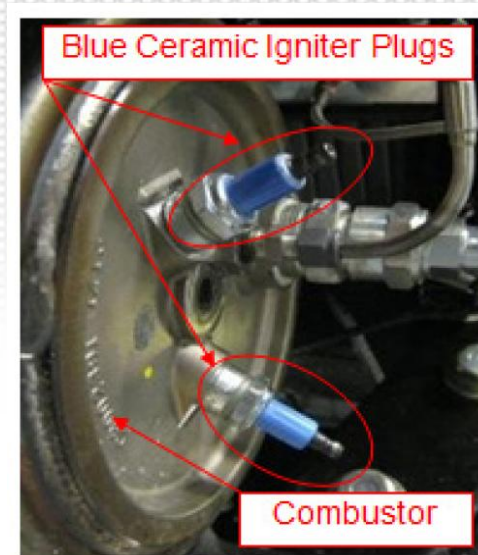
6. Remove both blue ceramic igniter plugs from the combustor.

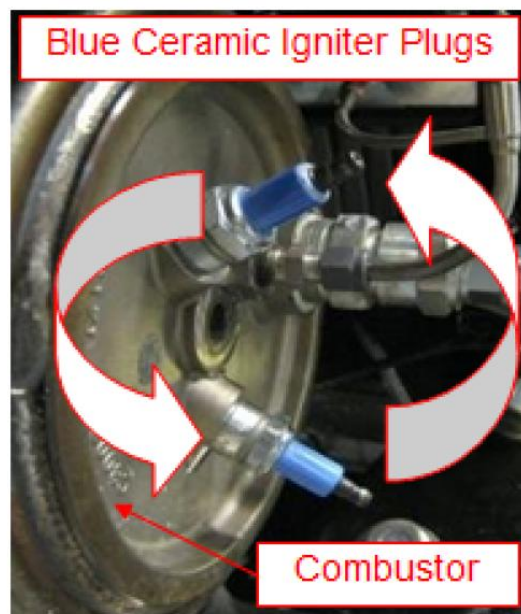
7. Switch igniter positions from side to side. Reinstall both igniter plugs and torque to the specified torque.

Specified Torque: 22.0 lb-ft (29.8 Nm)

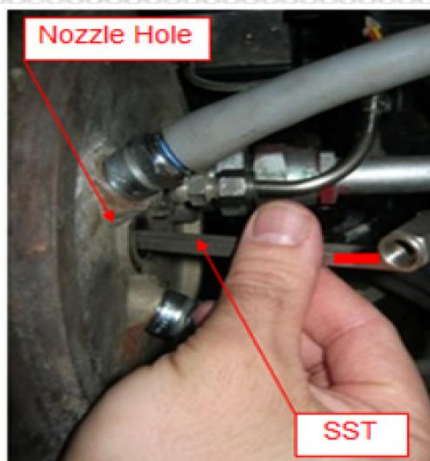
8. Using the SST, does the igniter gap fall within the specification?

NOTE: If you can't get the igniter gap within the specification, it is recommended that the igniters are replaced.

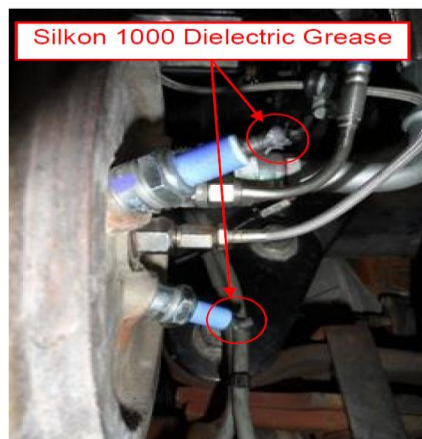
10. Apply a small amount of Silkon 1000 dielectric grease on each blue ceramic igniter plug terminal.

Notice: Do not forget to apply the Silkon 1000 dielectric grease to the igniter plug terminal. Failure to apply Silkon 1000 dielectric grease may cause electric corrosion on the igniter terminal during operation. Electrical corrosion on the igniter terminal may result in a burner system misfire.

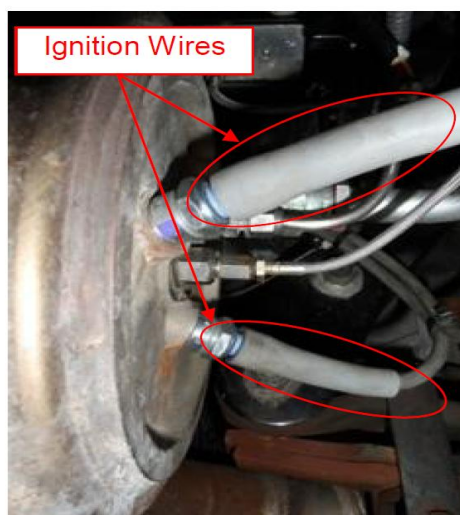
11. Install and electrically connect each ignition wire onto the corresponding blue ceramic igniter plug.

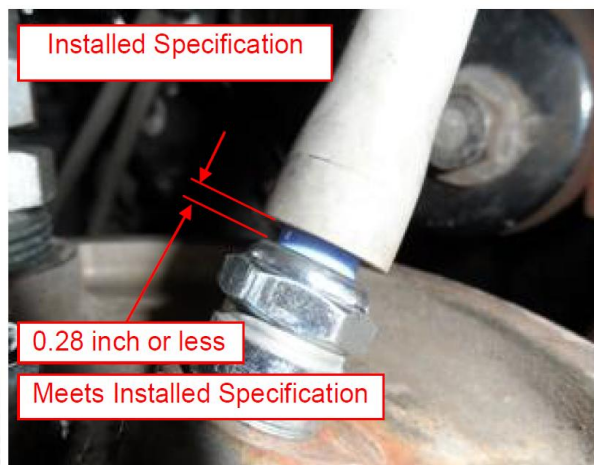
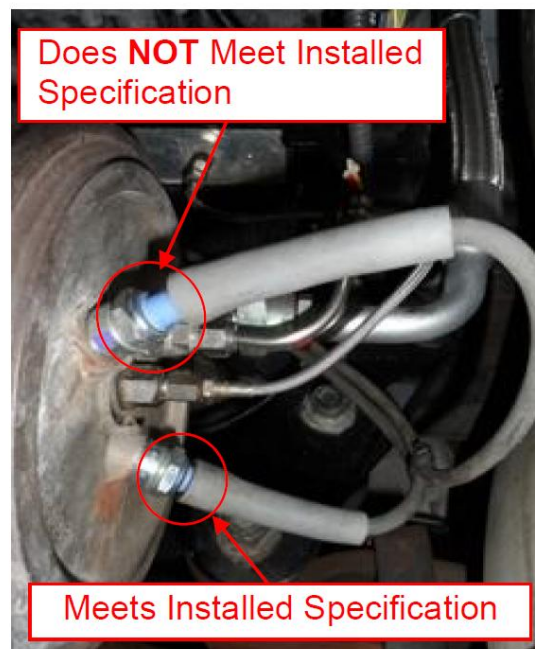
12. Check the exposed ceramic surface of each igniter plug. If not within the installed specification, adjust the ignition wire boot to meet the installed specification.

Installed Specification: 0.28 inch (7mm) or less .

Notice: Failure to install the ignition wire boot to meet the installed specification may result in a burner system misfire.

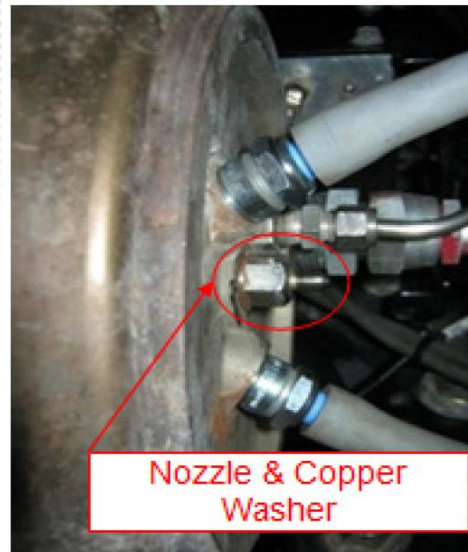
13. With the copper washer, install the nozzle and tighten to the specified torque.

Specified Torque: 19.9 lb-ft (27.1 Nm)

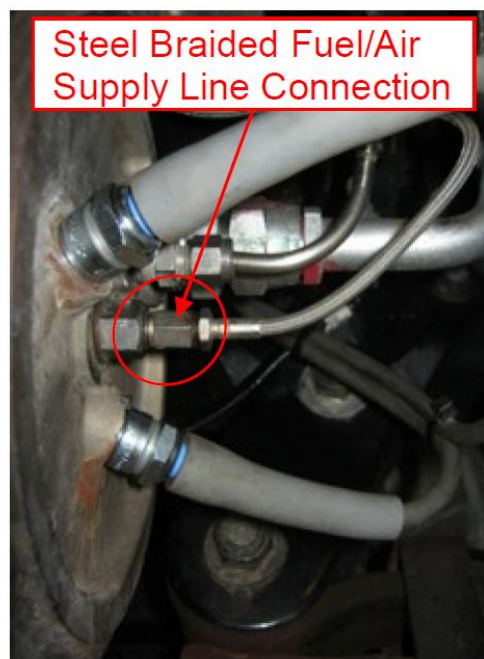
14. Connect the steel braided fuel/air supply line fitting at the nozzle and tighten to the specified torque.

Specified Torque: 8.3 lb-ft (11.3 Nm)

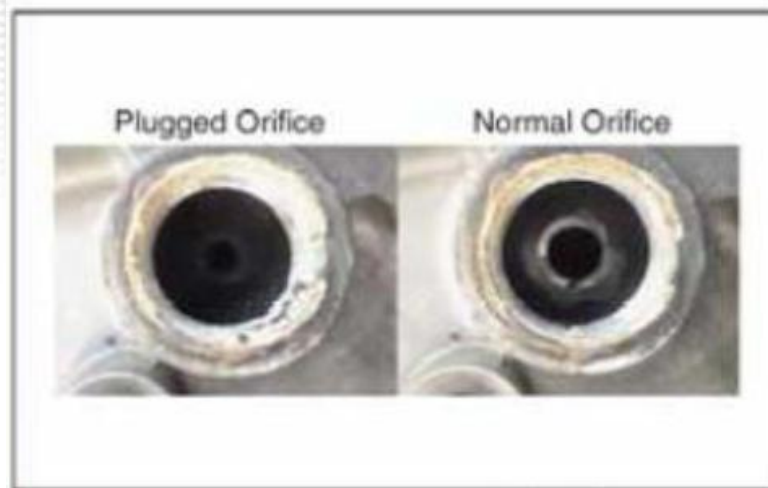
15. Disconnect the combustion air hose from the combustor and check the orifice. Carefully, clean the orifice with brake cleaner and a wire brush.

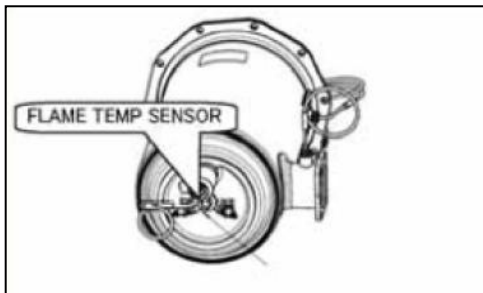
17. Replace the flame temperature sensor.

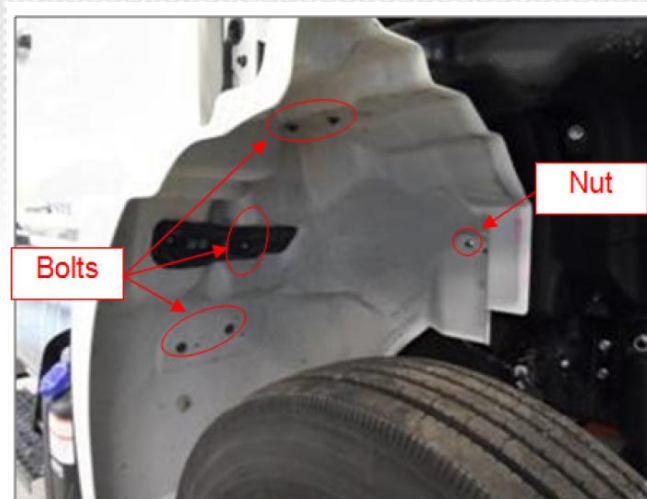
19. Install the right front fender and secure using one (1) nut and six (6) bolts (shown in the illustration to the right). Tighten each fastener to the specified torque value.

Nut: 9.6 lb-ft (13.0 Nm)

Bolt: 10.4 lb-ft (14.0 Nm)

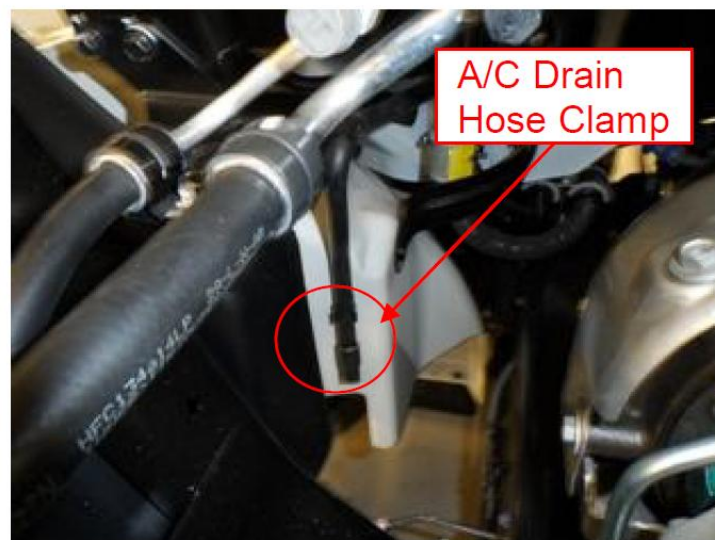
20. Make certain the A/C drain hose is secured by the clamp located on the engine side of the right fender.

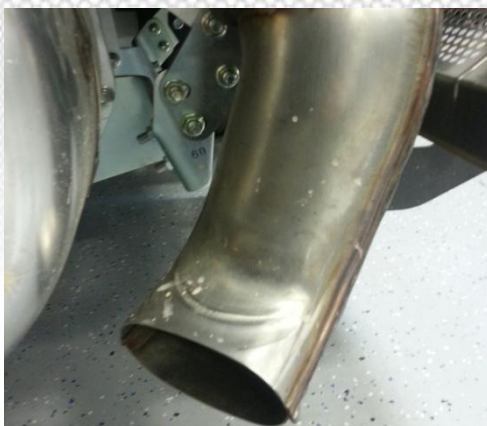
21. Perform a manual regeneration and check for soot in the tailpipe. If soot is found in the tailpipe, a physical DPF inspection must be done.

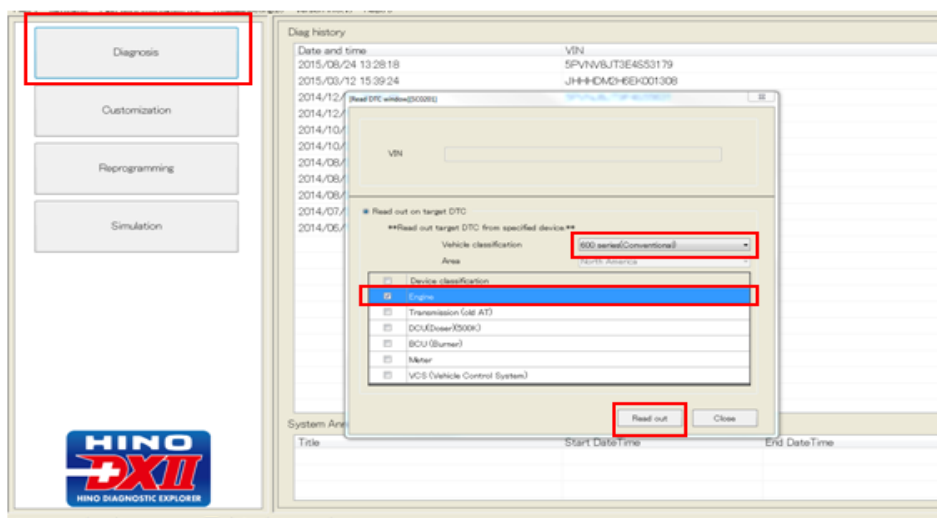
a. Select “Diagnosis” on the left side of the screen, select “600 Series” and “North America” from the drop down boxes. Place a check next to the “Engine” selection and select “Read Out”.

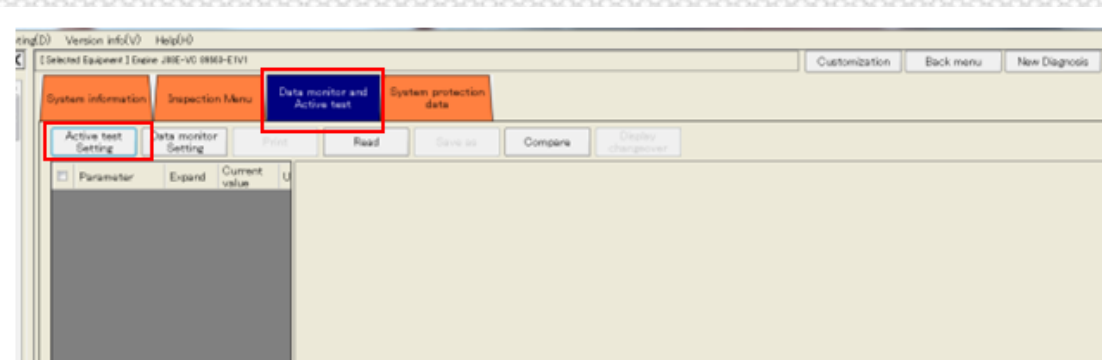
b. Select the “Data Monitor and Active Test” tab and select “Active Test Setting”.

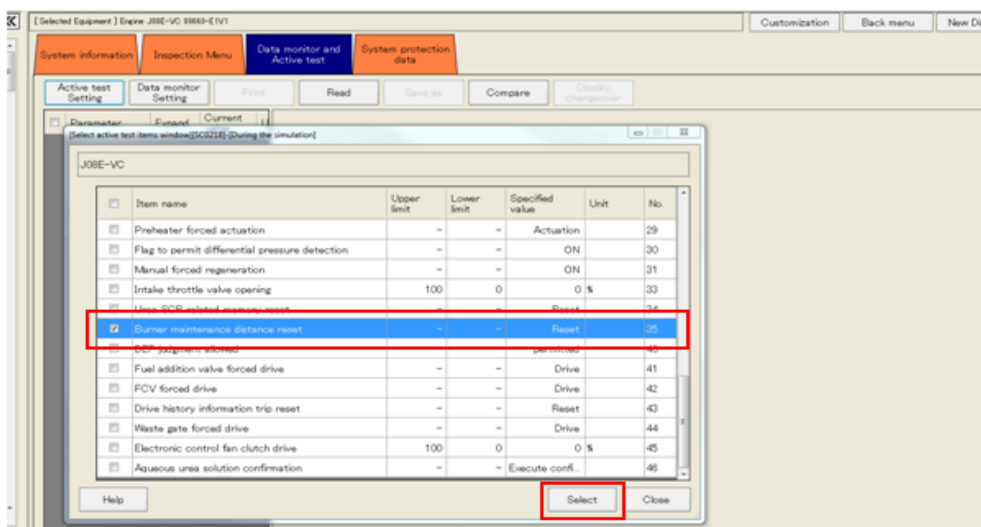
c. Check the “Burner Maintenance Distance Reset” and select “Select”.

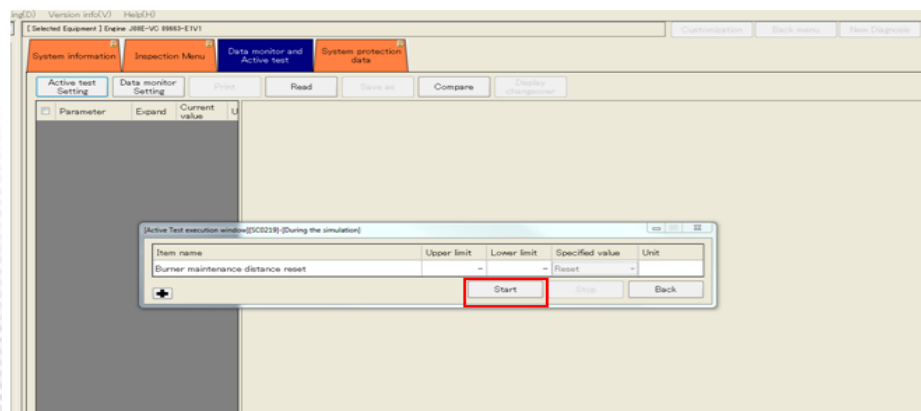
d. Select “Start” and complete the burner maintenance reset.
