TECHNICAL SERVICE BULLETIN

Group:	61-CAB AND BODY
Bulletin No:	SB-15-045
Issue Date:	11-19-2015
Reference:	HMM-151119-B1

Subject: SNOW PLOW HOOD CRACK REPAIR

RELEVANT MODEL: 11MY-16MY Hino Conventional Trucks (238, 258, 268 or 338) equipped with a snow plow specification stationary grille.

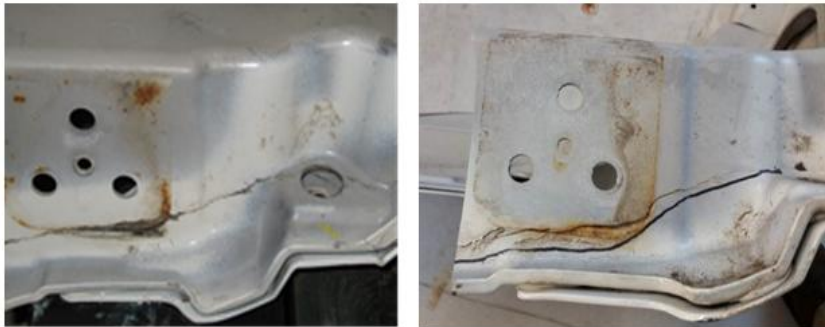
1. The following photographs are examples of cracking that you may see around the hinge plate of a snow plow hood that can be repaired.
