# WARRANTY BULLETIN

CAN-AM® ROADSTER

Subject: **Gearbox Position Sensor Contamination**

No. **2015-7**

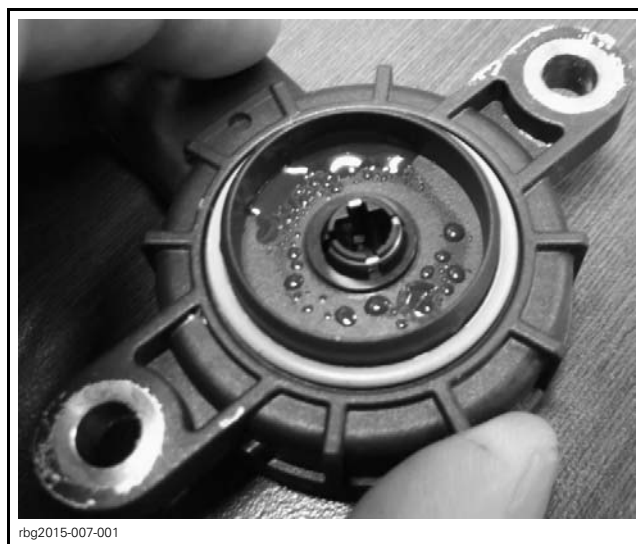
A limited quantity of vehicles were shipped with liquid contaminants in the gearbox position sensor (GBPS) housing that will damage the sensor.

A damaged GBPS may lead to; P-codes, limp home mode activation or vehicle does not shift.

Replace GBPS and clean its housing.

**NOTICE** Make sure to clean and dry all dust and liquid contaminants on the crankcase before the installation of the new GBPS.
