# SERVICE BULLETIN

<b>Classification:</b> ST12-007a	<b>Reference:</b> NTB12-078a	<b>Date:</b> February 6, 2015
-------------------------------------	---------------------------------	----------------------------------

## NISSAN; POWER STEERING SYSTEM SERVICE INFORMATION

## Power Steering Gear Inspection

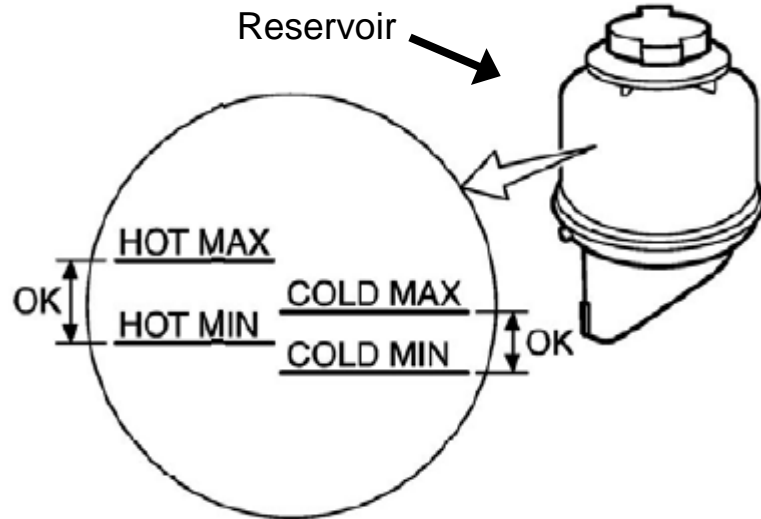
Figure 2: Make sure the fluid level is in OK (normal) range.

1. Verify the fluid level in the reservoir is within OK (normal) cold or hot range, as it applies.

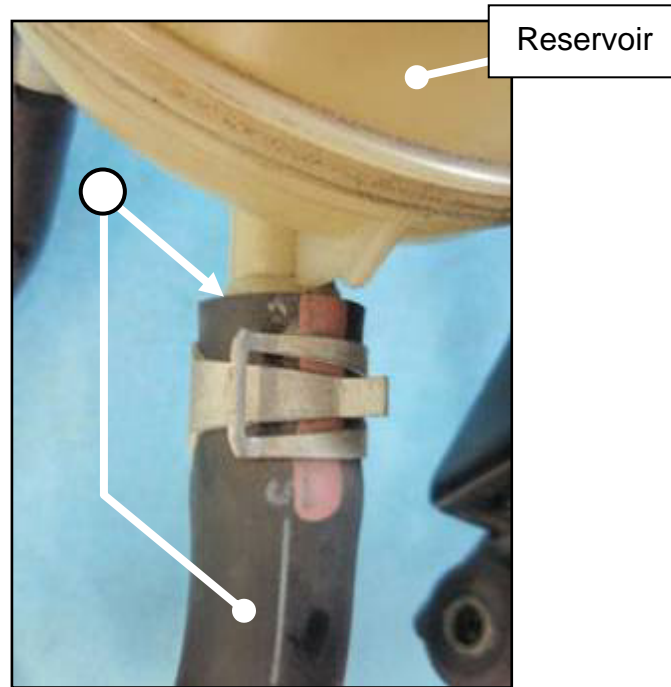
Figure 3

2. If the fluid level is lower than specification, check for leaks at all hose fittings for the power steering system.

- For sample locations of inspection, see Figure 3, 4, and 5 below.

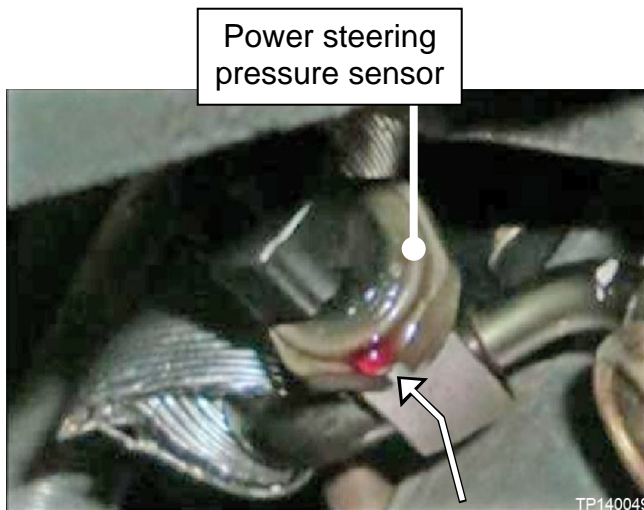
Figure 4: Presence of **RED** fluid indicates a power steering fluid leak.

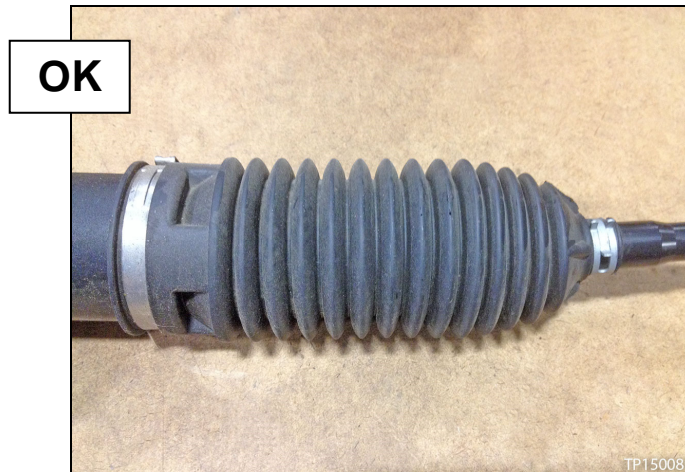
Figure 6: Example of no leaks inside the boot. Boot is dry, dusty, feels firm to the touch.

3. If no leakage is found at any hose fittings, inspect the steering rack dust covers (boots).
4. If the boots appear similar to the example in Figure 6 below, the steering rack is not leaking.
  - a. Do **NOT** replace the steering rack.
  - b. Clean off any oil/grease residue on the steering rack (see page 5-6).
  - c. Inspection is complete.
  - d. Return the vehicle to the customer and check for leakage at the next dealer visit.

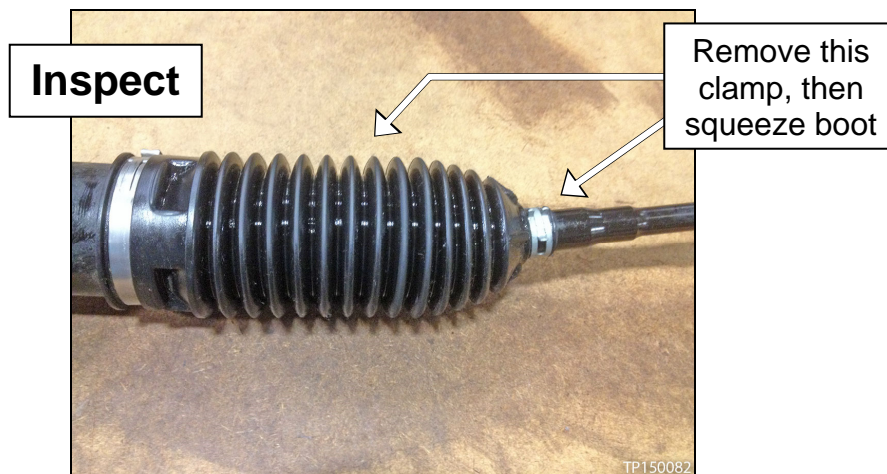
5. If a boot appears similar to the example in Figure 7 below, the steering rack may be leaking.

Figure 7: Example of a possible leak inside a boot. Fluid permeates the boot, giving it a dark, shiny black appearance. Feels soft to the touch.

6. Remove the small clamp, and then squeeze the boot (see Figure 7).
7. If fluid comes out the small end of the boot, replace the steering rack.
8. If no fluid comes out, do **NOT** replace the steering rack.
  - a. Verify there are no other vehicle fluid leaks getting on the boot.
  - b. Clean off any oil/grease residue on the steering rack and boot (see page 5-6).
  - c. Inspection is complete.
  - d. Return the vehicle to the customer and check for leakage at the next dealer visit.

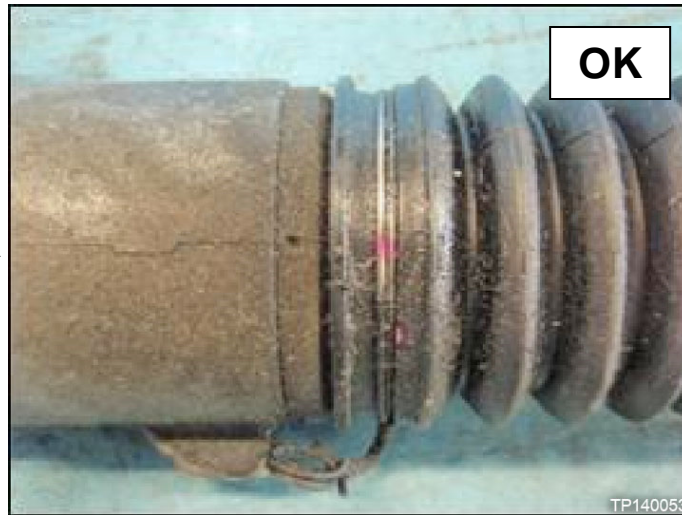
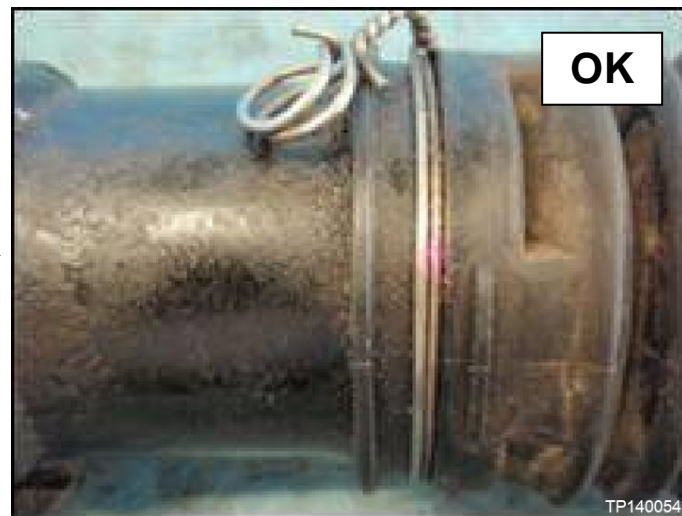
The following pictures show steering racks that are **NOT** leaking:

Boot-to-gear housing area:  
Clean off all residue

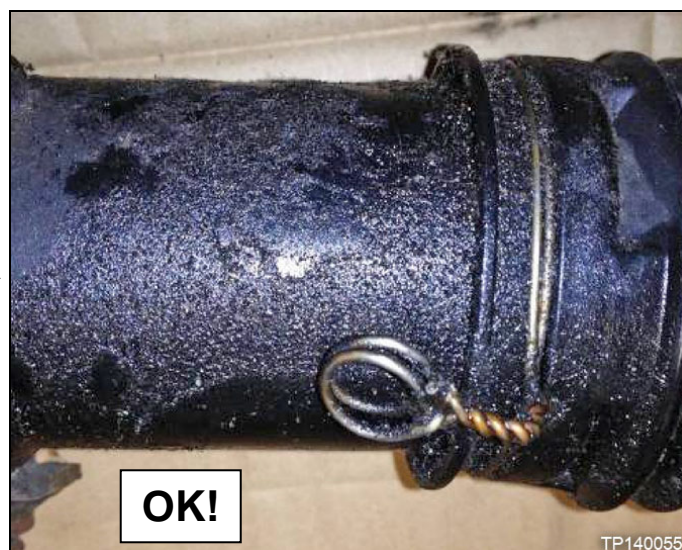
Figure 14: Yes, the steering rack above is OK (not leaking power steering fluid). The extra greasy appearance was caused by an excessive amount of assembly lube.

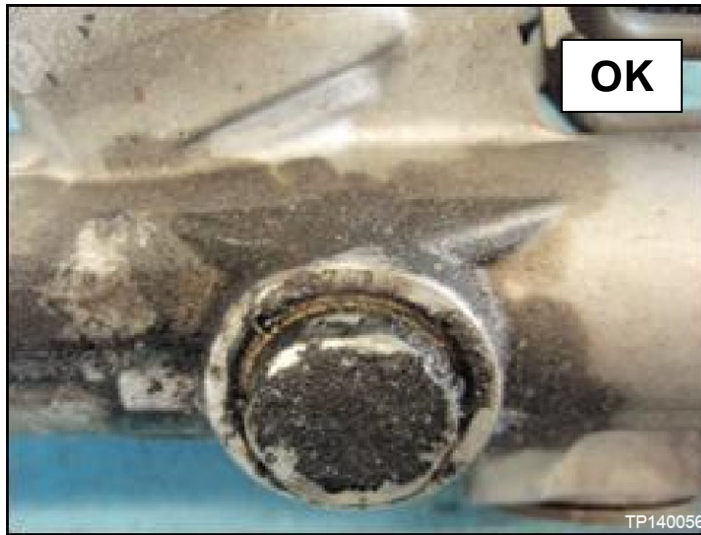
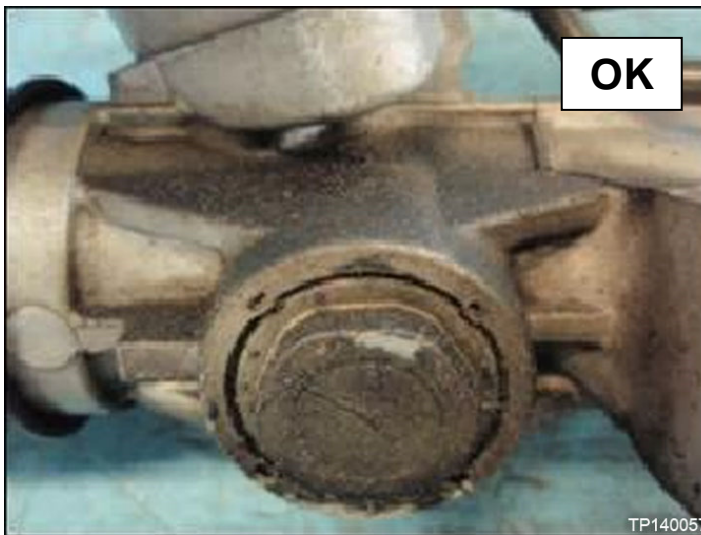
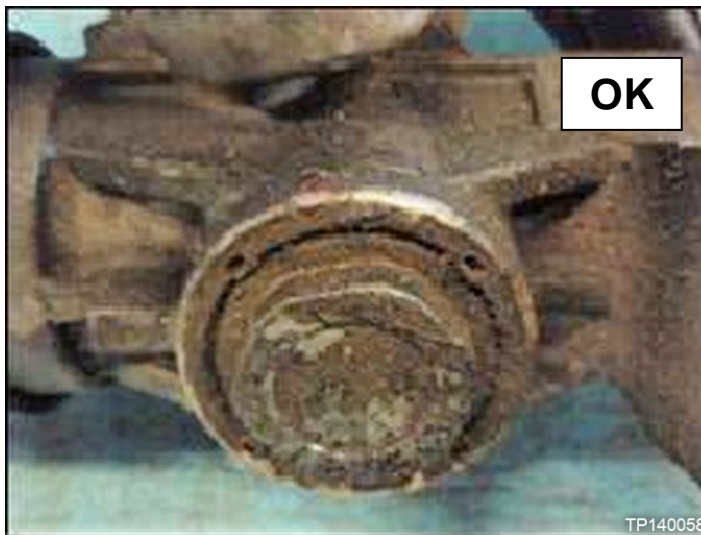
The following pictures show steering racks that are **NOT** leaking:

Adjusting  
screw area:  
Clean off  
all residue
