SERVICE BULLETIN

Classification: BT99-031g	Reference: NTB99-060g	Date: March 11, 2015
------------------------------	--------------------------	-------------------------

PAINT SWELL/STAIN/SPOT UNDER PAINT GUARD FILM

APPLIED VEHICLES: All Nissan Production Models with Paint Guard Film

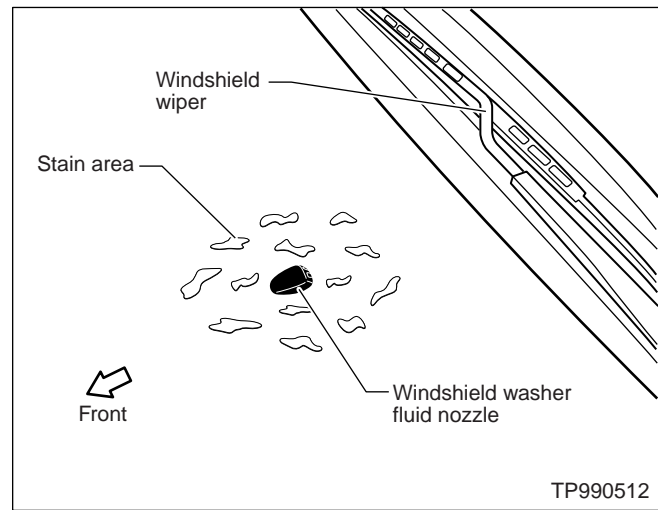
Figure 1

If a Nissan vehicle exhibits swelling, stains or spots on the paint finish (which appear milky or whitish on dark colored vehicles and dark-shaded or coffee-colored on light colored vehicles) immediately after the PGF is removed, the cause may be moisture collection under pockets/creases of the PGF. The paint may absorb moisture which may cause the affected paint finish area to temporarily discolor.

The size of the swell, stain, or spot may range from a dime to a clinched fist and have an irregular shape and possibly a slightly raised surface.

This incident may occur anywhere under the PGF, but may be noted in particular to occur around the windshield fluid nozzle (see Figure 1) and on the deck lid. In any case, use the following service procedure to correct the incident.

IMPORTANT: If this condition occurs, do not rebuff or initially attempt to repaint the affected area. Perform the following service procedure first.

In warm weather, place the vehicle in the sun light. The paint condition should disappear in a few hours depending on the severity of the condition.

In cold weather, place the vehicle indoors at a temperature of approximately 70° F. The paint condition should disappear in about 8 to 12 hours depending on the severity of the condition.

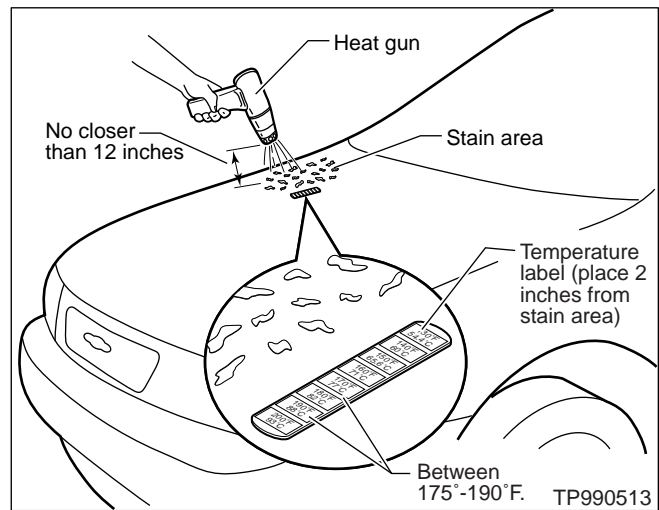
Figure 2

- Maintain the heat lamp/heat gun distance so the painted surface temperature is between 175° and 190° F (80° - 90° C). Affix a paper label thermometer on the paint surface, two inches away from the affected area (see Figure 2), to monitor the surface temperature.

- Do not apply the heat gun for more than 5 minutes as permanent damage (i.e., bubbling, burns, etc.) can occur to the paint.
- Do not hold the heat gun closer than 12 inches from the paint surface. Also, do not hold the heat gun in one position, rather, move it continuously from side to side to heat the affected area evenly.
- Do not apply heat directly on to the paper label thermometer, as this will give a false temperature reading.
