NISSAN BULLETIN

2015 Rogue (T32) Door Latch Dealer Inventory Inspection

Reference: PC382

Door Latch Inspection Procedure

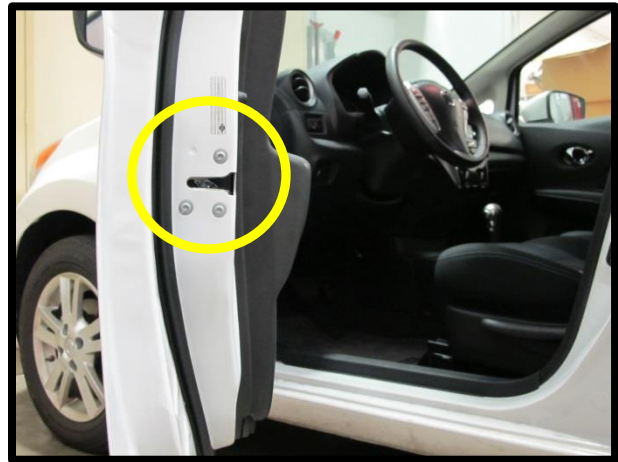
Figure 1

3. Remove the Door Finisher of the door/s with a suspect latch identified in Step 2.

- Verify door window is in the full up position.
- Refer to the applicable Electronic Service Manual (ESM). Section INT-Interior, for removal procedures.

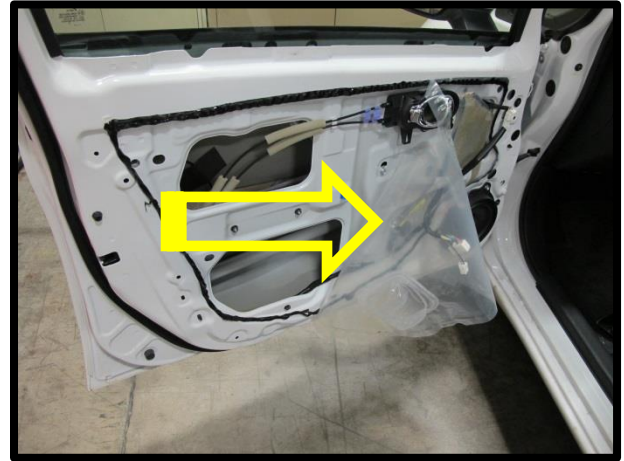
Figure 4

4. Working from the rear of the door, partially peel back the vapor barrier from door panel.

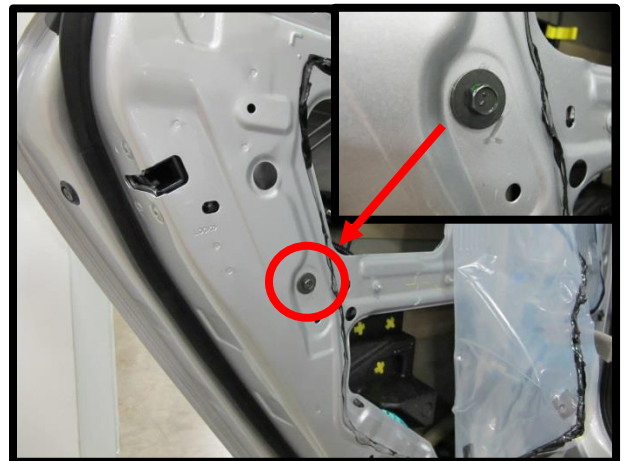
Figure 8

Sentra Left Rear Door ONLY. Refer to Figure 8.

- Remove the (1) 10 mm run channel retaining bolt.
- Push the bottom of rear window run back providing clearance to remove the door lock assembly.
- Do NOT attempt to remove the run channel as it is attached to the door at the top and could cause run channel damage.

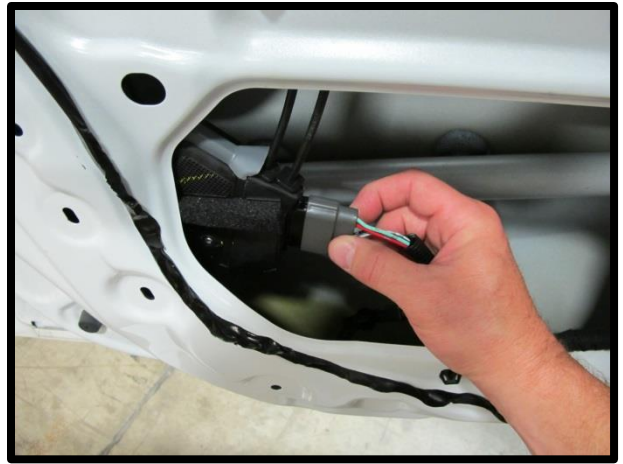
Figure 10

9. Vehicles Equipped With Power Door Locks:

Locks:
Disconnect the door lock harness connector.

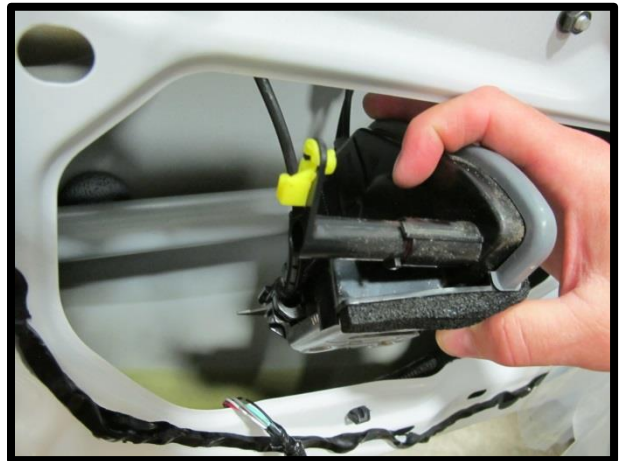
Figure 11

10. Pull the door lock assembly out of the door.

- Do not kink the door lock cables or disconnect them from the door handles.
