2015 Sentra and Versa Note Door Latch  
Dealer Inventory Inspection

Reference: PC383  
Date: July 1, 2015

# Door Latch Inspection Procedure

## 2015 Sentra/Versa Note and Rogue

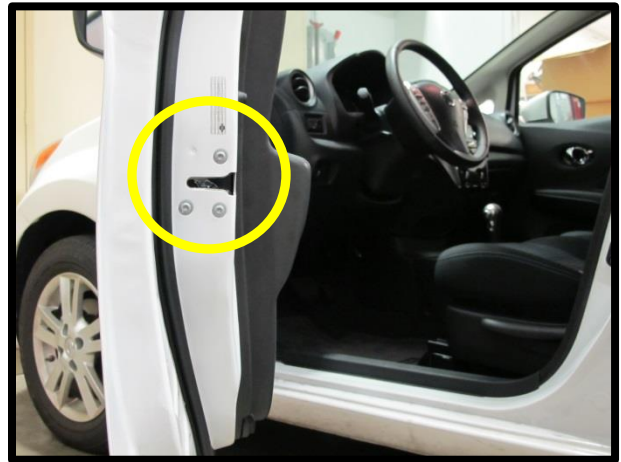
Figure 1

1. Locate door latch Julian Date on applicable vehicle door/s listed below.

- **Sentra/Versa Note:**  
Left Front and Left Rear Doors
- **Rogue:**  
Left Rear Door ONLY

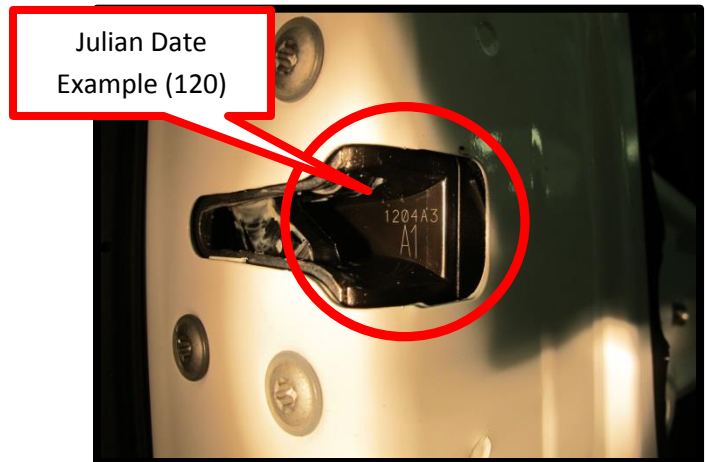
Figure 2

2. Inspect first three digits of the above model specified door latch/s Julian Date. Refer to Figure 2.

- If the first three Julian date digits **ARE** within (including) **154-160 or Unreadable**, continue to Step 3.
- If the first three Julian date digits are **NOT** within (including) **154-160**, then submit claim and release the vehicle.

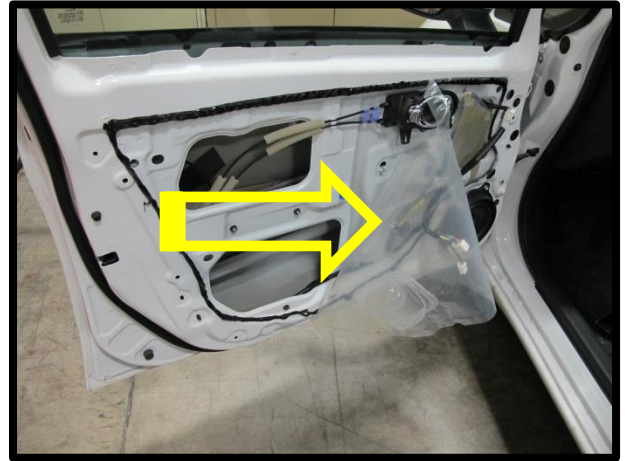
Figure 4

4. Working from the rear of the door, partially peel back the vapor barrier from door panel.

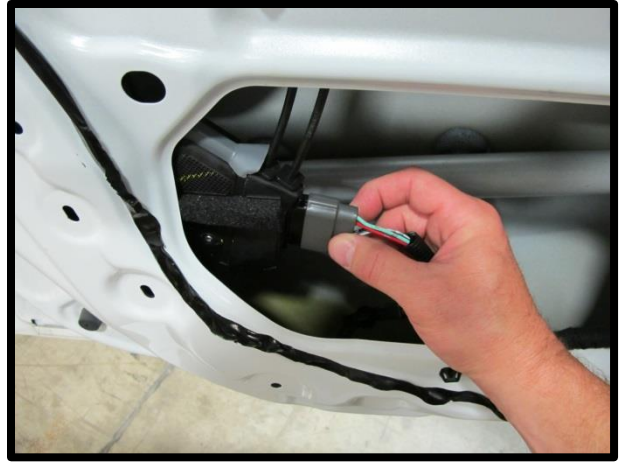
Figure 10

9. Vehicles Equipped With Power Door Locks:

Disconnect the door lock harness connector.

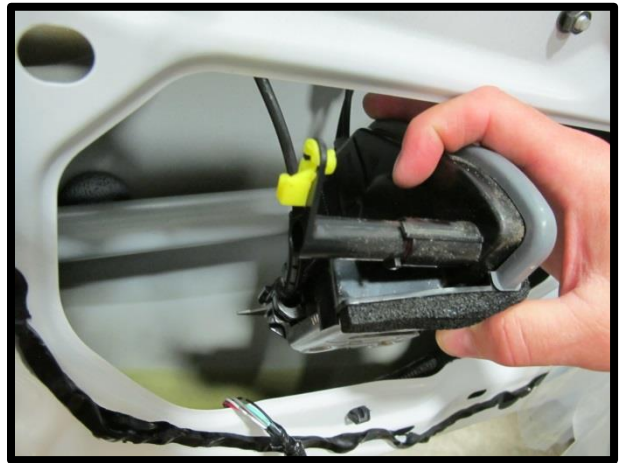
Figure 11

10. Pull the door lock assembly out of the door.

- Do not kink the door lock cables or disconnect them from the door handles.
