SERVICE BULLETIN

Classification: EM14-004a	Reference: NTB14-057a	Date: August 6, 2015
------------------------------	--------------------------	-------------------------

NISSAN; FLUID LEAK REPAIR SERVICE INFORMATION

APPLIED VEHICLES: All Nissan vehicles

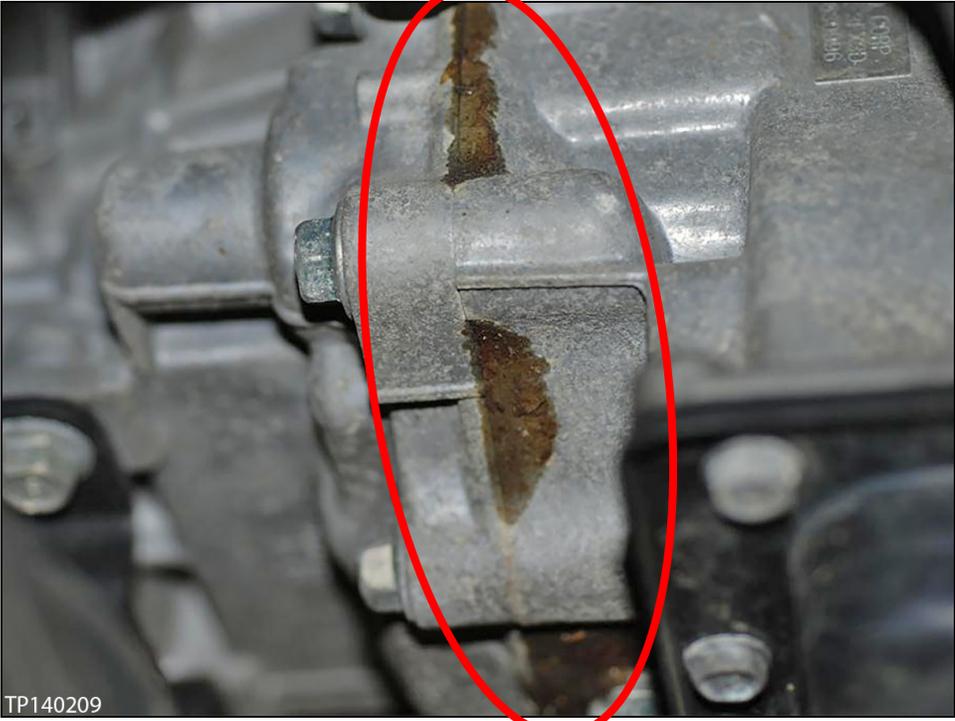
TP140209

Pictures of acceptable oil seepage

Transmission case halves area

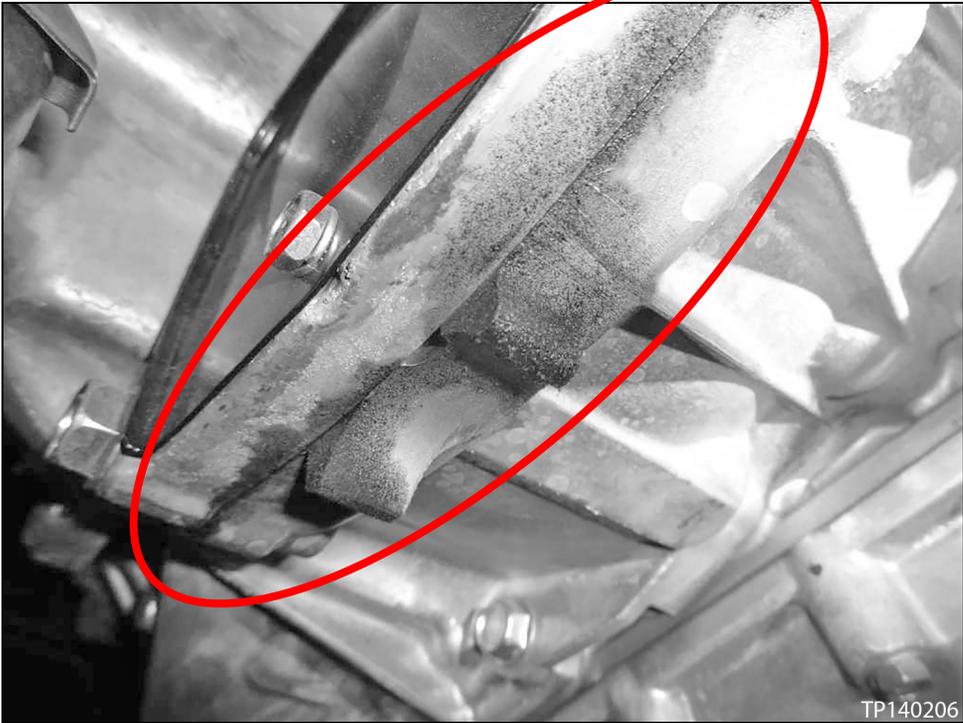
TP140206

Rear cover plate area

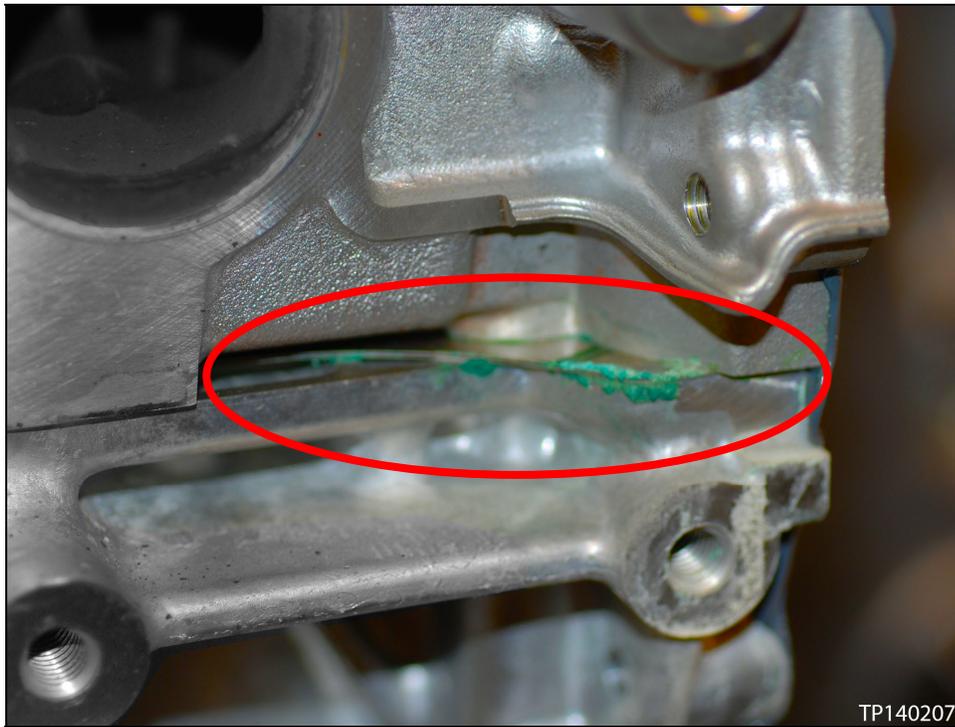
Pictures of acceptable coolant seepage (crusting)

Head gasket area

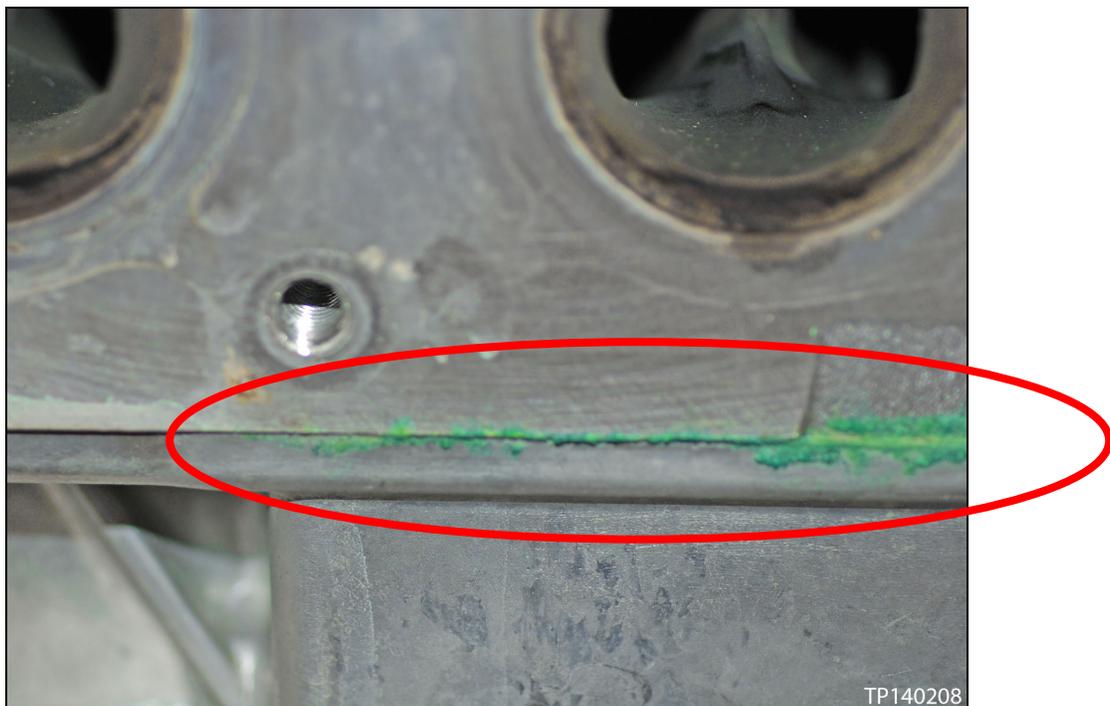
Head gasket area
