# SERVICE BULLETIN

EL15-021 NTB15-068 August 7, 2015

# 2013-2015 SENTRA; RATTLE AND/OR BRAKE PEDAL VIBRATION INSIDE VEHICLE AT IDLE IN DRIVE

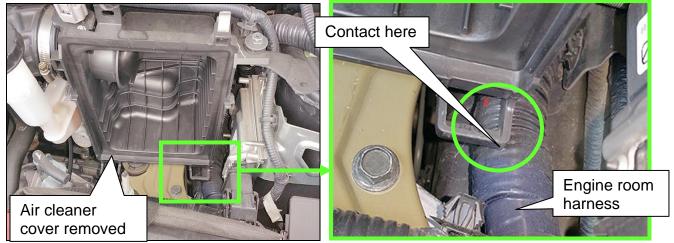
Figure 1

The engine room harness is in contact with the air filter assembly (Figure 1).

Install a zip tie to secure the engine room harness to the driver's side frame rail.

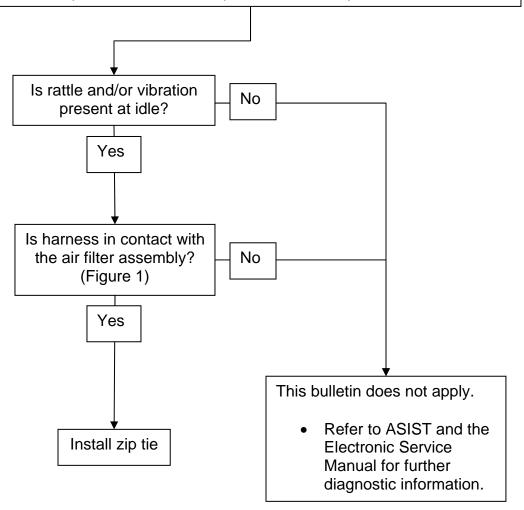
Figure 2

- 1. Remove the air cleaner assembly from the vehicle.
  - Refer to the Electronic Service Manual (ESM), section EM – Engine Mechanical for removal and reinstallation.

- 2. Loosely attach the zip tie to the engine room harness.
- 3. Snap the zip tie into the frame rail hole shown in Figure 3.
