NISSAN BULLETIN

Transverse Link Dealer Inventory Inspection

Reference: PC392

PC392 – 2015 Nissan – Pathfinder (R52) / Rogue (T32) – Transverse (TV) Link Pivot Locking Nut and Torque Service Inspection

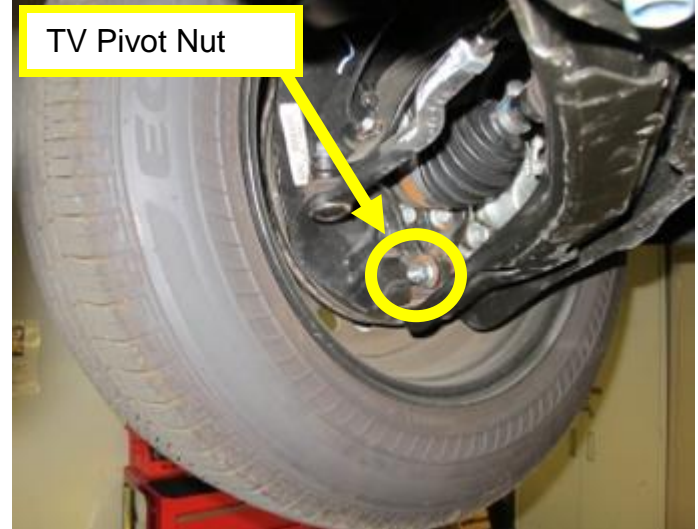
Figure 1

Driver Side Shown (Passenger is Similar)

1. Lift the vehicle using a hoist.
2. On the driver side knuckle, inspect the TV Link Pivot Nut/Bolt (Figure 1) to ensure it has a locking nut as pictured in (Figure 2).
3. If locking nut is present, use a torque wrench and an 18MM wrench to hold the bolt secure while checking the torque to the following spec:
 - **For Pathfinder:** TV Link Pivot Nut/Bolt:
63.8 N·m (47 ft-lb)
 - **For Rogue:** TV Link Pivot Nut/Bolt:
71.3 N·m (53 ft-lb)
4. On the passenger side knuckle, inspect TV Link Pivot Nut/Bolt to ensure it is a locking nut as pictured in (Figure 2).
5. If locking nut is present, use a torque wrench and an 18MM wrench to hold the bolt secure while checking the torque to the following spec:
 - **For Pathfinder:** TV Link Pivot Nut/Bolt:
63.8 N·m (47 ft-lb)
 - **For Rogue:** TV Link Pivot Nut/Bolt:
71.3 N·m (53 ft-lb)

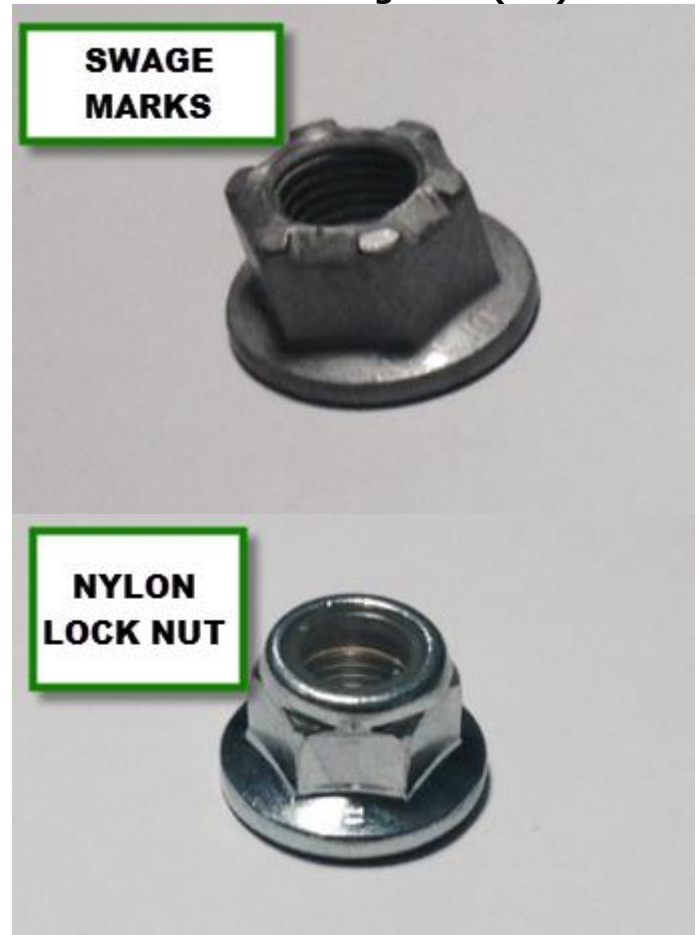
Figure 2

Correct Locking Nuts (OK)

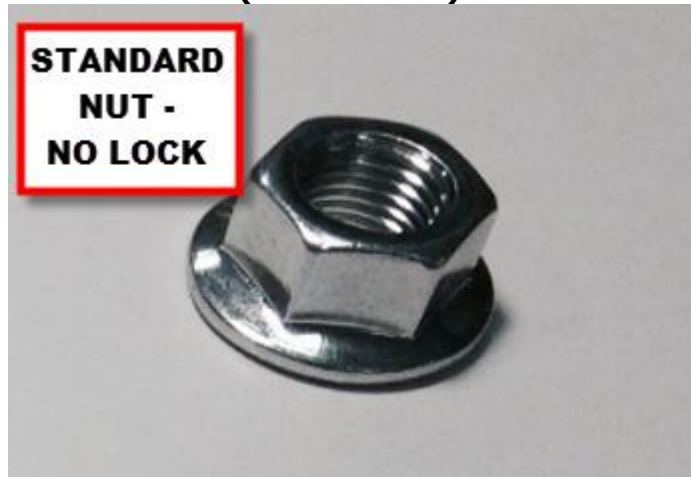
Figure 3

**Not Correct NON-Locking Nut
(Send E-Mail)**

6. If a locking nut is **NOT** present (Figure 3), proceed to Step 7b.

7. Were the TV Link Pivot Locking Nuts present and found to be correctly torqued?
- a. If the correct locking nuts ARE present and the locking nuts did NOT move when torque was checked:**
- Submit warranty claim using Op Code **PC3920** (see claims info).
 - Release the vehicle.
- b. If a TV Link Pivot nut is MISSING, or a NON-Locking TV Link Pivot nut is found, or the locking nut MOVED before the torque wrench clicked:**
- Continue to **HOLD** the vehicle.
 - Do not submit warranty claim.
 - Send an E-mail to the below address:
