SERVICE BULLETIN

Classification: EM15-004	Reference: NTB15-097	Date: November 5, 2015
-----------------------------	-------------------------	---------------------------

2014-2015 NV; COOLANT LEAK FROM HEATER HOSE BLEEDER CAP

APPLIED VEHICLES: 2014-2015 NV Cargo (F80)
2014-2015 NV Passenger (F80)

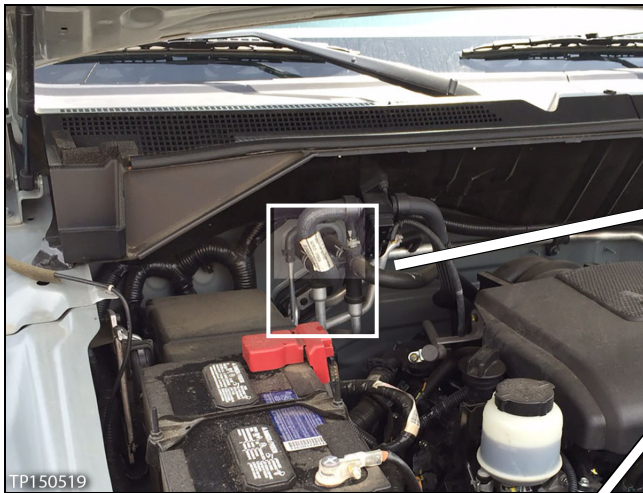
Figure 1

- The bleeder cap may show signs of cracking (see pictures on the next page).

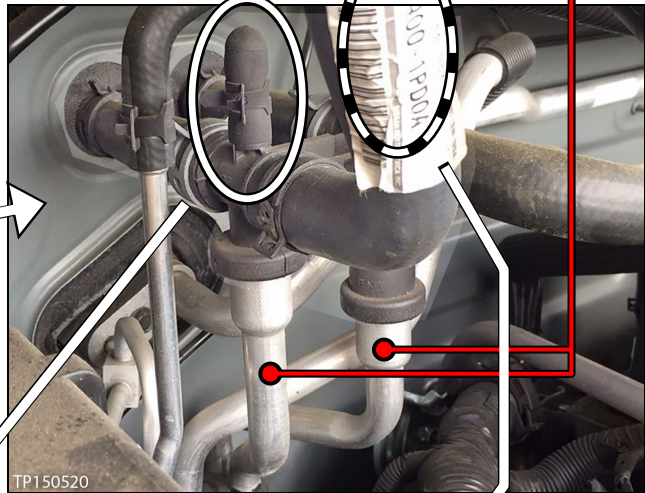
Figure 2 shows NV Passenger with rear heater piping (not equipped on NV Cargo).
NOTE: There is only one bleeder cap per vehicle – NV Passenger's is on the right, NV Cargo's on the left (its location is hidden in Figure 2).

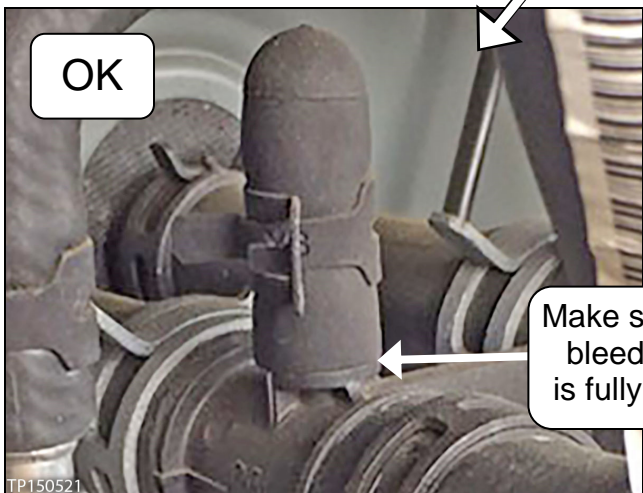
Figure 3; NV Passenger only

NOTE: The bleeder cap may not be fully seated down (see pictures on the next page).

- The new bleeder cap is listed in the **PARTS INFORMATION**.
- Make sure the bleeder cap is fully seated against the heater hose junction (see Figures 3 and 4 on the next page).
