## SERVICE BULLETIN

HA15-006

### 2014 TAXI; A/C CONDENSER LEAK NEW RADIATOR CORE SUPPORT

**APPLIED VEHICLES:** 2014 Taxi

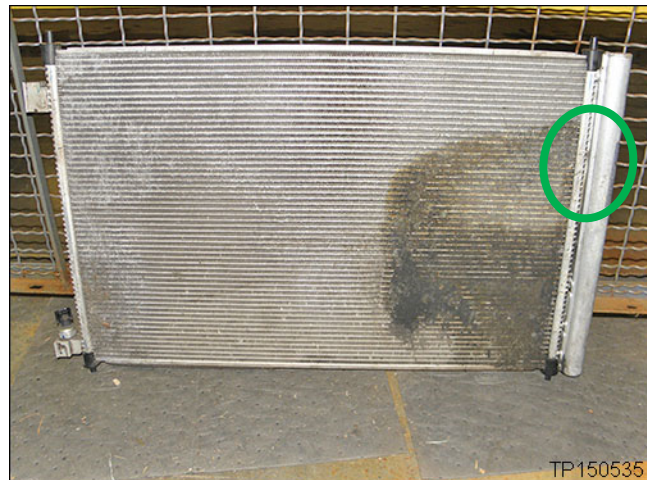
Figure 1

The A/C condenser has a crack and leak in the area shown in Figure 1.

Replace the A/C condenser and the radiator core support lower.

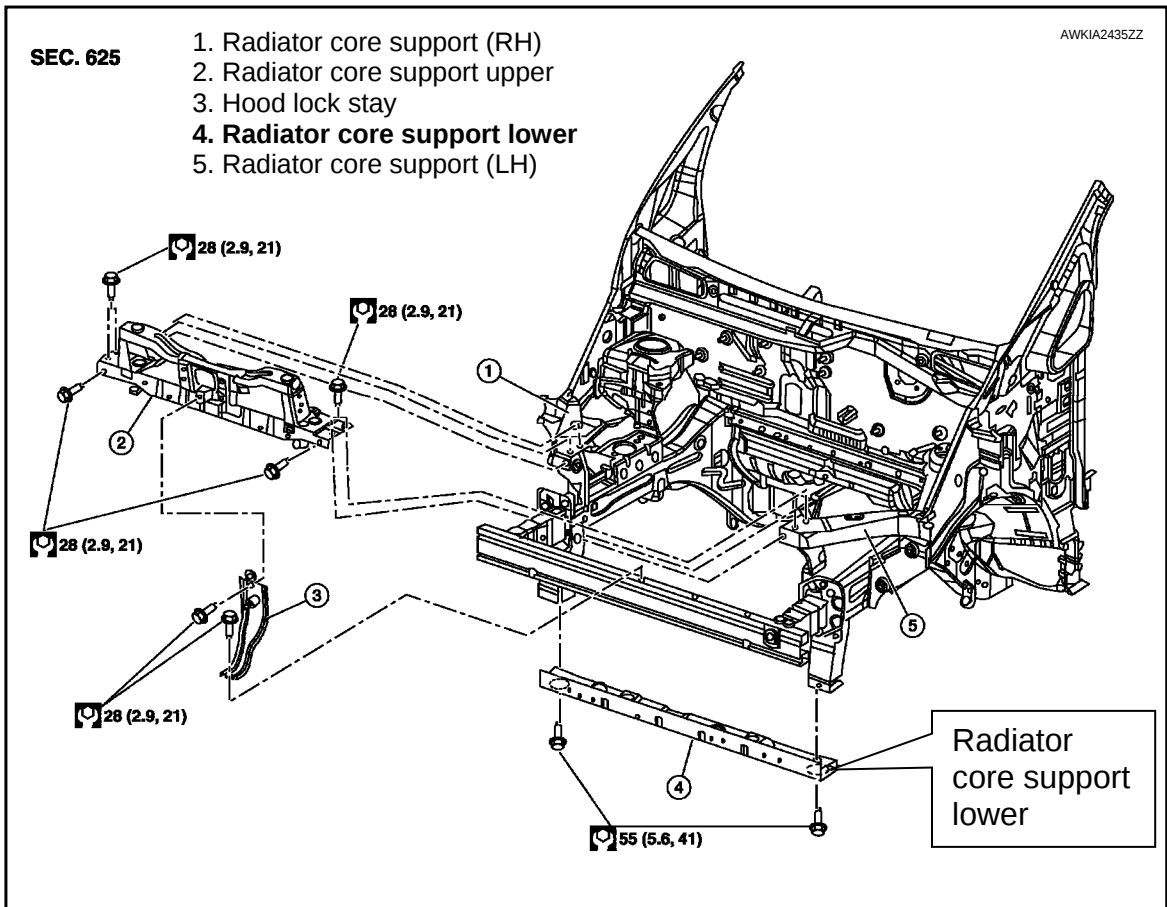
- The radiator core support lower is shown in Figure 2 on the next page.
- Use the new radiator core support lower listed in the Parts Information.
- Refer to the Electronic Service Manual (ESM) for replacement information.
  - For the condenser; ESM section HA – Heater & Air Conditioning System
  - For the radiator core support lower; ESM section DLK – Door and Lock
