Technical News 164
July 2015
Strictly Confidential

Contents

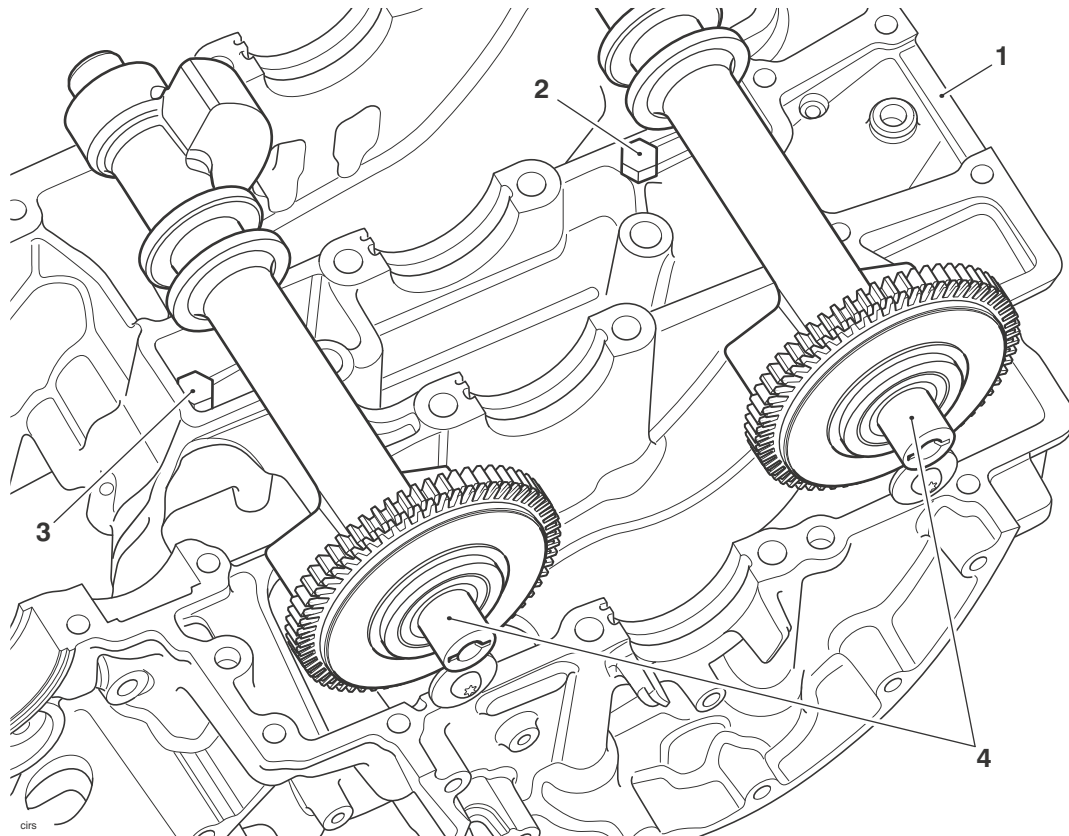
A new crankcase assembly has been introduced for the above models from engine number 713402. The new assembly features modifications to the crankcase castings. As a result, both front and rear balancer shaft oil cooling jets have changed from M6 to M8.

1. Lower crankcase half
2. Front balancer shaft cooling jet
3. Rear balancer shaft cooling jet
4. Balancer shafts (shown for positional reference only)

The new M8 oil cooling jets are not retrofittable and parts will continue to support the old condition M6 oil cooling jets for models already in service. The balancer shaft oil cooling jets should be tightened as follows:

- Old condition M6 oil cooling jets - **5 Nm**
- New condition M8 oil cooling jets - **6 Nm**.

- **Models already in service need not be retightened unless the oil cooling jets have been loosened or removed.**
- **If loosened or removed for any reason, the oil cooling jets must be replaced.**

A crankcase parts kit comprising the new crankcase assembly and balancer shaft oil cooling jets has been released for use when replacing crankcases on the above models up to engine number 713401.

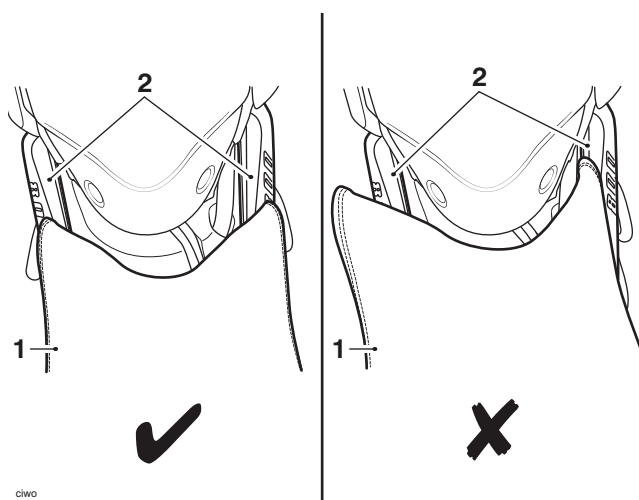
It has come to our attention that the rider's seat can become damaged on the above models, if care is not taken to correctly position the seat over the fuel tank infill panels during installation.

- 1. Rider's seat
- 2. Fuel tank infill panels

Take care when installing the rider's seat. Always ensure that the seat is correctly positioned over the fuel tank infill panels, before attempting to engage the seat's mounting rails.

Dealers are advised to install the rider's seat as described in the Owner's Handbook, noting that care should be taken to correctly position the seat over the fuel tank infill panels before attempting to engage the seat's mounting rails.

During pre-delivery inspection, ensure that the seats are fitted correctly onto the motorcycle. Inspect the seat covers for damage paying particular attention to the front and lower edges of the rider's seat.

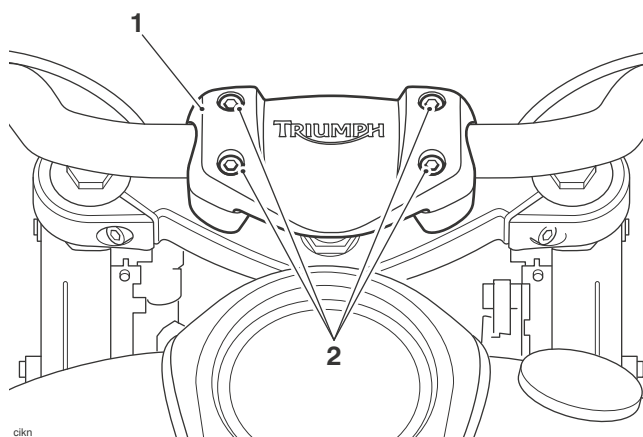
1. Handlebar clamp
2. Fixings

The torque figure for the handlebar clamp fixings has changed to **27 Nm** on the above models.

- **Models already in service need not be retightened unless the fixings have been loosened or removed.**

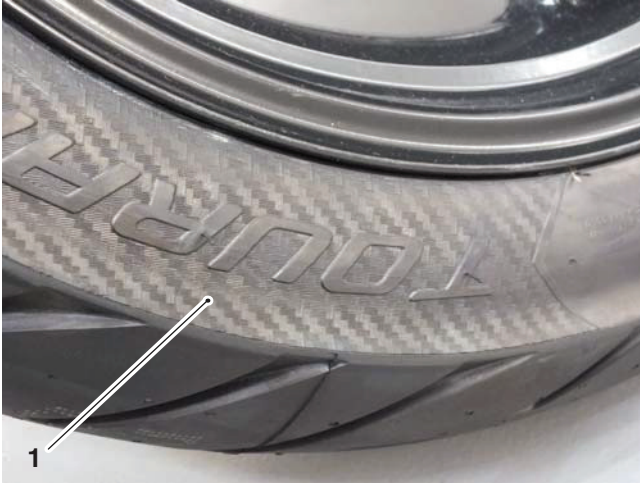
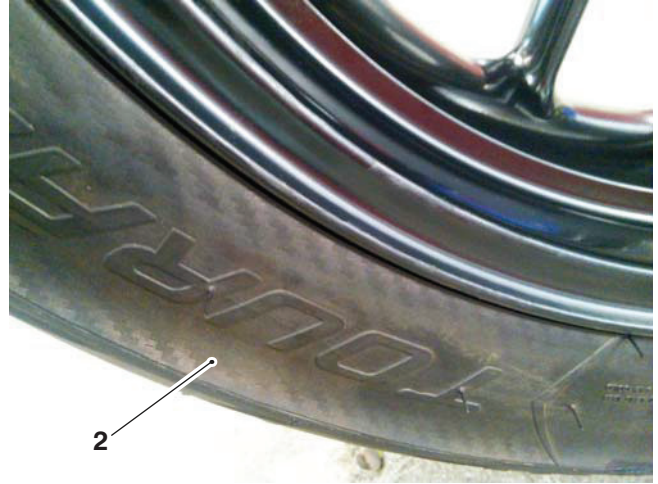
It has come to our attention that the clarity of the moulded pattern, present on the side wall of the Metzeler rear tyre fitted to the above models, may vary from motorcycle to motorcycle.

- 1. Tyre wall moulded pattern - high clarity
- 2. Tyre wall moulded pattern - low clarity

Dealers are advised that this variation of the aesthetic properties of the rear tyre's side wall is not considered to be a fault.

Triumph can confirm that the Metzeler rear tyres fitted to the above models comply fully with our specifications and that the quality and performance of the tyres is unaffected. The tyre specification and homologation markings provided on the side wall of the tyre are also unaffected.
