US 61737415-01

Side covers come loose

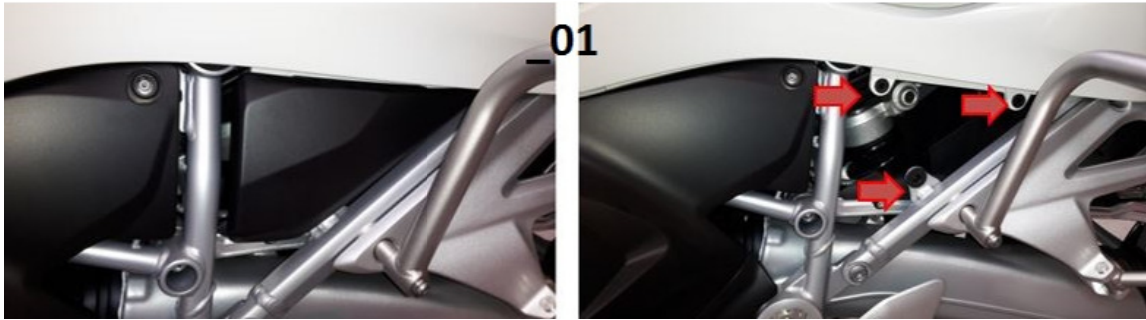
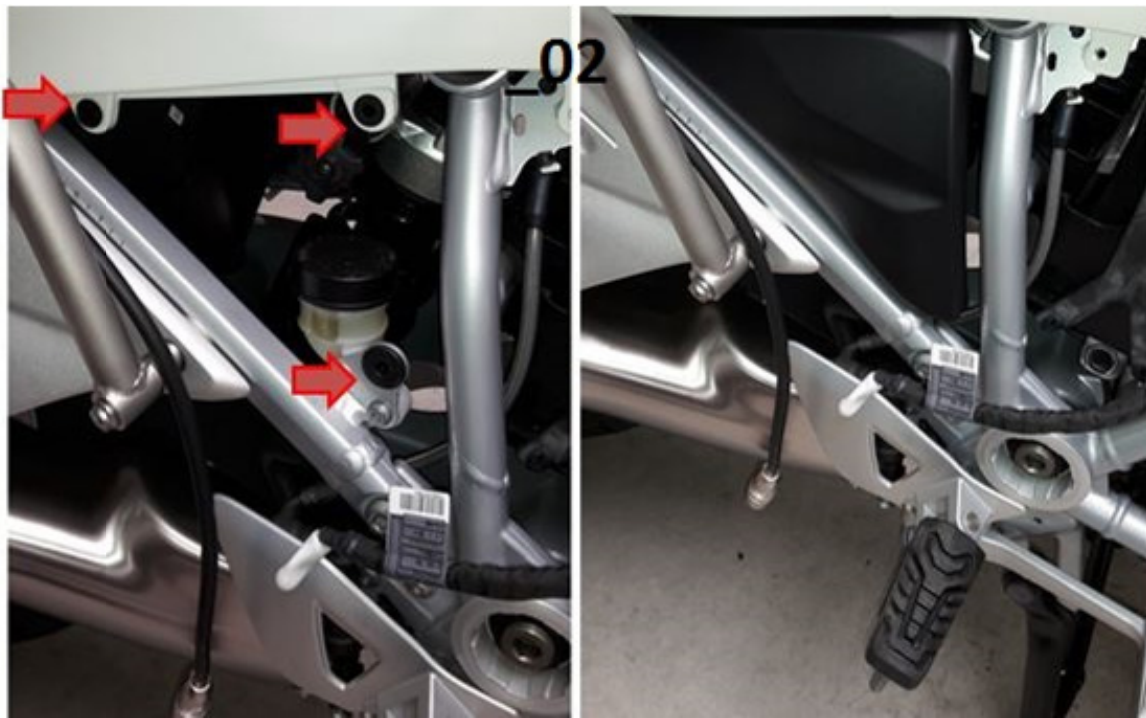
The spring strut cover 46 63 8 534 860 on the left and the handwheel cover 46 63 8 534 861 on the right come loose very easily when the motorbike is being ridden.

The cover mounting is too loose. They come out of the rubber mounting easily due to the air stream. Pictures\_01 and \_02 show the covers fitted and when they have been removed.

It is crucial that the covers are fitted correctly. When fitting them, it is important to take extra care to ensure that all the studs have been pushed in their rubber mounts properly. If any of the studs have not been properly pushed in, the panel in question will be loose.
