MODEL  
2011~2016MY  
Optima Hybrid  
(TF HEV)

NUMBER  
PS391

OPTIMA HYBRID (TF HEV) WITH DTC B1695 - LOST  
COMMUNICATION WITH E-COMP

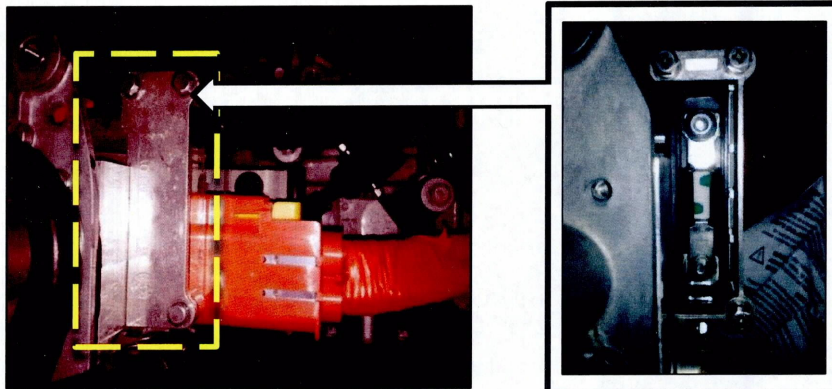
Begin the diagnosis process by locating the HV E-Comp fuse on the HPCU. The fuse is located at the rear of the unit just above the 270V input to the HPCU. Once the fuse is located, remove it and test for continuity across the fuse. If the continuity test reveals an open circuit, order a replacement fuse. **Note – If the fuse is blown, it is likely due to either a harness or an E-Comp concern. Verify the root cause before replacing the fuse or it will likely blow again. For additional diagnosis information, refer to the Service Information on KGIS.**
