# SS 469081TBB Emergency Pushout Window Buzzer sounds cold temp

## Subject: Replacement of Magnet in Vertical Push Out Window

**Models Affected: 2008 and newer C2****Subject: Alarm sounding that vertical push out is open and the window is locked.**

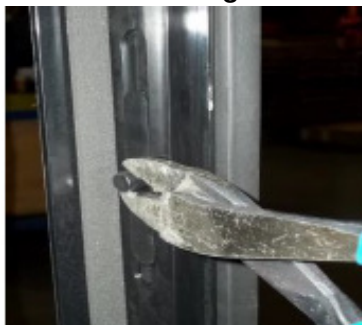
**Figure 1**

- 1) Place bus in Park/neutral and chock wheels on bus.
- 2) Turn ignition off.
- 3) Remove vertical push out window from bus.
- 4) Before starting replacement, make sure that you have these tools available:
  - Long nose pliers
  - Flat head screw driver
  - Slide bar assembly with spring pin, switch and magnetic shield and slide retainer.**(Left hand window THSP-67008, Right hand window THSP-67009)**
  - Magnet
- 5) Lift red handle on the vertical push out window and open window.
- 6) With pliers, remove the two slide retainers as shown in **Figure 1**.

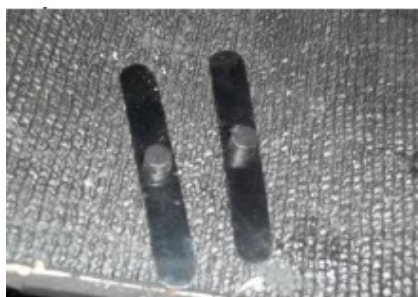
- 7) Throw out the used slide retainers. **Figure 2**

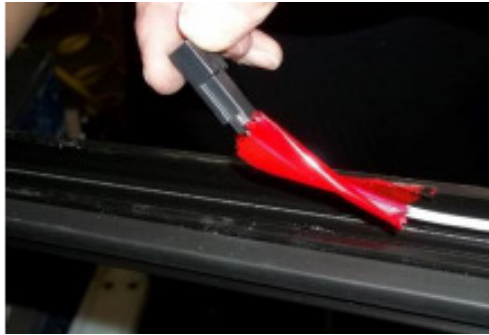
**Figure 3**

- 8) On the top of the window frame disconnect the wiring as shown in **Figure 3**.

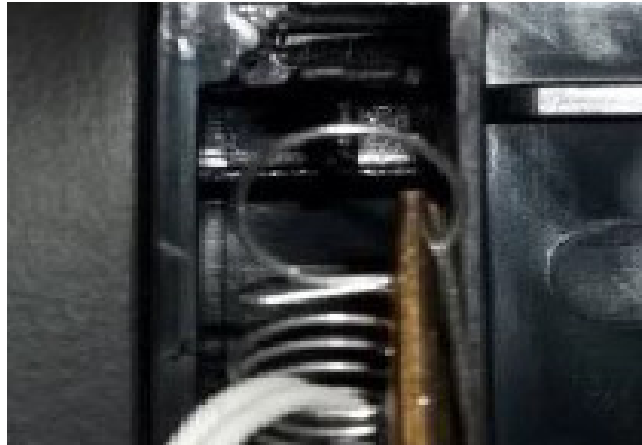
**Figure 4**

- 9) Remove the two white wires from the side of the frame leading down to the handle.
- 10) With a long pair of needle nose pliers, disconnect the spring ring from the tab at the top of the window.

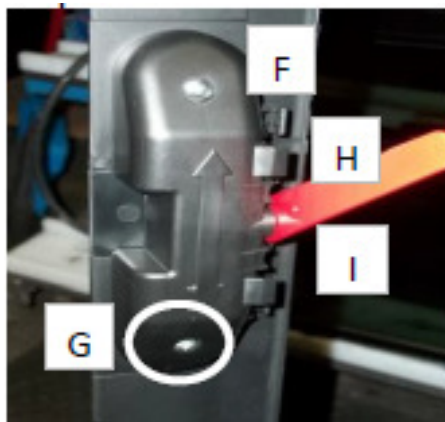
- 11) With a Philips head screwdriver, remove screws F and G in **Figure 5**

12) Remove screws H and I. **Figure 5**

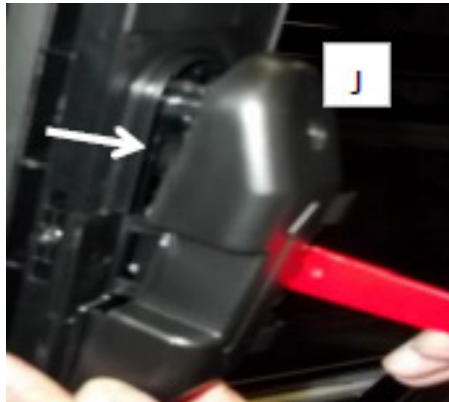
13) Remove the cover to the handle. **Figure 6**

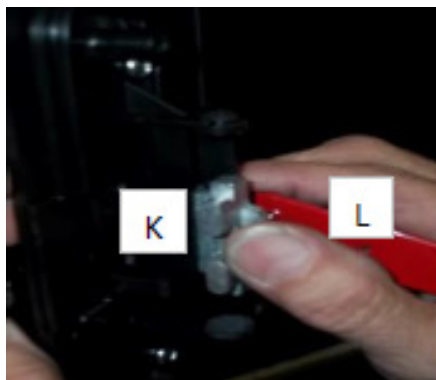
14) Remove the lock fork (K) and handle (L) **Figure 7**

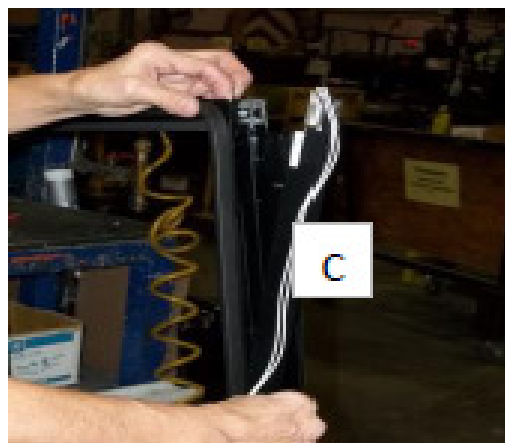
15) Remove the sliding bar assembly (C) from the handle side and discard **Figure 8**

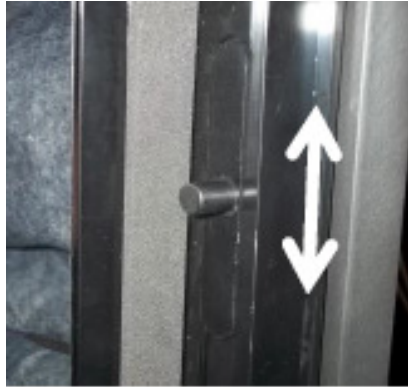
Figure 10

- 16) Put new sliding bar assembly into place.
- 17) Install the new slide retainers using a rubber hammer. **Figure 9**

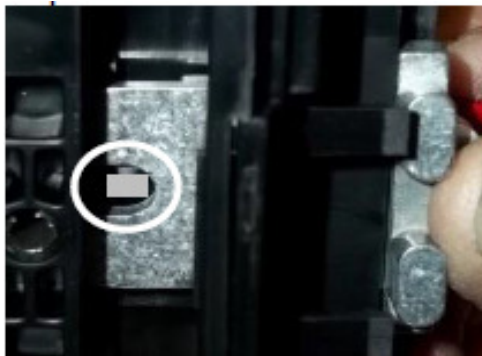
Figure 10

- 18) Put in place the lock fork. **Figure 10**

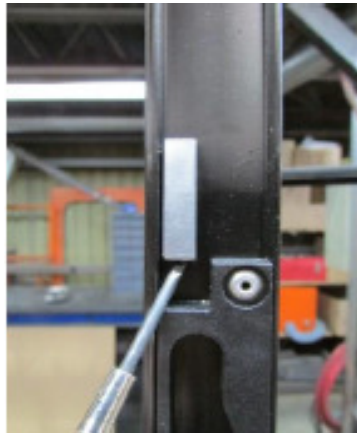
Figure 11

- 19) Reinstall the red handle.
- 20) Reinstall switch cover using the four screws taken out in steps 11 and 12
- 21) Lift the red handle and open inner frame to expose the magnet located on the frame side above the lock guide. Remove magnet with flat head screw driver and remove any glue residue. **Figure 11**

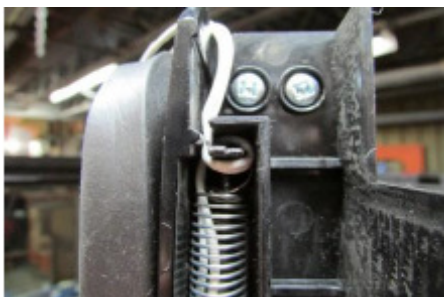
**Figure 12**

- 22) Position the bottom of the new magnet to be flush with the top of the lock guide and .2 inches (.2 for sash window only, .49 for panoramic and T-Slider window.) from the frame's outer edge. Press firmly in place. The magnets dot mark must be oriented downward. (If available, use a drop of cyanoacrylate glue on the magnet's tape before gluing it.)
- 23) With long needle nose pliers, reattach the ring of the spring to tab.
- 24) Lift red release handle to stretch spring. Loop wires around the tab before inserting the wires in groove.
