# SS 469084 TBB Heater Hose cover heat shield improvement

# Service Solution

### Subject: Heater Hose covering at Wheel well

**Models Affected:** Type D buses

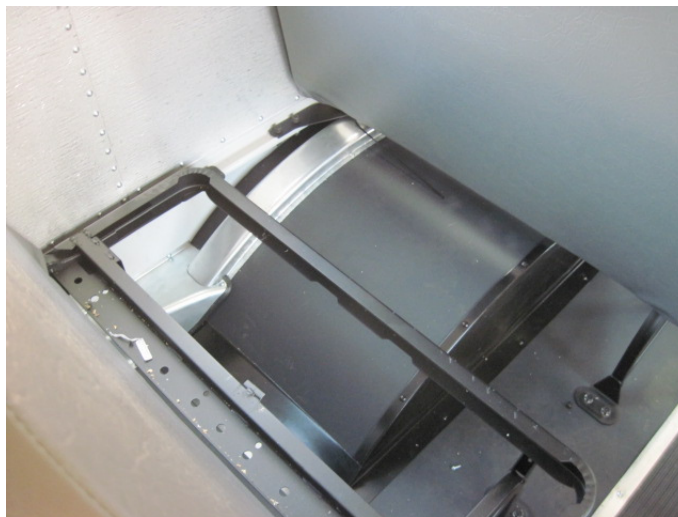
1. Turn vehicle off, place in park and chock wheels.
2. Remove the seat bottoms of the seat that is above the wheel well and the seat behind to expose the heater hose cover. **Figure 1**

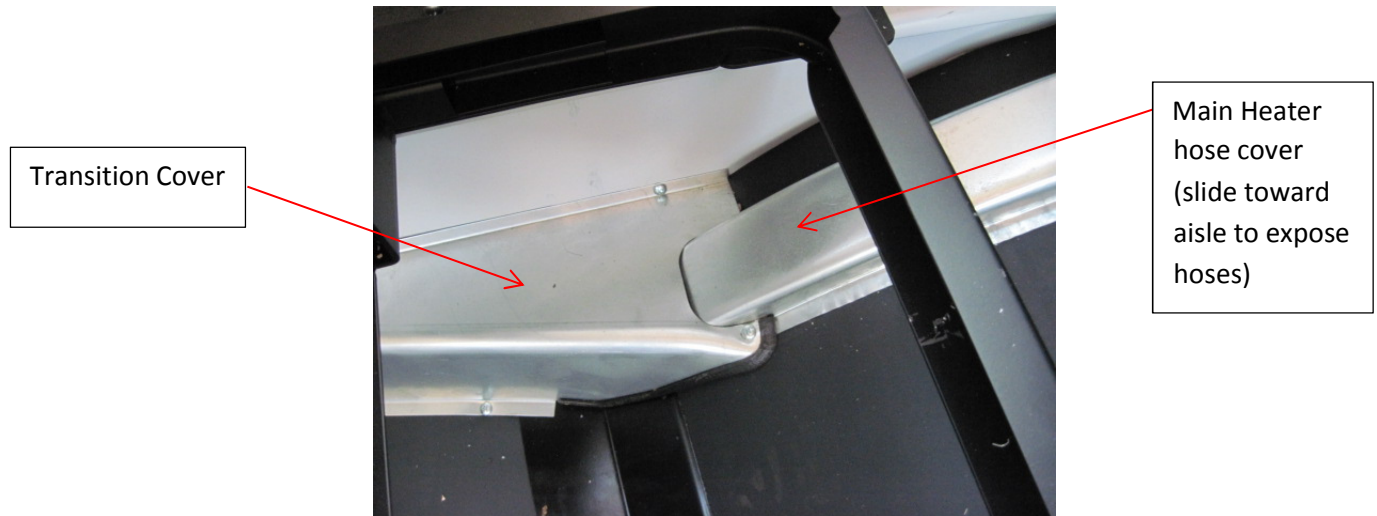
3. Once seat bottoms are removed, the metal covers are to be removed next. This requires removing the front and rear transition pieces using the screw gun. **Figure 2**

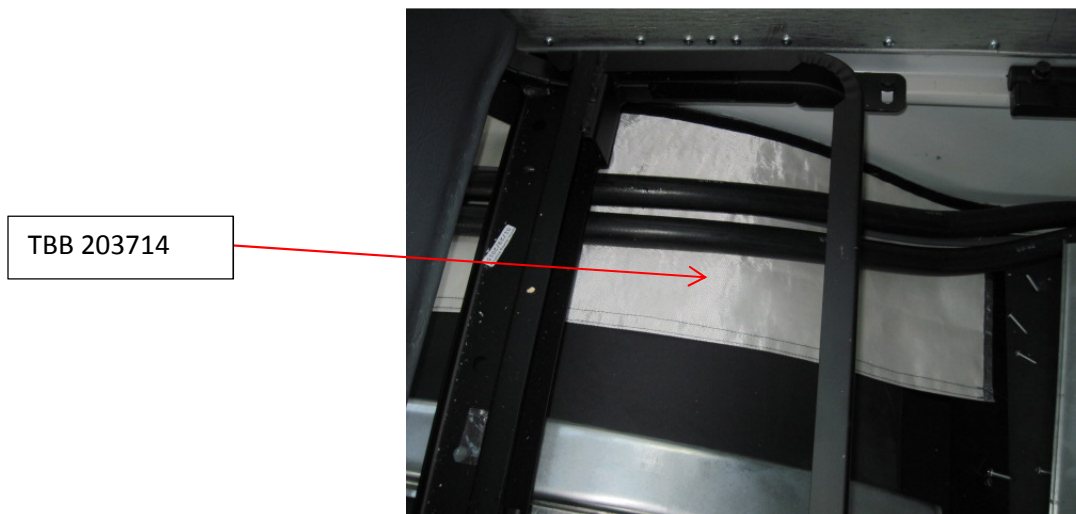
4. Once the front and rear transition covers are removed, the main cover can be moved off the hoses and pulled toward the center of the bus to keep out of the way.
5. The heat cover (TBB 203714) needs to be slid under the heater hoses as shown in **Figure 3**

6. Make sure that the hoses are centered in the cover and the cover is set so that it will cover the wheel well.
7. Wrap the covering around the hoses and attach Velcro.
8. Slide the metal covering back over the hoses and the covering. Make sure that all covering is under the metal cover.
