| TSB150156 |

Turbocharger Coolant Hose Malfunction Caused by Hose Clamp

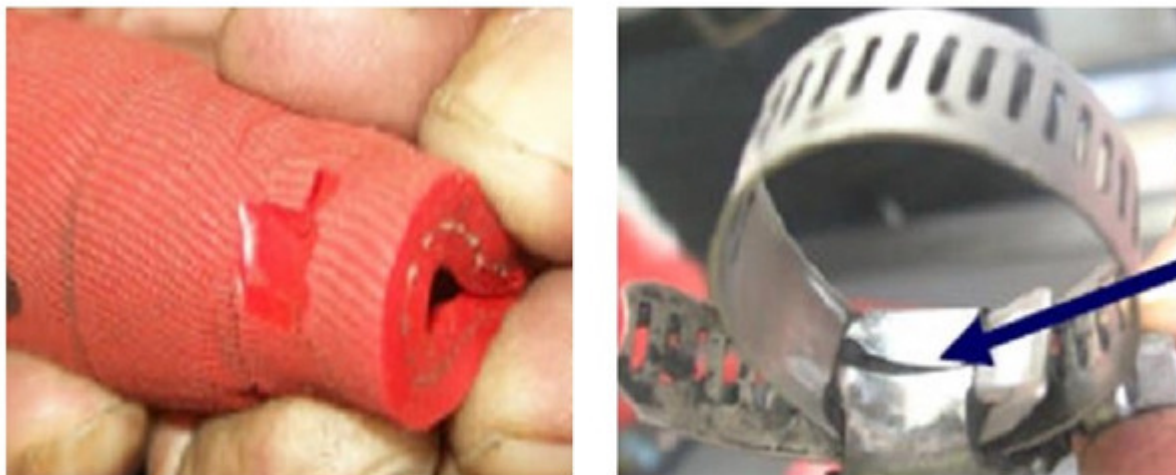
10r00149

The turbocharger coolant hose can leak as the result of damage caused by a hose clamp.

If the turbocharger coolant hose is leaking coolant, inspect the hose clamp installation area of the turbocharger coolant hose for damage. See Figure 1 below for an example of damage.

Figure 1, Damage to Turbocharger Coolant Hose and Suspect Hose Clamp

Replace the damaged turbocharger coolant hose. When installing the new turbocharger coolant hose use spring hose clamp, Part Number 5267079, instead of hose clamp, Part Number 3820672 or Part Number 5316194.
