# Service Bulletin

Subject: **Checking-fixing exhaust pipes cover**

Product: **Turismo Veloce - Turismo Veloce Lusso - Stradale**

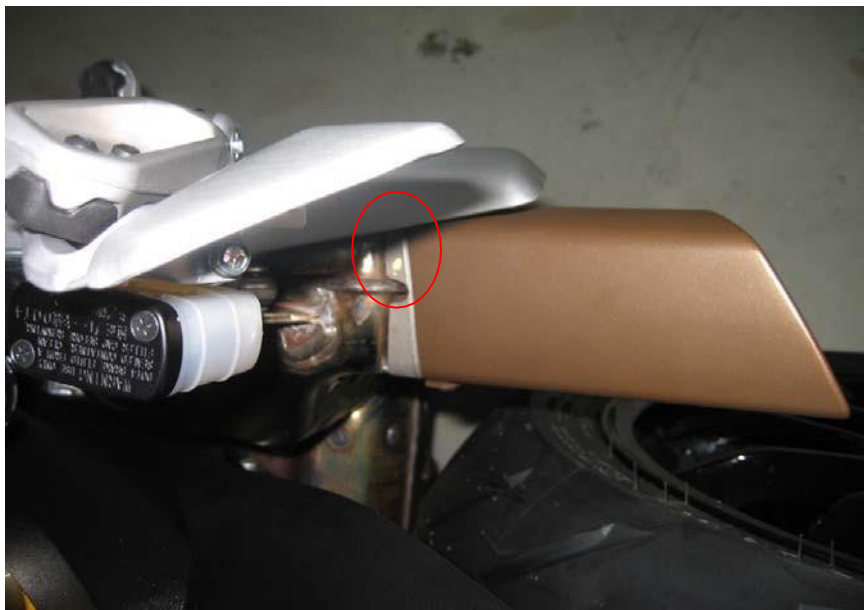
**- Motorcycles with VIN included in the range indicated, but tagged with the yellow dot on the exhaust pipe (as shown in the image below) have already been updated in MV Agusta.**
