**NUMBER:** 23-023-15

Wind Noise Dual Pane Sunroof

This bulletin involves inserting a foam stuffer into the sunroof bulb seal.

2015 (UF) Chrysler 200

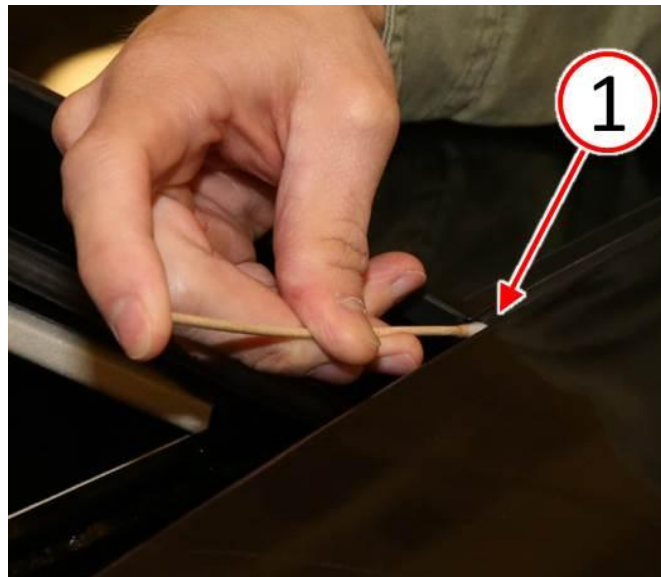
**Fig. 4 Clean Inside Sunroof Fixed Pane Bulb Seal**

- 1 - Sunroof Bulb Seal
-

- 
4. Using a cotton swab or equivalent, clean inside the sunroof fixed pane bulb seal (1) with isopropyl alcohol (Fig. 4).
