# Service Action Campaign – U.S. ONLY

Code: 20T8

**Subject: Certain 2009-2012 Model Year Vehicles with TDI® Clean Diesel Engine  
Install Misfueling Guard**

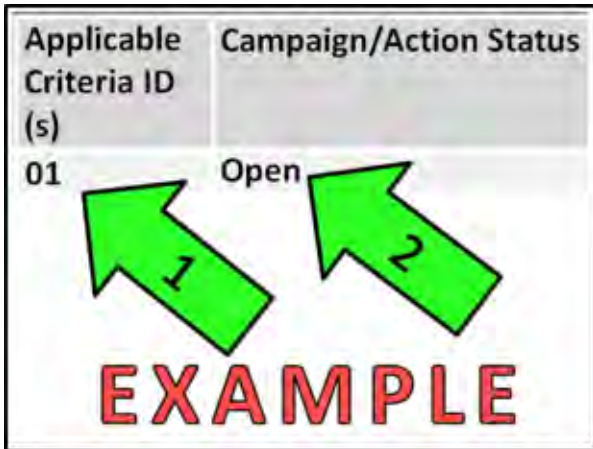
**Section A – Identify Criteria and Check for Open Status**

- Enter the VIN in ElsaWeb and proceed to the “Campaign/Action” screen.
- ⇐ Ensure that the Status is “Open” <arrow 2>.
- ⇐ Note the Applicable Criteria ID <arrow 1> for use in determining the correct work to be done and associated parts.

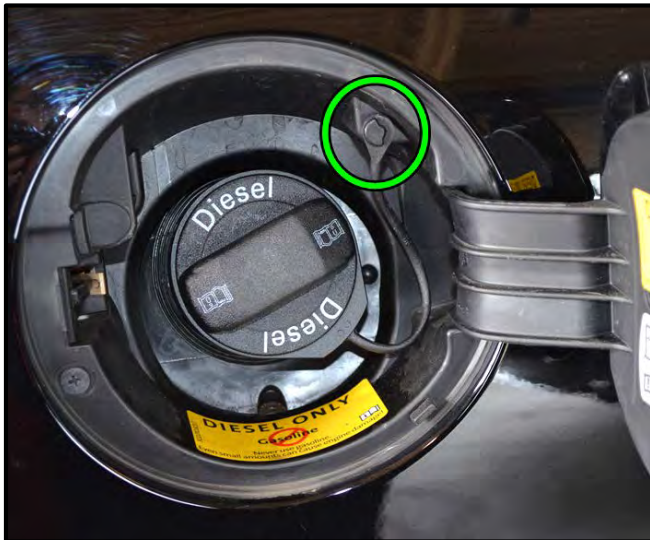
- Open the fuel filler door
- ⇐ Remove the fuel cap and the fuel cap tether <circle> from the vehicle.

**Tip:** If the customer has installed their own locking or aftermarket fuel filler cap, be sure to return the old fuel cap to the customer.

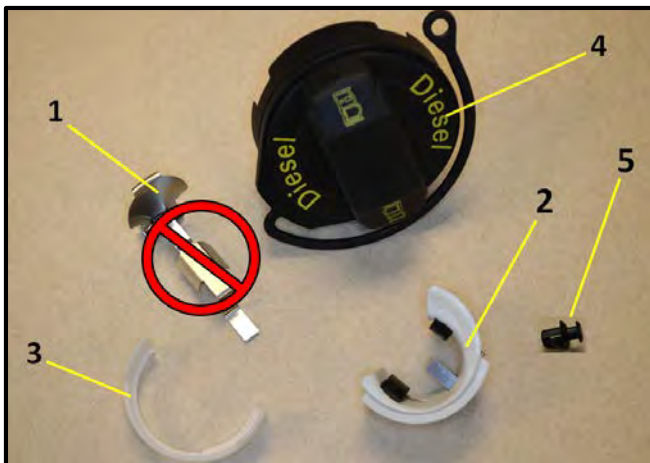
- ⇐ The misfueling guard kit p/n - 5K0 201 400 consists of five pieces <left>.

**NOTE: DO NOT INSTALL the spring loaded flap insert (#1)**

1. Spring Loaded Flap Insert (**NOT USED**)
2. Fuel filler lockout mechanism.
3. Plastic retaining ring.
4. Replacement fuel cap w/tether.
5. Mounting pin for fuel cap tether.

**Note:** On SportWagen models the tether is attached to a permanent anchor inside the fuel filler housing. On Jetta sedans the tether is mounted to the fuel filler door hinge using a plastic mounting pin (#5 above). A replacement pin is included in every misfueling guard kit, but is not used on some models.

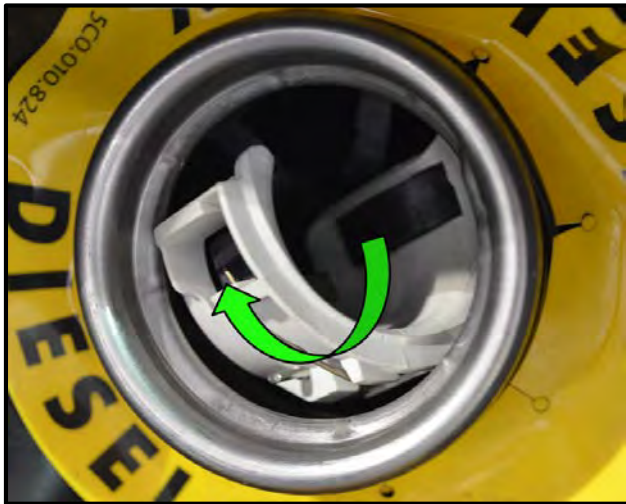
⇐ Insert the lockout mechanism into the filler neck and rotate from right-to-left <arrow> to seat properly into position.

**Tip:** The right side of the mechanism must be placed into the filler neck opening first.

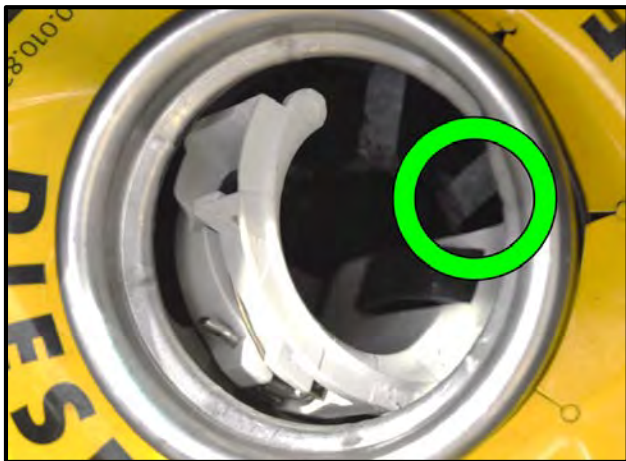
⇐ During installation the lockout mechanism must remain to the right of the right tab in the filler neck opening <circle>.

- With the right side of the lockout mechanism properly lined up, press the left side into the filler neck.

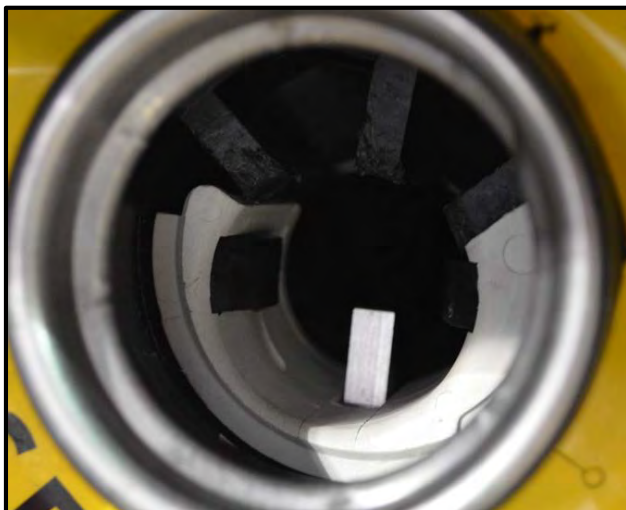
⇐ Align the lockout mechanism with the tabs in the filler neck, and then push the lockout mechanism down into the filler neck until it is fully seated <as shown>.

**Tip:** The fuel filler lockout mechanism is fully seated into position when it bottoms out against the fuel filler neck <as shown>.

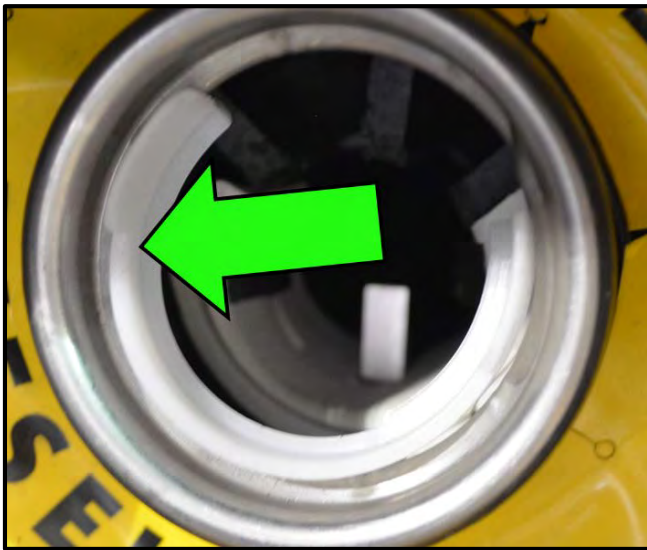
⇐ Insert the retaining ring into the filler neck <arrow>.

- The ring will lock into place at both the 9 o'clock and the 3 o'clock positions when fully seated against the lockout mechanism.

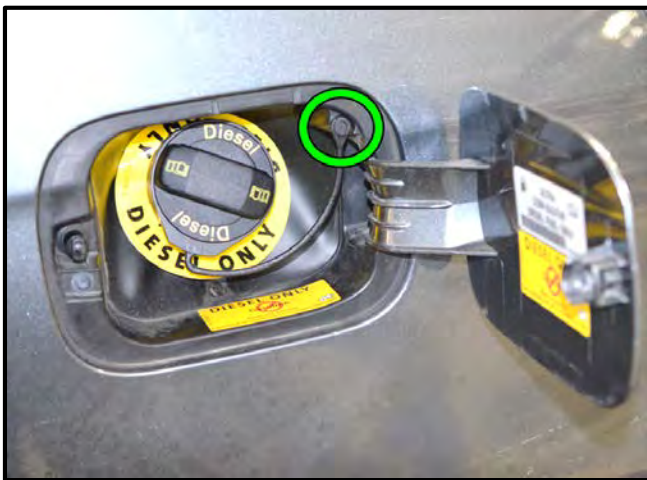
- Install the replacement fuel cap.

⇐ Attach the fuel cap tether <circle> and close the fuel filler door.
