Service Action Campaign

Code: 20U3

**Subject: 2010-2012 Model Year Audi A3 with TDI® Clean Diesel Engine
Install Misfueling Guard**

May 21, 2013

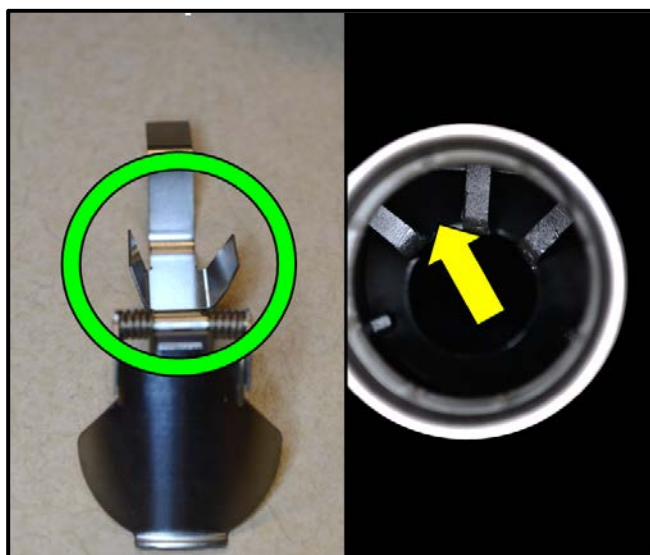
- ⇐ The misfueling guard kit p/n - 5K0 201 400 consists of five pieces (left) which must be installed in the following order:
 1. Spring loaded flap insert.
 2. Fuel filler lockout mechanism.
 3. Plastic retaining ring.
 4. Replacement fuel cap w/tether.
 5. Mounting pin for fuel cap tether (not used on A3 models).

Note: The plastic mounting pin (#5 above) included in the misfueling guard kit is not used on A3 models, and can be discarded.

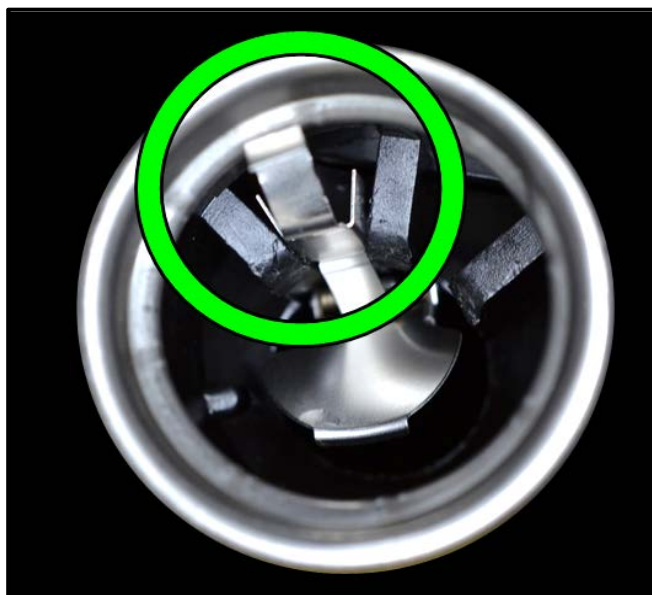
- ⇐ The spring loaded flap insert is installed into the filler neck, **flap side first**, with the tabs <circle> inserted into the left slot <arrow> in the filler neck.

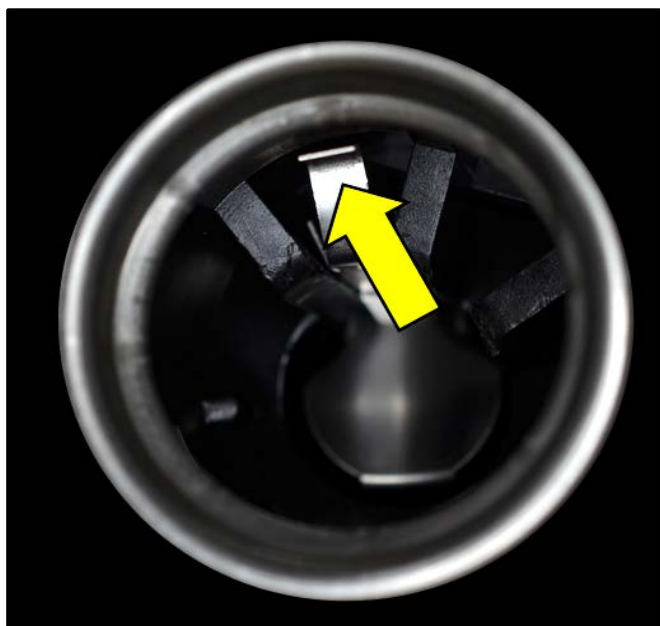
⇐ Install the flap insert as shown, aligning the tabs with the filler neck slot <circle>.

Note: It may be necessary during this step to push upward on the flap insert, pressing it against the wall of the filler neck, and causing it to flex slightly. By doing this the tabs will align correctly with the filler neck. When done properly the flap insert will not be bent or damaged – **DO NOT** force the flap insert into the filler neck. When the tabs line up properly the insert will fit easily into place.

Note: During installation the flap itself will also flex backward slightly. This allows the flap to fit fully down into the filler neck. It will return to its original position with the flap insert fully seated in the filler neck.

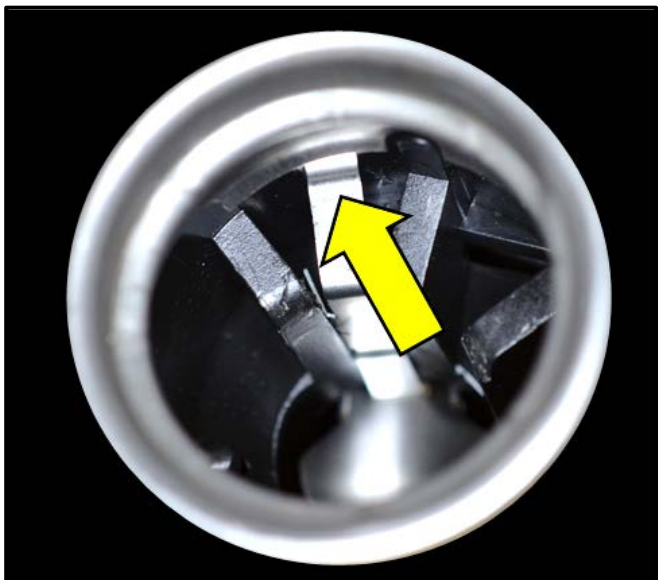
- With the tabs on the flap insert properly fitted into the filler neck slot, push the flap insert straight into the filler neck until it is seated.
- ⇐ To lock the flap insert into position, push the locking tab inward using a pocket screwdriver, or equivalent, where shown <arrow>.
- There will be an audible click when the locking tab is fully engaged.

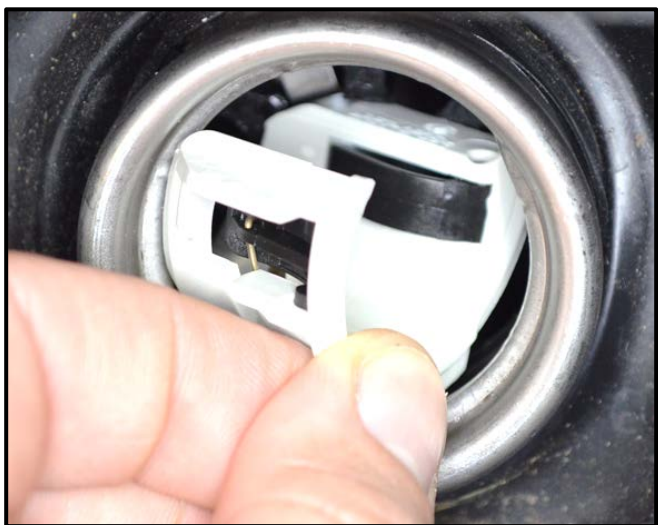
⇐ Verify the locking tab on the flap insert is fully seated behind the ring of the filler neck <arrow>.

- Using a pair of needle nose pliers, or equivalent, check for proper operation of the flap itself. Verify it does not stick closed and that it returns to a closed position after being pressed open.

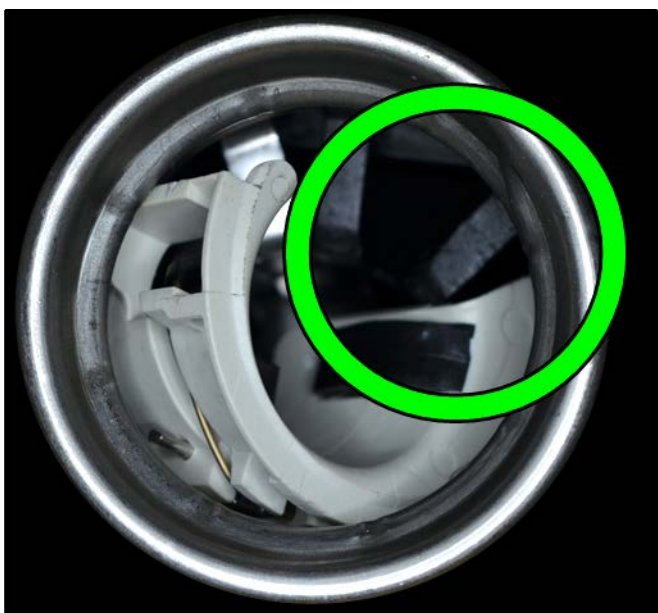
⇐ Insert the lockout mechanism into the filler neck as shown.

- The right side of the mechanism must be placed into the filler neck opening first.

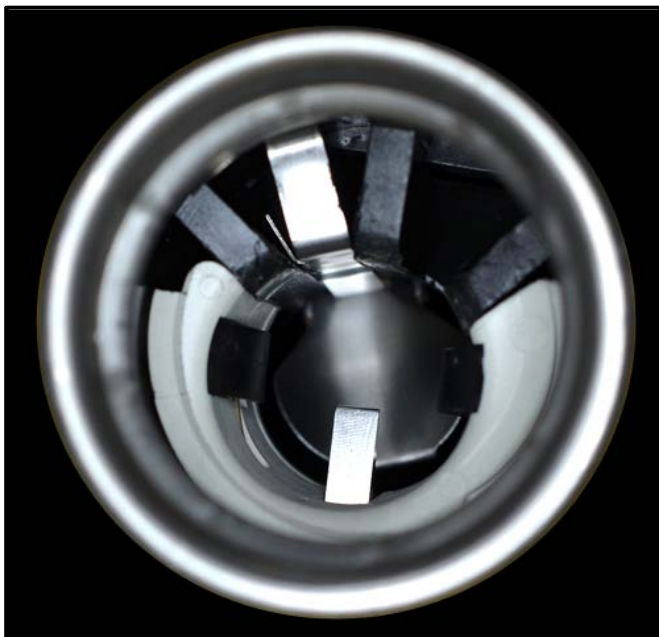
⇐ During installation the lockout mechanism must remain to the right of the right tab in the filler neck opening <circle>.

- With the right side of the lockout mechanism properly lined up, press the left side into the filler neck.

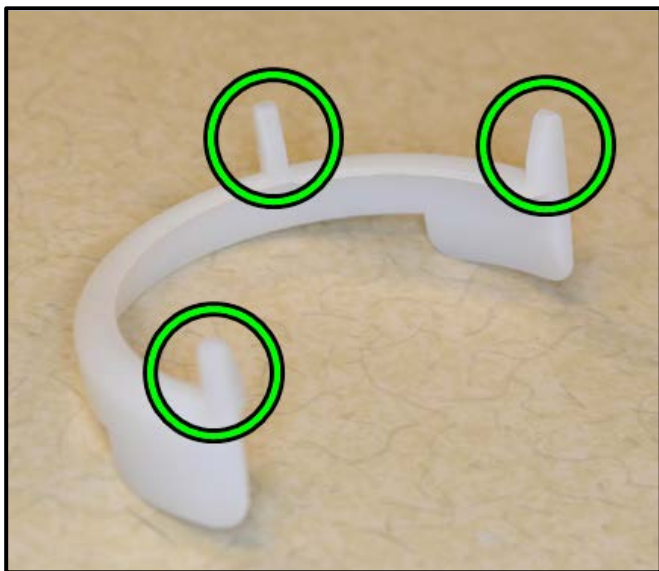
- ⇐ Align the lockout mechanism with the tabs in the filler neck, then push the lockout mechanism down into the filler neck until it is fully seated (left).

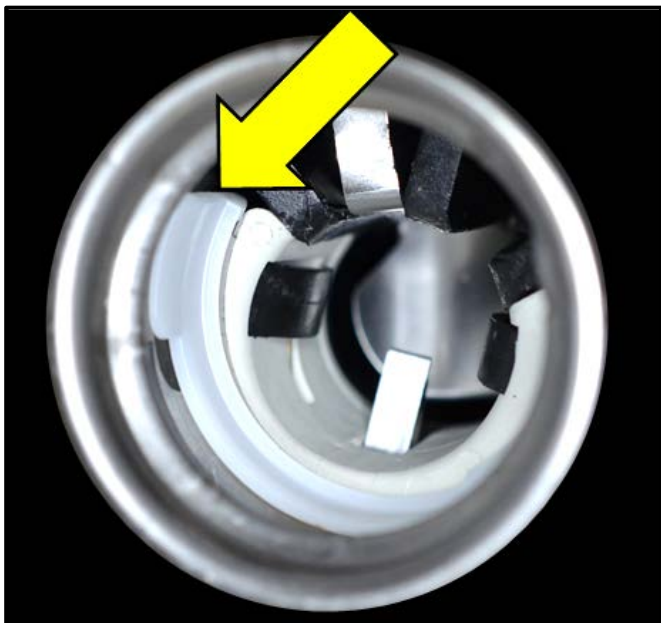
- ⇐ The retaining ring is installed into the filler neck with the alignment pins <circles> facing toward the fuel tank.
