Service Action Campaign

REVISION
Code: 20U3

**Subject: 2010-2012 Model Year Audi A3 with TDI® Clean Diesel Engine
Install Misfueling Guard**

June 28, 2013

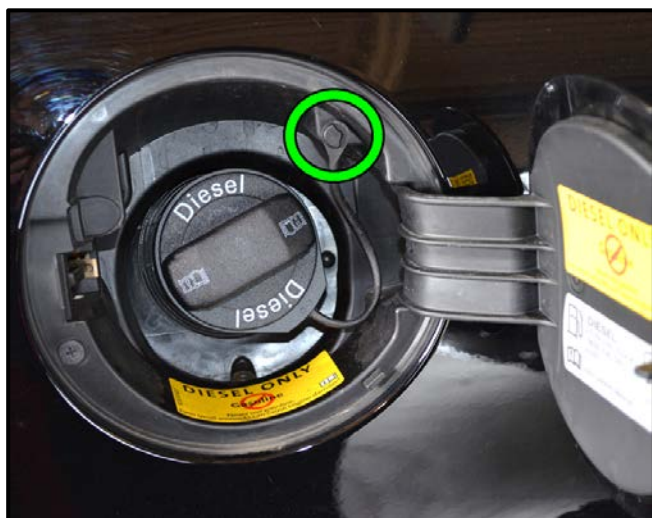
Section B – Install Misfueling Guard Kit

- Open the fuel filler door.
- ⇐ Remove the fuel cap and the fuel cap tether <circle> from the vehicle.

Tip: If the customer has installed their own locking or aftermarket fuel filler cap, be sure to return the old fuel cap to the customer.

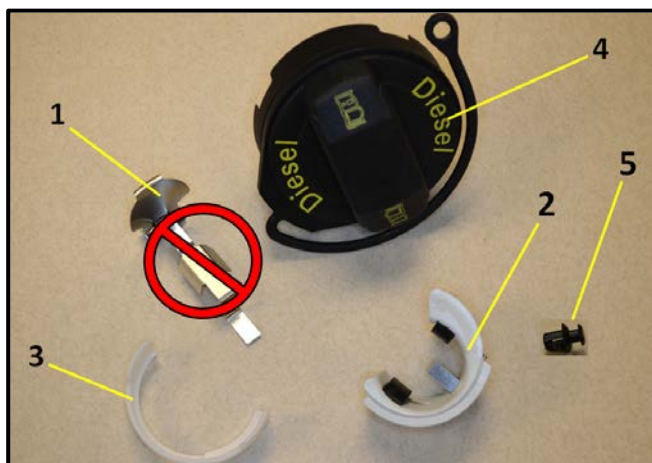
- ⇐ The misfueling guard kit p/n - 5K0 201 400 consists of five pieces (left) which must be installed in the following order:

NOTE: DO NOT INSTALL the spring loaded flap insert <1>.

1. Spring loaded flap insert. (**NOT USED**)
2. Fuel filler lockout mechanism.
3. Plastic retaining ring.
4. Replacement fuel cap w/tether.
5. Mounting pin for fuel cap tether (not used on A3 models).

Note: The plastic mounting pin (#5 above) included in the misfueling guard kit is not used on A3 models, and can be discarded.

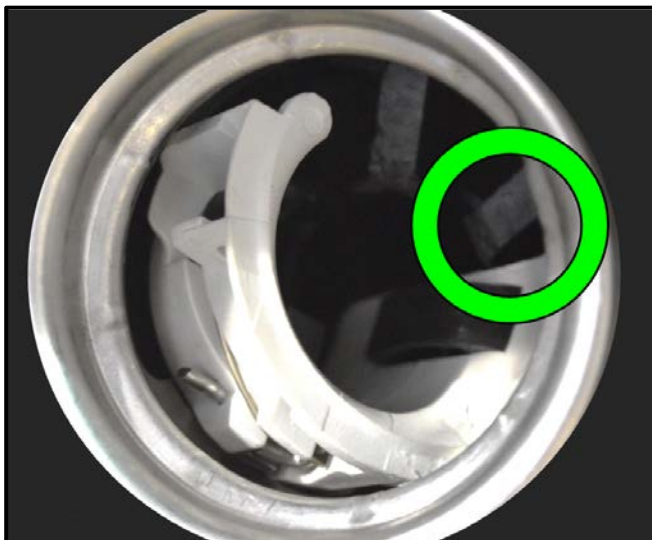
⇐ During installation the lockout mechanism must remain to the right of the right tab in the filler neck opening <circle>.

- With the right side of the lockout mechanism properly lined up, press the left side into the filler neck.

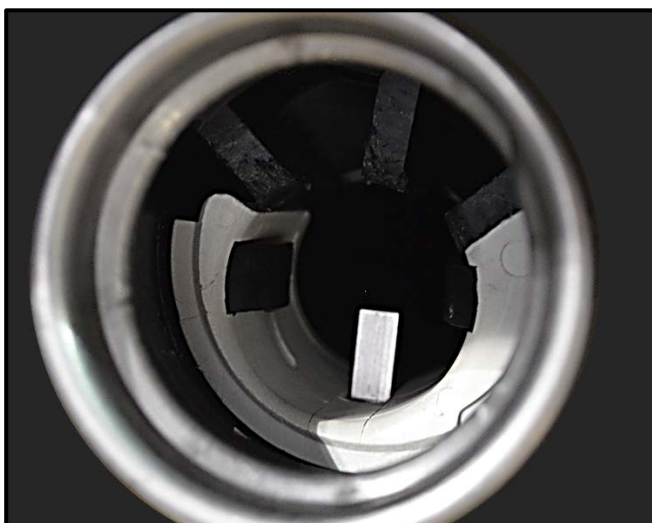
⇐ Align the lockout mechanism with the tabs in the filler neck, then push the lockout mechanism down into the filler neck until it is fully seated <as shown>.

Tip: The fuel filler lockout mechanism is fully seated into position when it bottoms out against the fuel filler neck <as shown>.

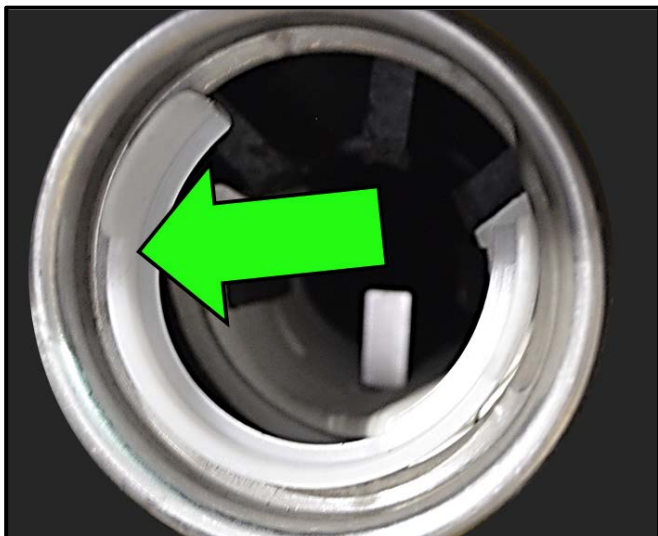
⇐ Insert the retaining ring into the filler neck <arrow>.

- The ring will lock into place at both the 9 o'clock and the 3 o'clock positions when fully seated against the lockout mechanism.
