HYUNDAI NEW THINKING. NEW POSSIBILITIES. Technical Service Bulletin	GROUP CAMPAIGN	NUMBER 15-01-007
	DATE FEBRUARY 2015	MODEL(S) Elantra Touring (FD)
SUBJECT: FRONT AND REAR UNDER BODY CORROSION PREVENTION TREATMENT (SERVICE CAMPAIGN TW9)

Description: This bulletin provides a preventative procedure to apply cavity wax and undercoating to the front and rear under body.

SUBJECT: FRONT AND REAR UNDER BODY CORROSION PREVENTION TREATMENT

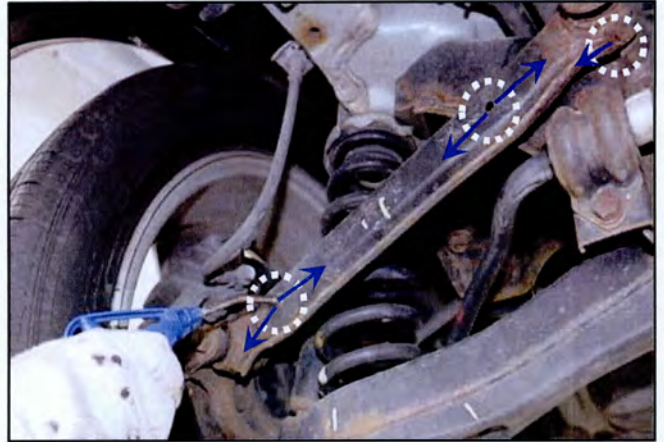
Left and right rear upper arms.

4. Remove the remaining debris in the components by inserting an air gun into the circled holes. Blow the air in multiple directions to remove as much debris as possible. Refer to the photos on the right.

Repeat this step two to three times to remove the remaining debris from inside the components.

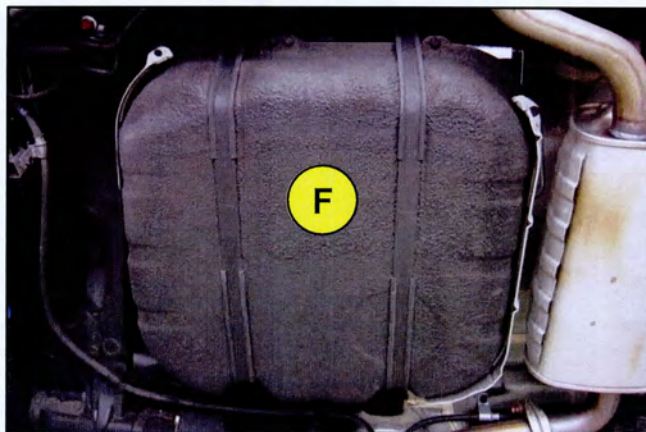
Top, bottom and sides of the fuel tank (F).

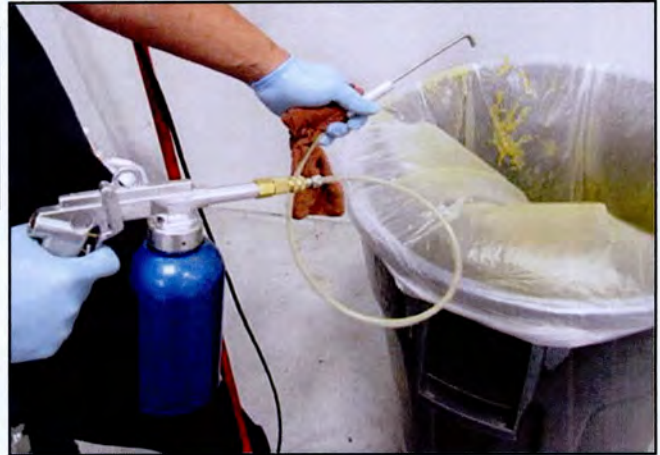
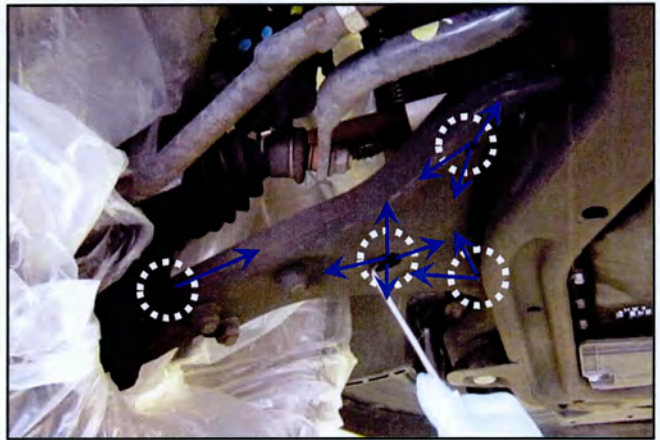
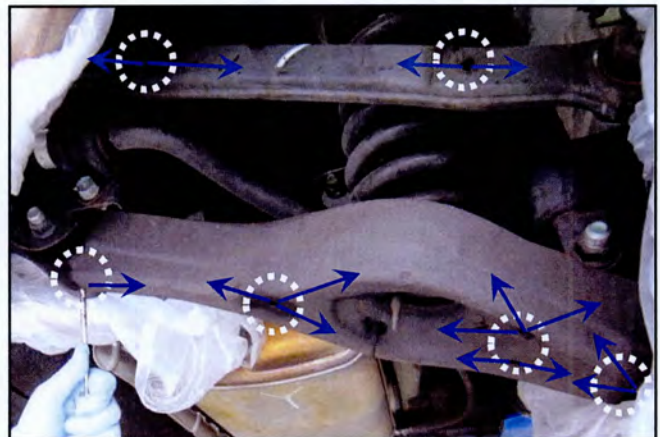
Left and right front lower arms.

Left and right rear upper and lower arms.

7. Spray cavity wax through the marked holes on the inside of the rear crossmember, front lower arms, and rear upper and lower arms. Spray in multiple directions to coat the interior surface. Refer to the photos on the right.

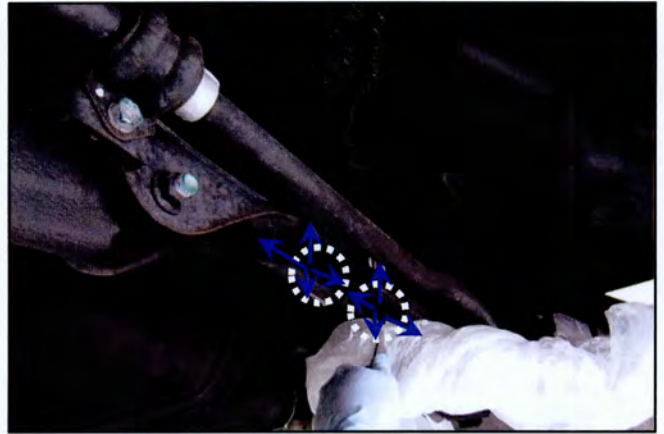
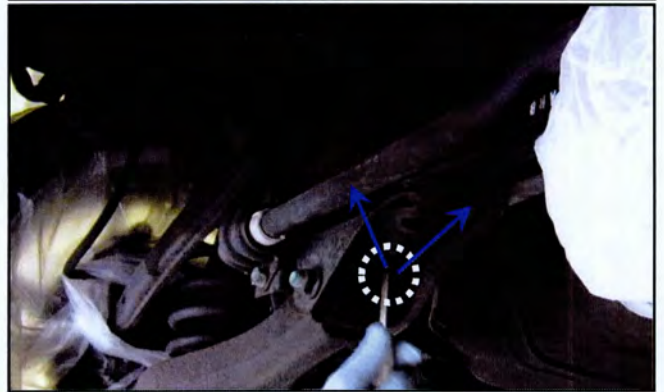
Rear crossmember.

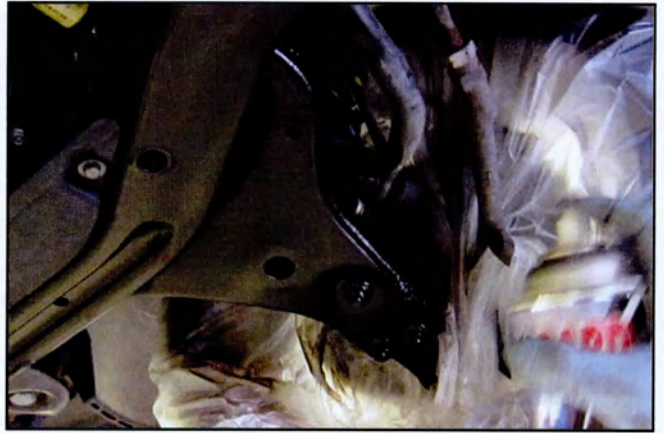
Left and right front lower arms.

- 9. Spray the black undercoating on all exterior surfaces of the front and rear crossmembers, front lower arms, rear upper and lower arms and fuel tank. Refer to the photos on the right.

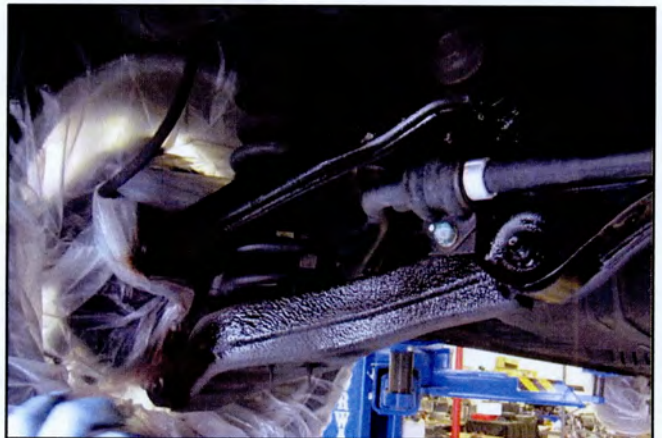
Left and right rear lower and upper arms.

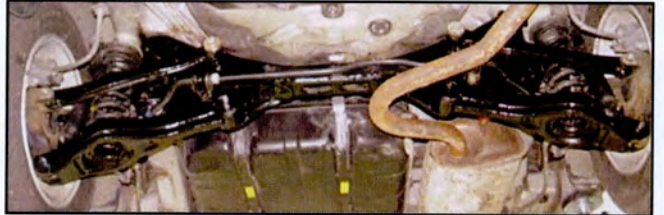
Rear lower and upper arms and crossmember.

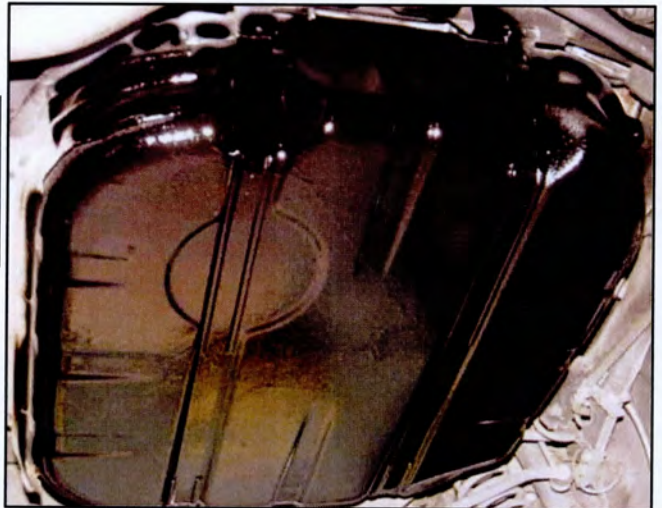
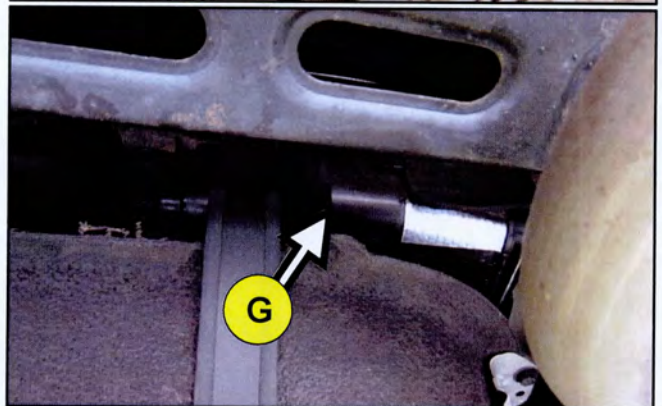
Fuel tank

Spray undercoating on all exposed areas of the fuel tank, including the top half. Avoid overspray on the evaporator canister (G) and hoses.
