Subject: Limited Service Campaign (LSC) FLA  
Certain 2013 Model Year GS 350 and GS 450h Vehicles  
Front Passenger Supplemental Restraint System

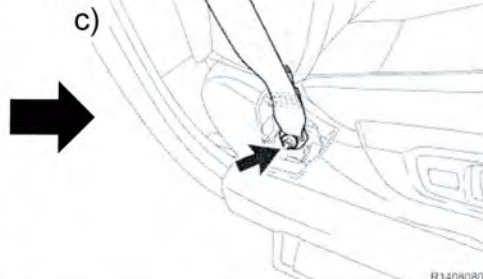
R1408080076

- a) Remove the head rest from the seat back.
- b) Remove the passenger seat belt anchor cover cap.
- c) Remove the front passenger seat anchor nut and remove the seatbelt anchor.
- d) Apply protective tape as shown to the lower portion of the seat belt.

Guide

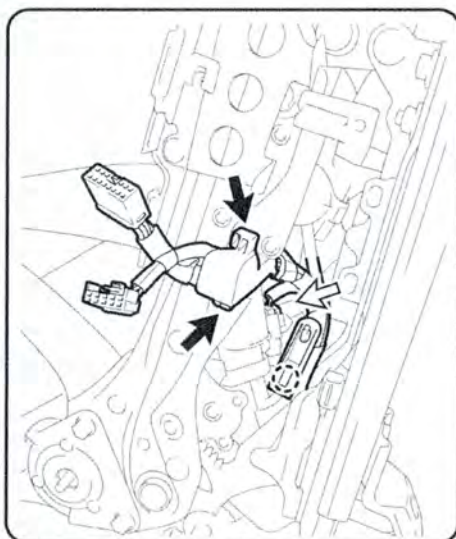
R1408080108

- a) Disconnect the 3 connectors.
- b) Disengage the claw.

○ : Claw  
↔ : Connector

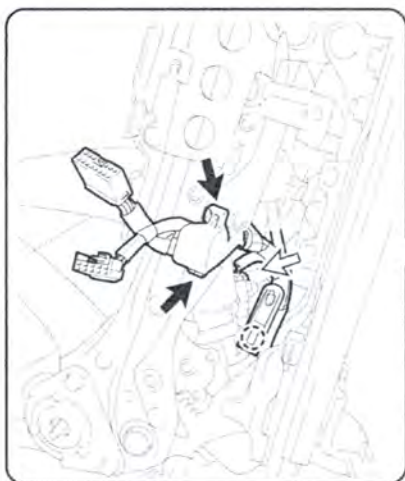
- e) Reconnect the 3 connectors and 7 clamps.
- f) Engage the claw.

○ : Claw  
 ◌ : Connector

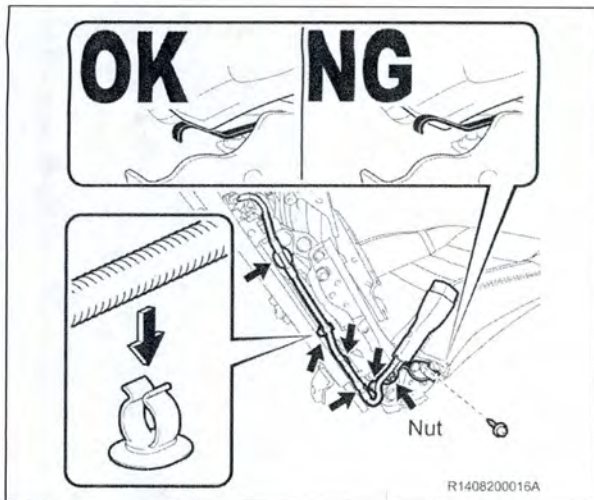
R1408080111A

d) Reinstall the limit switch with the screw.

**STOP** Install the limit switch firmly, or abnormal noise can occur.

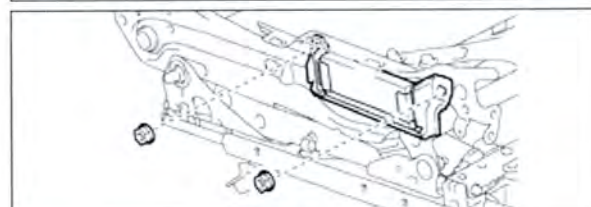
- Remove the connector lock from the seat heater control sub-assembly and remove the connector.

- Remove the seat cushion spring damper.

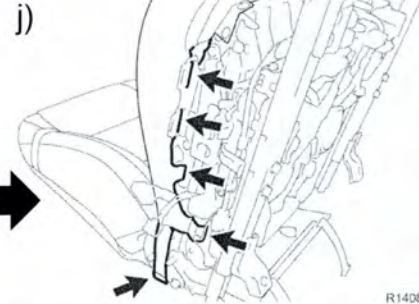
k) Remove the 6 clips.

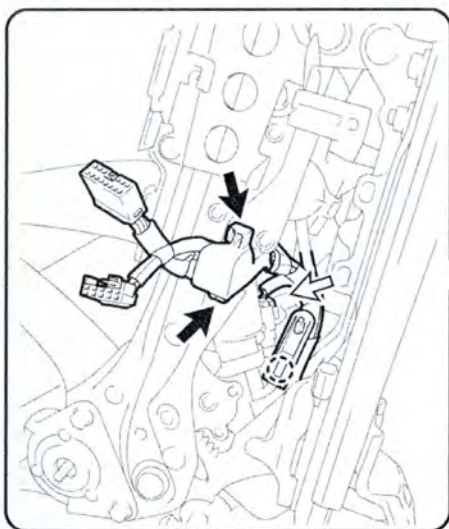
R1408190023

- a) Disconnect the 4 connectors and the 7 clamps.
- b) Disengage the claw and remove the 3 bolts.

○ : Claw  
← : Connector

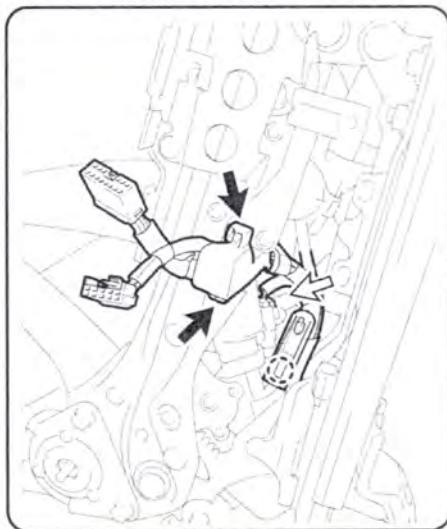
R1408190023

- e) Reinstall the 3 bolts.
- f) Engage the claw.
- g) Reconnect the 4 connectors and 7 clamps.

○ : Claw  
 ↳ : Connector

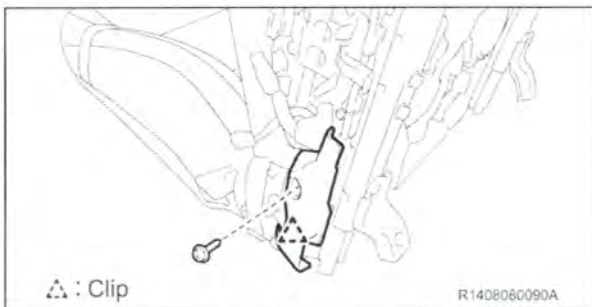
## 28. REINSTALL THE SEAT INNER CUSHION SHIELD

- a) Engage the 3 claws and guide.
- b) Reinstall the screw.

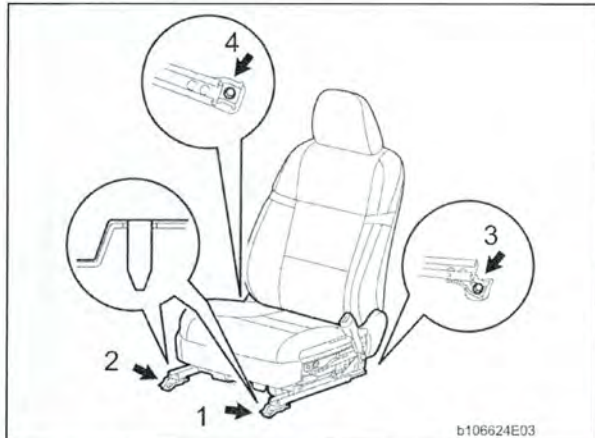
**Torque Spec:** 37N\*m (377kgf\*cm, 27ft\*lbf)

- The bolt torquing sequence must be followed, otherwise the OCS calibration may be incorrect.
- Follow the procedure to prevent the seat tracks from locking separately.
