Replace 12V Positive Jump Post, Warm Weather Regions

Classification	Repair Bulletin	Section/Group	17 - Electrical	Country/Region	See Affected VIN(s) Table
Year	2012-2014	Model	Model S	Version	All

Bolt Contacting Front Suspension Fore Link

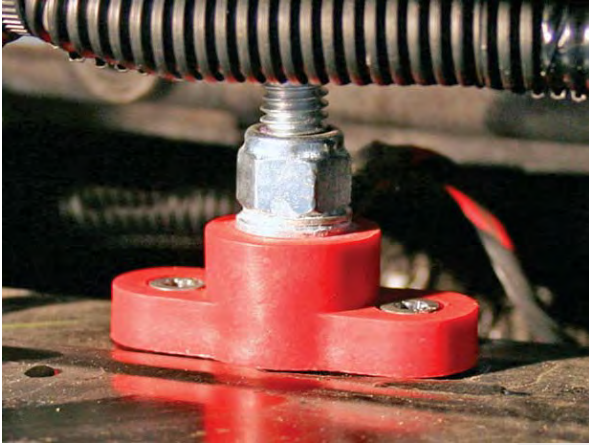
Figure 1

1. Remove the front underhood apron (refer to Service Manual procedure 12251002).
2. Inspect the 12V jump post:
 - If the vehicle has the first generation 12V jump post (Figure 1), continue to the “Prepare the New Jump Post” section.
 - If the vehicle has the second generation 12V jump post (Figure 2), discontinue this procedure.

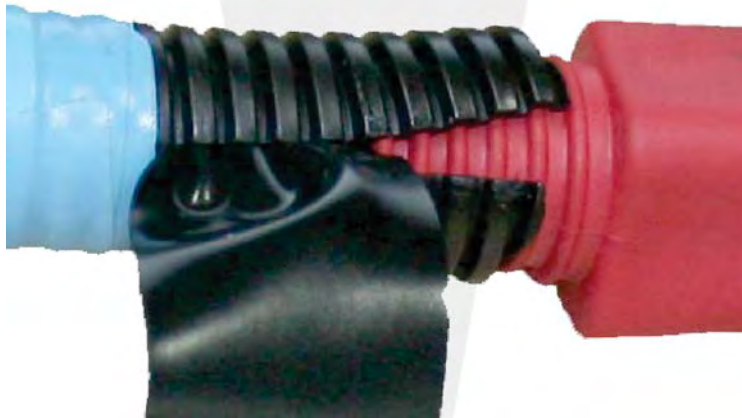
Figure 5

- Slide the corrugated tubing over the ribs at the base of the post so that the electrical tape passes through the slit in the tubing (Figure 5).

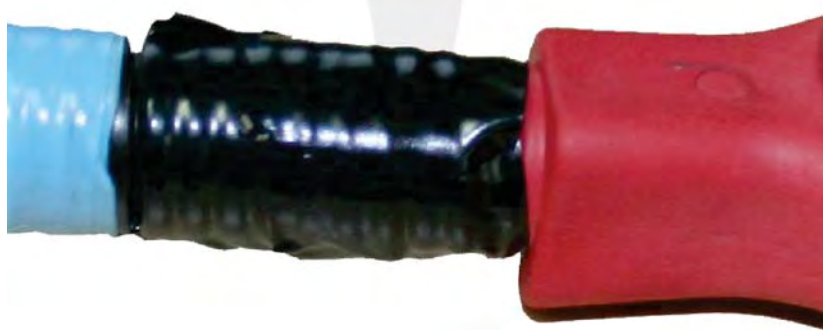
Figure 6

- Wrap the rest of the tape around the corrugated tubing, up to the base of the jump post (Figure 6).

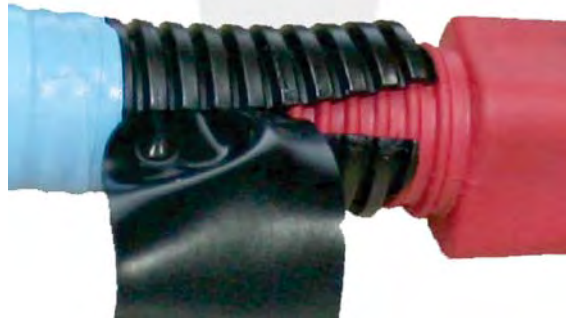
Figure 13

21. Route the electrical tape through the slit in the corrugated tubing (Figure 13).

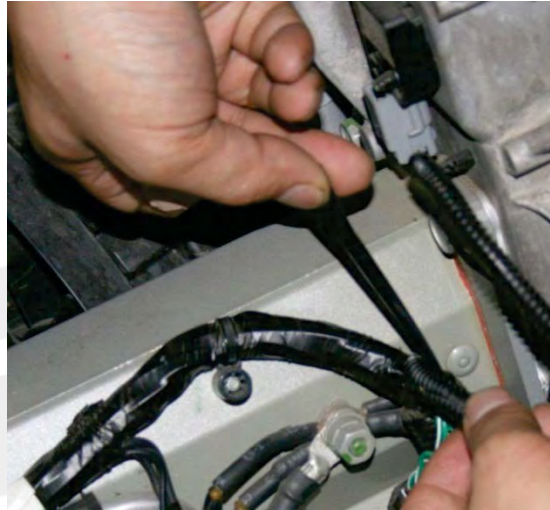
Figure 14

23. Apply 2 wraps of electrical tape around the junction of the corrugated tubing and the main harness (Figure 14). Ensure that the tape is secure so that the corrugated tubing does not slide on the wire; if necessary, add additional tape.
