Front Lower Control Arm Washer Installation

Classification	Campaign Bulletin	Section/Group	31 - Suspension	Country/Region	North America, Europe
Year	2012-2013	Model	Model S	Version	All

This Service Bulletin supersedes SB-13-31-003, dated 10-Dec-13. Each content change is marked by a vertical line in the left margin. Discard the previous version and replace it with this one.

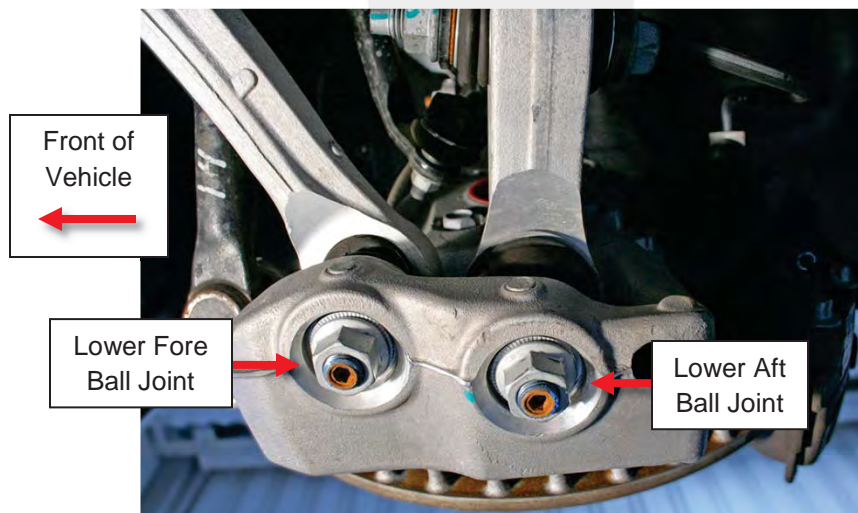
Figure 1 (RH side shown)

1. Remove the front wheels (refer to Service Manual procedure 34012401).
2. Check the front fore and aft lower control arms for visible play at the connections to the knuckle (Figure 1).
 - If there is no visible free play, skip directly to the “Wedge-Lock Washer Installation” section of this document.
 - If visible free play is found, continue to the next step in this procedure.

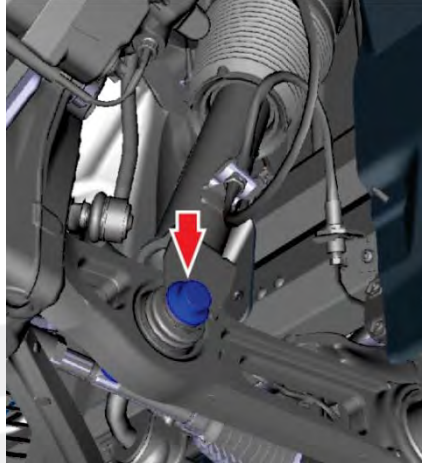
Figure 2

6. Remove the bolt and nut that hold the spring module to the lower aft arm (torque 140 Nm) (Figure 2).

7. Release the spring module from the lower aft arm.

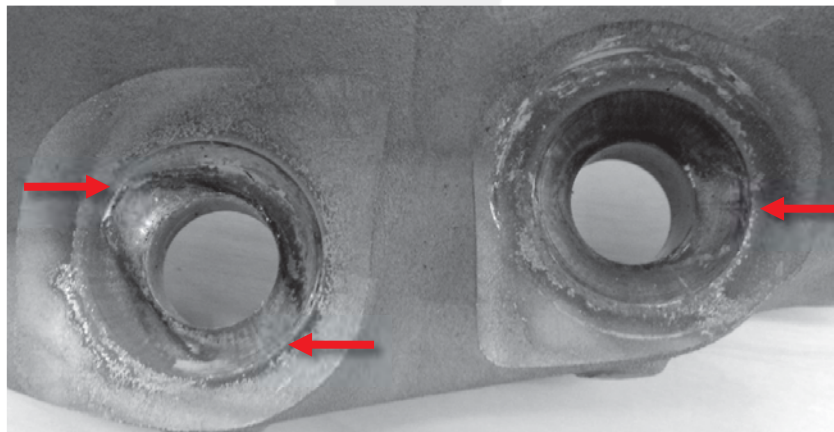
Figure 3

8. Hold the lower aft ball joint with a hex tool. Remove and discard the nut that holds the ball joint to the knuckle (torque 195 Nm).
9. Disconnect the lower aft control arm from the knuckle.
10. Inspect the ball joints and seating surfaces on the knuckles for shiny, oval-shaped wear marks. Examples of damage to the knuckle seating surfaces are shown in Figure 3.

11. Replace the knuckles if they have visible wear marks (refer to Service Manual procedure 31010102).
12. Replace the lower control arms if the ball joints have visible wear marks (refer to Service Manual procedure 31013402 or 31013602).
13. Continue to the “Wedge-Lock Washer Installation” section of this document.

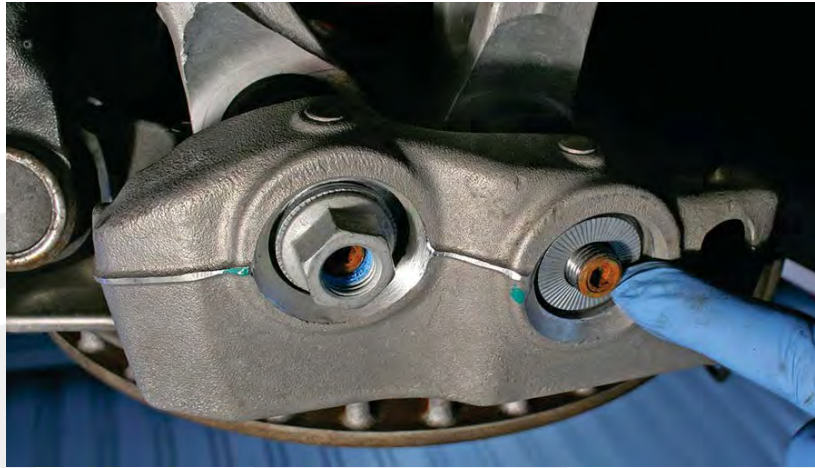
Figure 4 (RH side shown)

1. Remove and discard the 4 nuts that hold the lower control arm ball joints to the knuckle.
2. Install a wedge-lock washer on each ball joint stud, then loosely install a new nut (Figure 4).

3. Hold each lower control arm ball joint with a hex tool while torquing the nut to 195 Nm.
4. Check that there is no visible free play at the lower fore and aft control arms' connections to the knuckle.
5. Reinstall the wheels.
6. If the air springs were deflated, use Toolbox to inflate both front air springs.

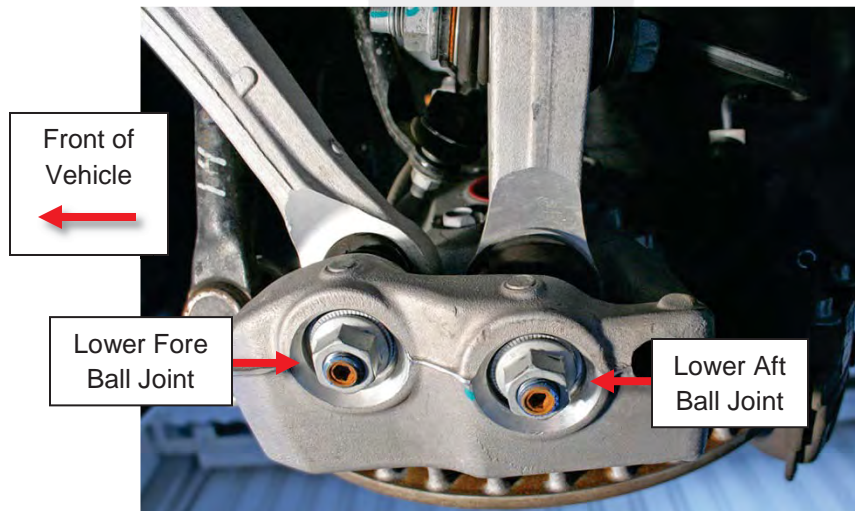
Figure 1 (RH side shown)

1. Remove the front wheels (refer to Service Manual procedure 34012401).
2. Check the front fore and aft lower control arms for visible play at the connections to the knuckle (Figure 1).
 - If there is no visible free play, skip directly to the “Wedge-Lock Washer Installation” section of this document.
 - If visible free play is found, continue to the next step in this procedure.

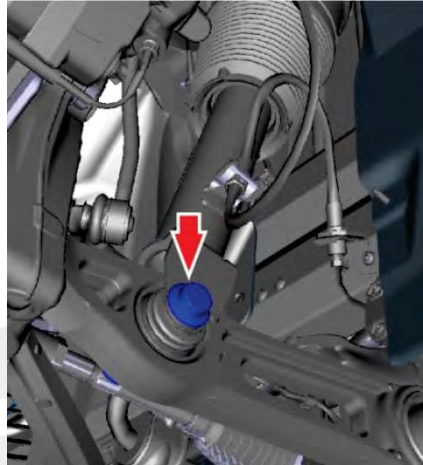
Figure 2

6. Remove the bolt and nut that hold the spring module to the lower aft arm (torque 140 Nm) (Figure 2).

7. Release the spring module from the lower aft arm.

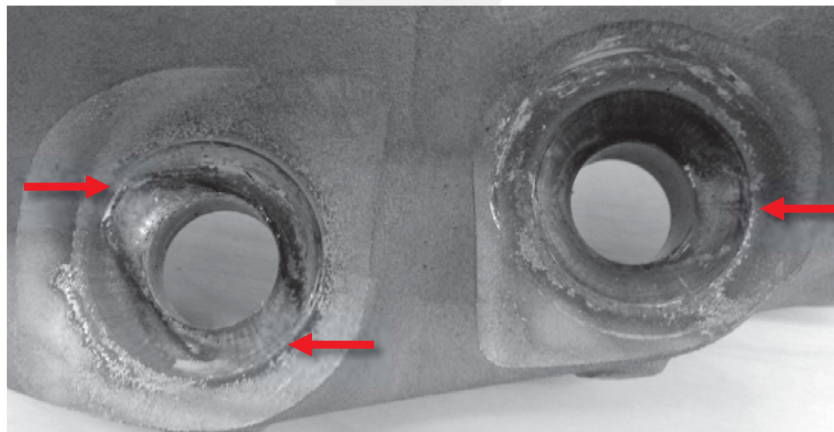
Figure 3

8. Hold the lower aft ball joint with a hex tool. Remove and discard the nut that holds the ball joint to the knuckle (torque 195 Nm).
9. Disconnect the lower aft control arm from the knuckle.
10. Inspect the ball joints and seating surfaces on the knuckles for shiny, oval-shaped wear marks. Examples of damage to the knuckle seating surfaces are shown in Figure 3.

11. Replace the knuckles if they have visible wear marks (refer to Service Manual procedure 31010102).
12. Replace the lower control arms if the ball joints have visible wear marks (refer to Service Manual procedure 31013402 or 31013602).
13. Continue to the “Wedge-Lock Washer Installation” section of this document.

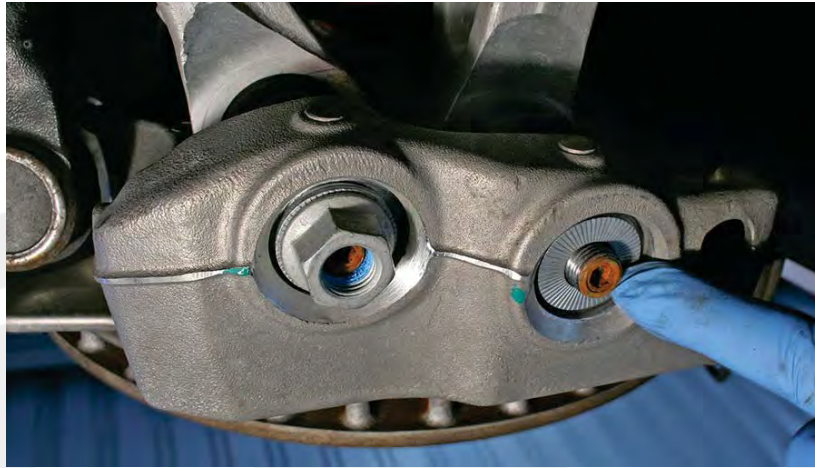
Figure 4 (RH side shown)

1. Remove and discard the 4 nuts that hold the lower control arm ball joints to the knuckle.
2. Install a wedge-lock washer on each ball joint stud, then loosely install a new nut (Figure 4).

3. Hold each lower control arm ball joint with a hex tool while torquing the nut to 195 Nm.
4. Check that there is no visible free play at the lower fore and aft control arms' connections to the knuckle.
5. Reinstall the wheels.
6. If the air springs were deflated, use Toolbox to inflate both front air springs.
