# Replace Prototype 12V Fuse Box Bracket

**Classification** Campaign Bulletin   **Section/Group** 17 - Electrical   **Country/Region** United States

**Year** 2014   **Model** Model S   **Version** Dual Motor

Some early dual motor vehicles were manufactured with a prototype 12V fuse box bracket.

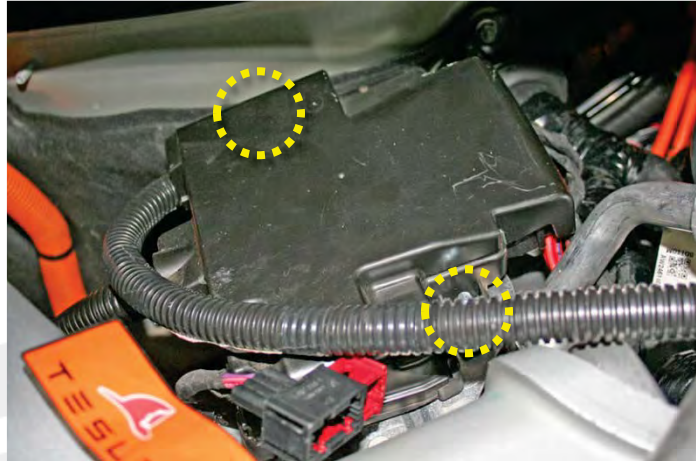
**Figure 3**

3. Remove the 2 bolts that secure the fuse box cover (Figure 3). Remove the fuse box cover.

38. Reinstall the 2 bolts that secure the fuse box cover (torque 3 Nm) (Figure 3).

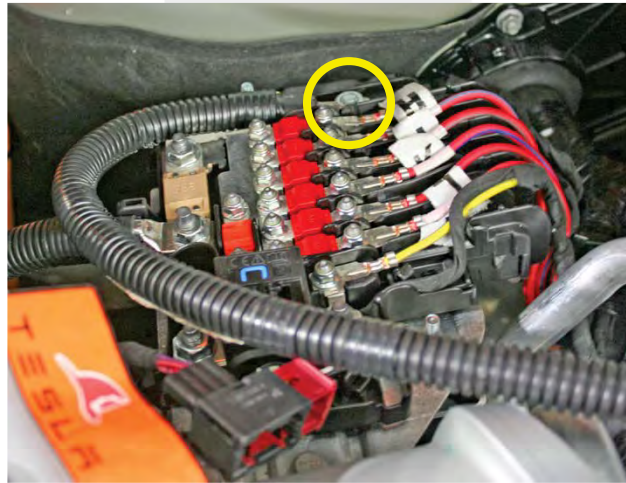
**Figure 4**

4. Remove the nut that secures the battery positive terminal to the rear of the fuse box (Figure 4).

37. Reinstall the nut that secures the battery positive terminal to the rear of the fuse box (torque 12 Nm) (Figure 4).

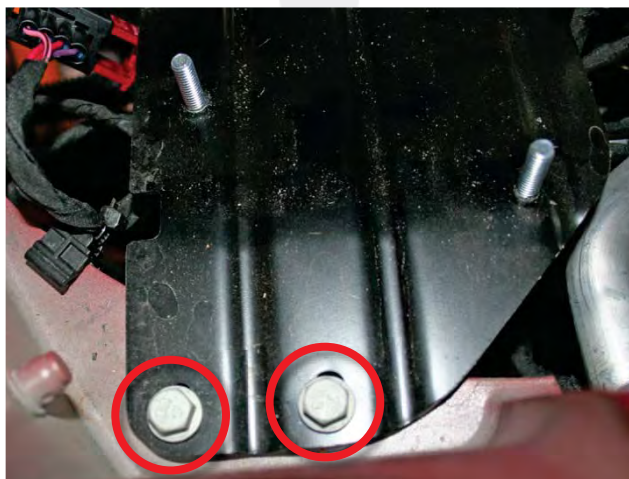
**Figure 8**  
**TESLA**

8. Remove and discard the 2 bolts that secure the front of the fuse box bracket to the shock tower (Figure 8).

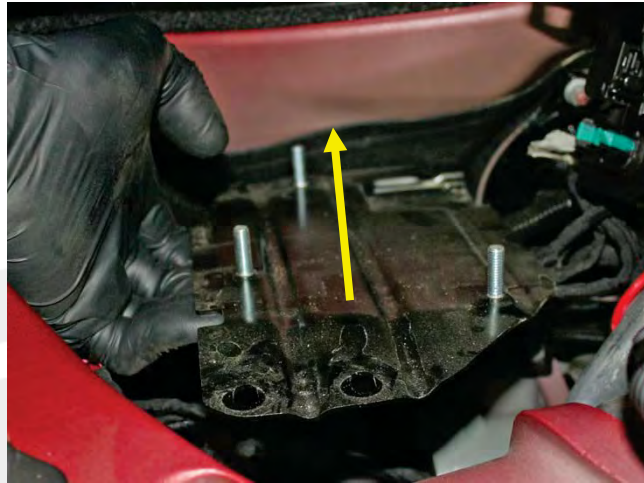
Figure 9

9. Bend the front of the bracket towards the bulkhead (Figure 9).

**NOTE:** It is okay to damage the bracket; it will be discarded later in the procedure.

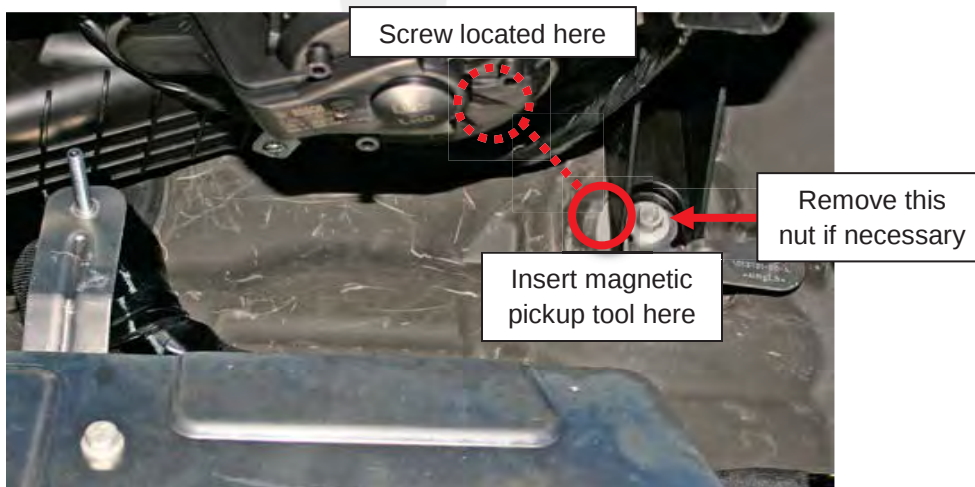
Figure 16

14. From inside the vehicle, remove the RH closeout extension (refer to Service Manual procedure 15191102).
15. Remove the RH footwell cover (refer to Service Manual procedure 14055402).
16. Fold the passenger footwell carpet away from the bulkhead.
17. Insert a magnetic pickup tool in front of the NVH padding to retrieve the screw from the bulkhead (Figure 16). Discard the screw.

**TIP:** It might be helpful to gently tap the tip of the screw towards the bulkhead from inside the frunk so that it is more accessible from inside the vehicle.

**NOTE:** If necessary, remove the nut that secures the bracket for the footwell stud.

**⚠ CAUTION:** Do not allow the screw to drop beneath the NVH material inside the vehicle.

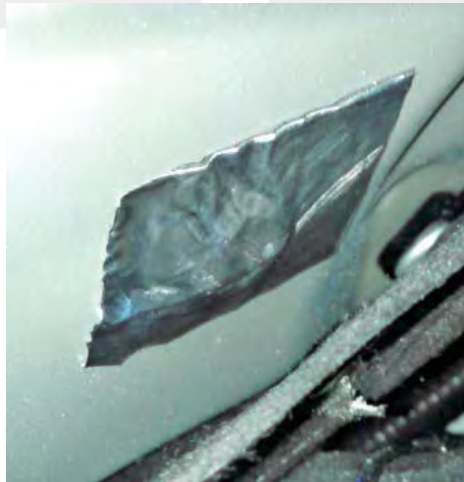
**Figure 17**

22. Apply a butyl foil patch over the hole in the bulkhead (Figure 17).

**NOTE:** Smooth out the entire surface of the butyl patch to ensure that it is fully adhered to the bulkhead and that all of the air bubbles have been removed.

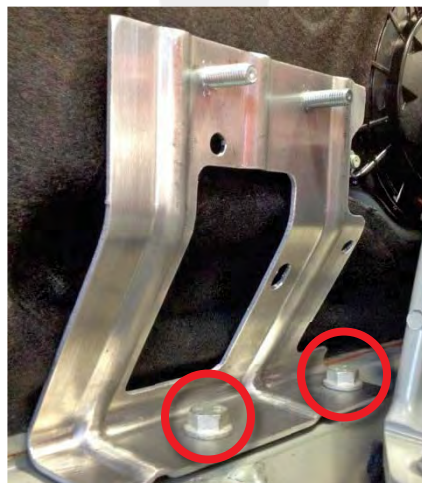
**Figure 18**

23. Install the 2 bolts that secure the new lower bracket (torque 19 Nm) (Figure 18).
