**NUMBER:** 23-027-15**GROUP:** Body**DATE:** June 20, 2015

Rear Door Rattle Noise

This bulletin involves testing left rear door lower latch operation and if necessary, replacing the rear door center striker in addition to the upper and lower rear door latches.

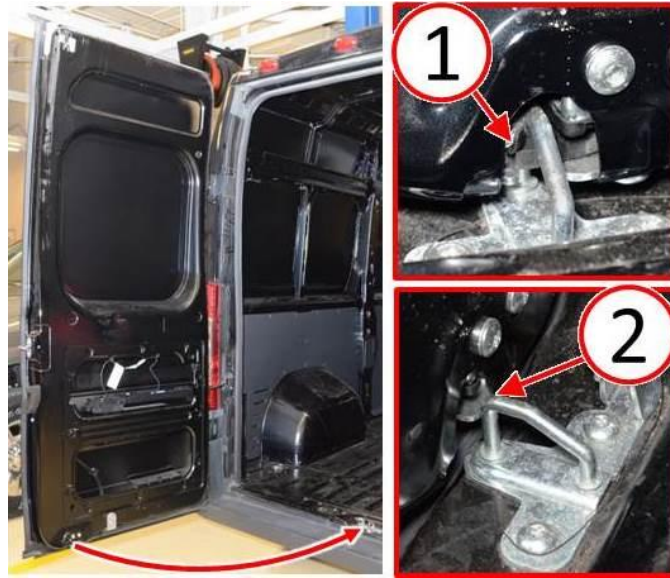
**Fig. 1 Left Rear Door Lower Latch**

The customer may describe a rear door rattle noise and/or a rear door lower latch not working properly. An example of a properly functioning latch (1) and malfunctioning latch (2) are shown in ([Fig. 1](#)).

1 - Proper Latch Operation - Latch Fully Engaged With Door Closed

2 - Latch Malfunction - Latch Not Engaged With Door Closed

1. Replace both right and left rear door upper latches. Refer to the detailed service procedures available in DealerCONNECT> TechCONNECT under: Service Info> 23 - Body> Doors - Rear> LATCH, Door, Rear Upper> Removal/Installation.
2. Replace the rear door lower latch. Refer to the detailed service procedures available in DealerCONNECT> TechCONNECT under: Service Info> 23 - Body> Doors - Rear> LATCH, Door, Rear Lower> Removal/Installation.
3. Replace the rear door center latch striker and fasteners. Refer to the detailed service procedures available in DealerCONNECT> TechCONNECT under: Service Info> 23 - Body> Doors - Rear> STRIKER, Door Latch> CENTER> Removal/Installation.
