## *SB-10058062-1804*

**FORD:**  
2015 F-150

Some 2015 F-150 vehicles equipped with an original Ford accessory tailgate liner may exhibit a warped tailgate liner.

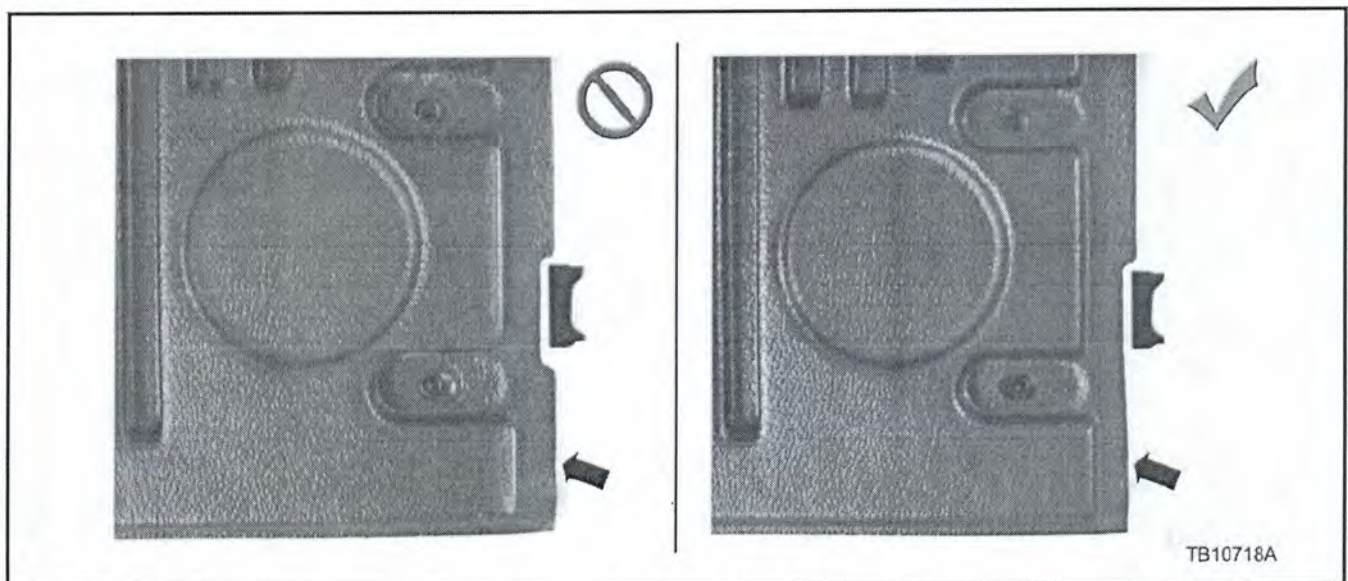
Figure 1 - Article 15-0076

1. Is the original Ford accessory tailgate liner warped?
  - a. No - this article does not apply.
  - b. Yes - proceed to step 2.
2. Inspect the tailgate liner outer edges. (Figure 1)

3. Have the outer edges of the tailgate liner been modified?
  - a. No - proceed to Step 4.
  - b. Yes - this procedure does not apply.
4. Install a tailgate liner replacement kit. Refer to Section 3 - Warranty Coverages - Service Parts Warranty, of the Warranty and Policy Manual for ordering instructions.
  - a. Refer to the installation instruction sheet included in the kit.
