SB-10058089-7770

SUBJECT: DELIVERY HOLD – Customer Satisfaction Program 15B14

Certain 2014 through 2015 Model Year Transit Connect Wagons

Third Row Seat Removal

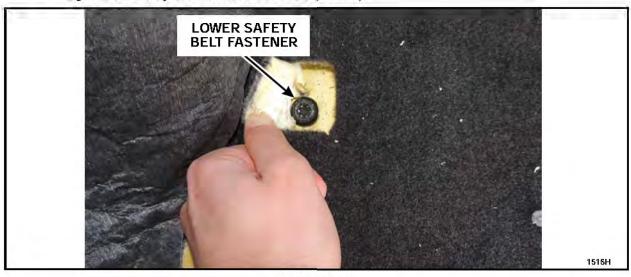
FIGURE 1

- 1. Remove the third row safety belt retractors. Please follow the Workshop Manual (WSM) procedures in Section 501-20.
- 2. Reinstall the lower safety belt fasteners (without safety belt). See Figure 1.
 - . Tighten the safety belt fasteners to 30 lb.ft (40 Nm).

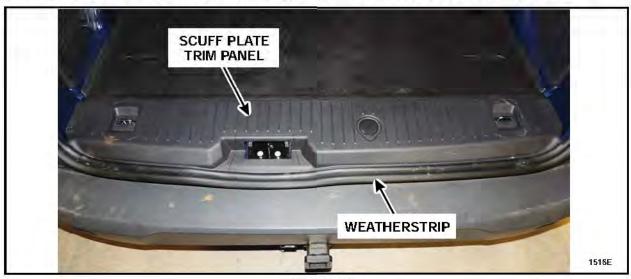
FIGURE 2

- 3. Remove the RH and LH D-Pillar trim. Please follow the WSM procedures in Section 501-05.
- 4. Position the weatherstrip aside and remove the rear scuff plate trim panel. See Figure 2.

- 13. Install the rear scuff plate trim panel. See Figure 2.
- 14. Install the new RH and LH D-Pillar trim. Please follow the WSM procedures in Section 501-05.

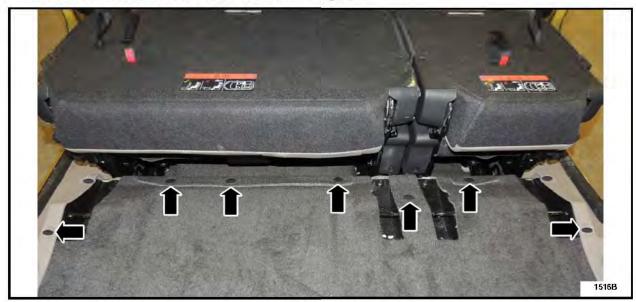
FIGURE 4

- 6. Place the second row seats in the stowed position.
- 7. Remove the floor cover retaining push-pins. See Figure 4.

- 10. Install the floor cover retaining push-pins. See Figure 4.
- 11. Return the second row seats to their original position.
- **NOTE**: There are two types of cargo hooks. If a *new* carpeted floor cover is being installed, the cargo hooks that were removed in Step 4 should be reinstalled. If installing a vinyl floor cover, a *new* set of cargo hooks should be used.
- 12. Install the two cargo hooks. See Figure 7.
 - Tighten cargo hook fasteners to 30 lb.ft (40 Nm).

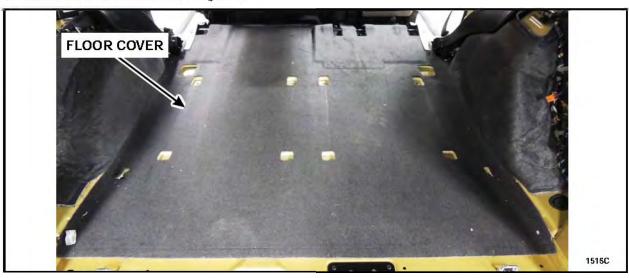
FIGURE 5

8. Remove the floor cover. See Figure 5.

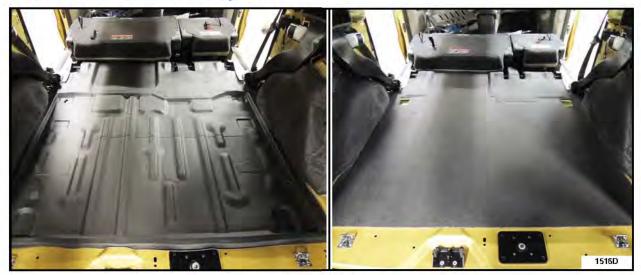
FIGURE 6

9. Install the new floor cover. See Figure 6.

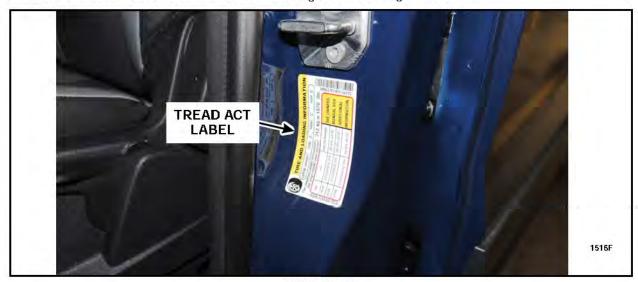
NOTE: Do not attempt to reposition the label. Once the adhesive touches the surface, any attempt to remove it will cause label damage.

- 1. With a damp cloth, wipe existing label clean of dirt or other contamination.
- 2. Install the new TREAD Act label over the existing label. See Figures 8 and 9.
