GROUP CHA	MODEL 2015MY Sedona (YP)
	NUMBER 053	DATE March 2015
TECHNICAL SERVICE BULLETIN		
SUBJECT: SERVICE ACTION: SEDONA (YP) HYDRAULIC STEERING RACK INSPECTION AND/OR REPLACEMENT (SA182)

SUBJECT: SERVICE ACTION: SEDONA (YP) HYDRAULIC STEERING RACK INSPECTION AND/OR REPLACEMENT (SA182)

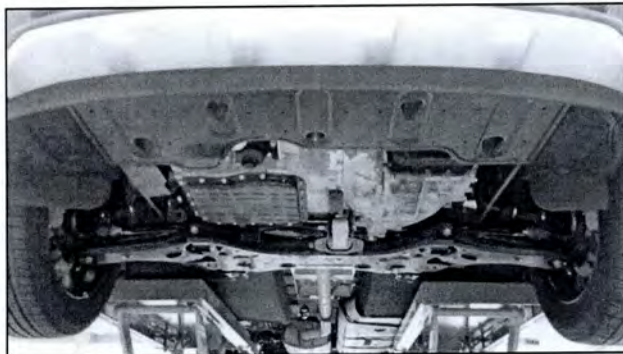
1. Place the vehicle on the lift.

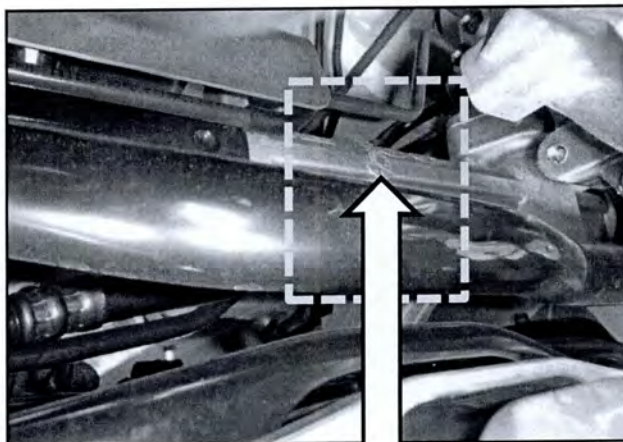
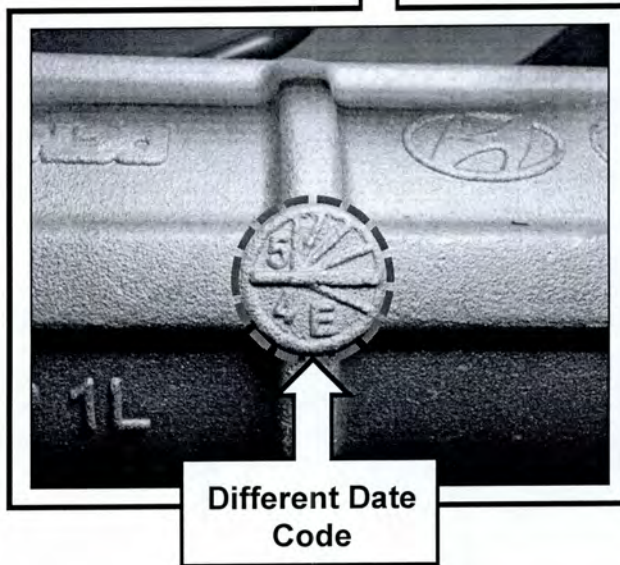
Reading the Date Code on the Steering Rack
4 J 1 7 (dots)

2. Locate the date code on the hydraulic steering rack. **NOTE: Refer to the table shown below to accurately read the date code information.**

A diagram showing a circular date code stamp on a steering rack. The stamp is divided into seven segments, numbered 1 through 7. Segment 1 contains the letter 'A', segment 2 contains '4', segment 3 contains 'J', segment 4 contains '1', segment 5 contains '7', segment 6 contains '1', and segment 7 contains '7'. Below the stamp is a legend with a circle containing the numbers 1 through 7 and the letters 'A' and 'J' arranged to match the stamp's segments. An arrow points from the legend to the stamp.

3. If the rack date code matches 4 J 1 7 (dots), replace the rack with an improved part. Proceed to the Service Procedure on Page 3.
4. If the date code is different than 4 J 1 7 (dots), do NOT replace the rack. No further action is required.
